**MARINE ACCIDENT
INVESTIGATION BRANCH**

SAFETY DIGEST

**Lessons from Marine
Accident Reports
1/2018**

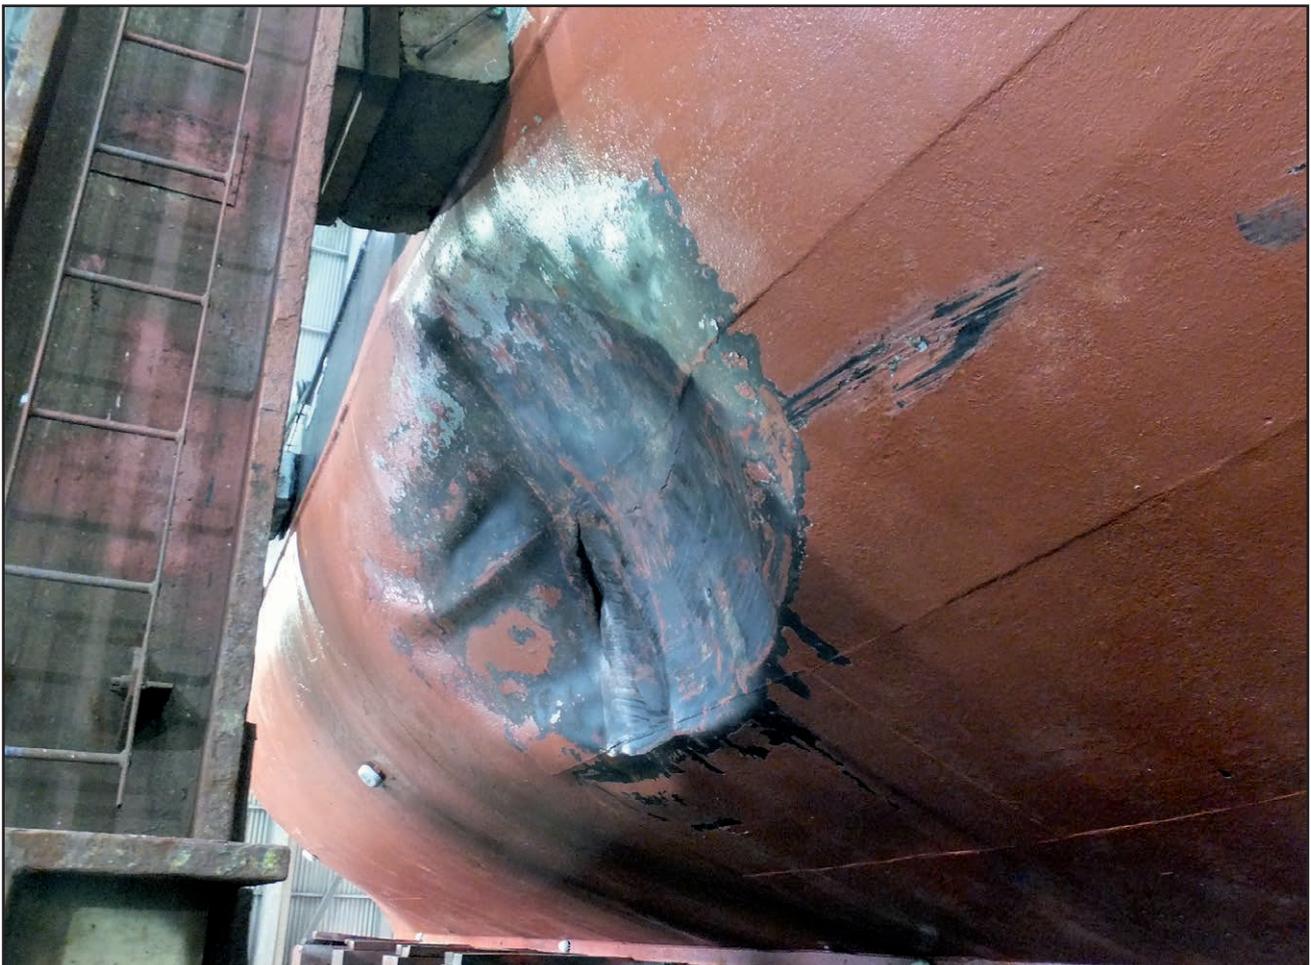
The bunker barge suffered a large indentation below the waterline where it was struck by the cargo ship's bulbous bow (see figure). There was also significant flooding of the vessel, the main engine seized and there was some pollution from leaking fuel cargo.

Figure: Indentation in the bunker barge's hull caused by the cargo ship's bulbous bow

4. Understanding stability is critical for maintaining the safety of your vessel, especially if it is damaged. In this case, the master of the bunker barge pumped water into the vessel without understanding the effect on the damaged stability. This made the stability situation worse, not better, and could have resulted in the loss of the vessel and, potentially, the lives of him and his crewman.

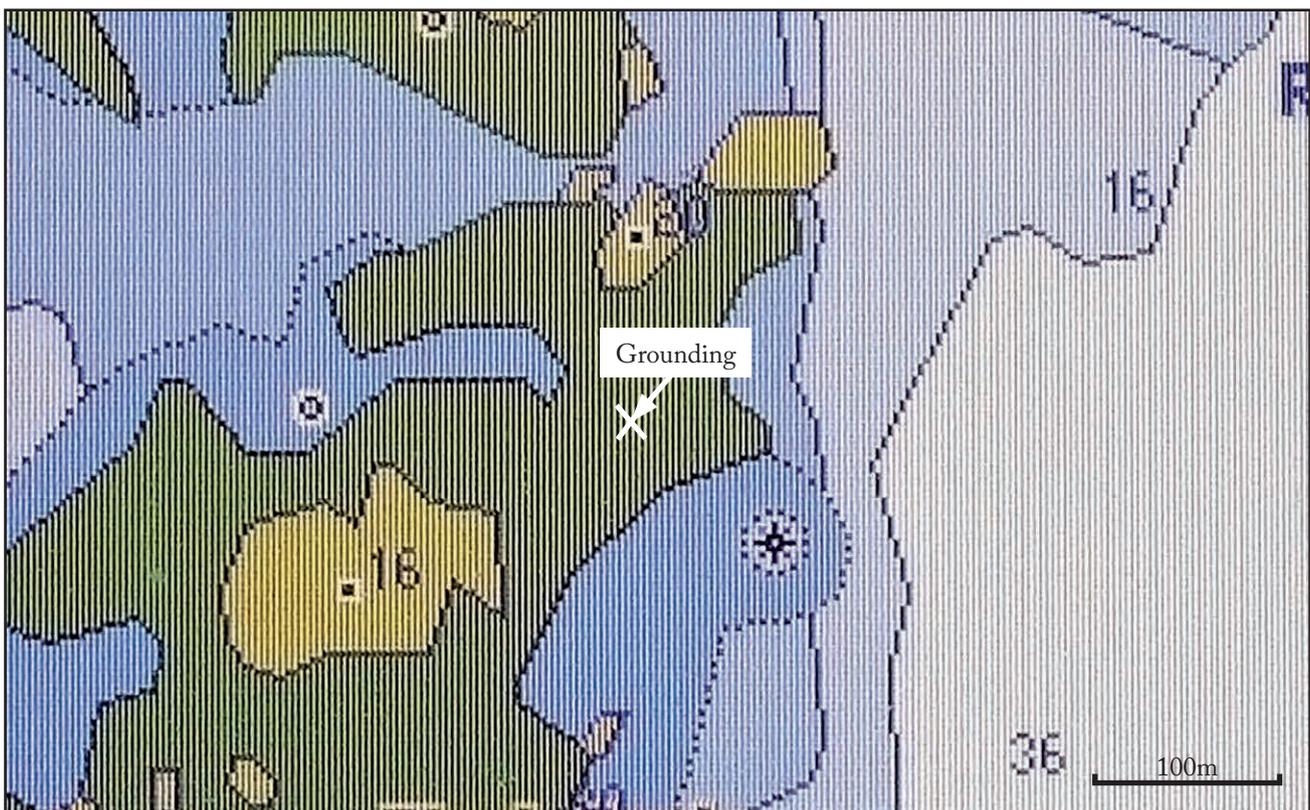
Figure: The grounding location on the intertidal area of the chart where no drying heights were shown

1. Whatever the nature of a vessel's task, every voyage needs to be properly planned and every plan should identify all the potential hazards that need to be avoided. In this case, the grounding occurred in an intertidal zone; this is the area between the high and low water marks and is coloured green on paper charts and electronic plotters. Navigating in intertidal areas needs to be undertaken with extreme caution. If there is a drying height (shown as an underlined number), it is possible to navigate safely where there is sufficient height of tide to account for the hazard heights and under keel clearance. However, in this case, there were no drying heights in the bay where the accident happened (see figure). This meant that the skipper was reliant on local knowledge or visual observation to prevent grounding. Unfortunately, the skipper was unaware of the exact location of every hazard at all states of the tide and had not seen the rock ahead, resulting in the grounding.

2. Electronic navigation aids can provide vital additional information for staying safe, especially in shallow waters. This historic passenger boat was not fitted with an echo sounder and the plotter's electronic charts were 10 years out of date. Although an echo sounder might not have provided sufficient warning to prevent this grounding, it would have aided the skipper's situational awareness. When persistently operating in the same shallow hazardous areas, familiarity with local depths would have been gained through echo sounder observations. Equally, keeping electronic charts up to date is important and simple plotter functions such as waypoints and cross track error alarms are helpful navigational features.

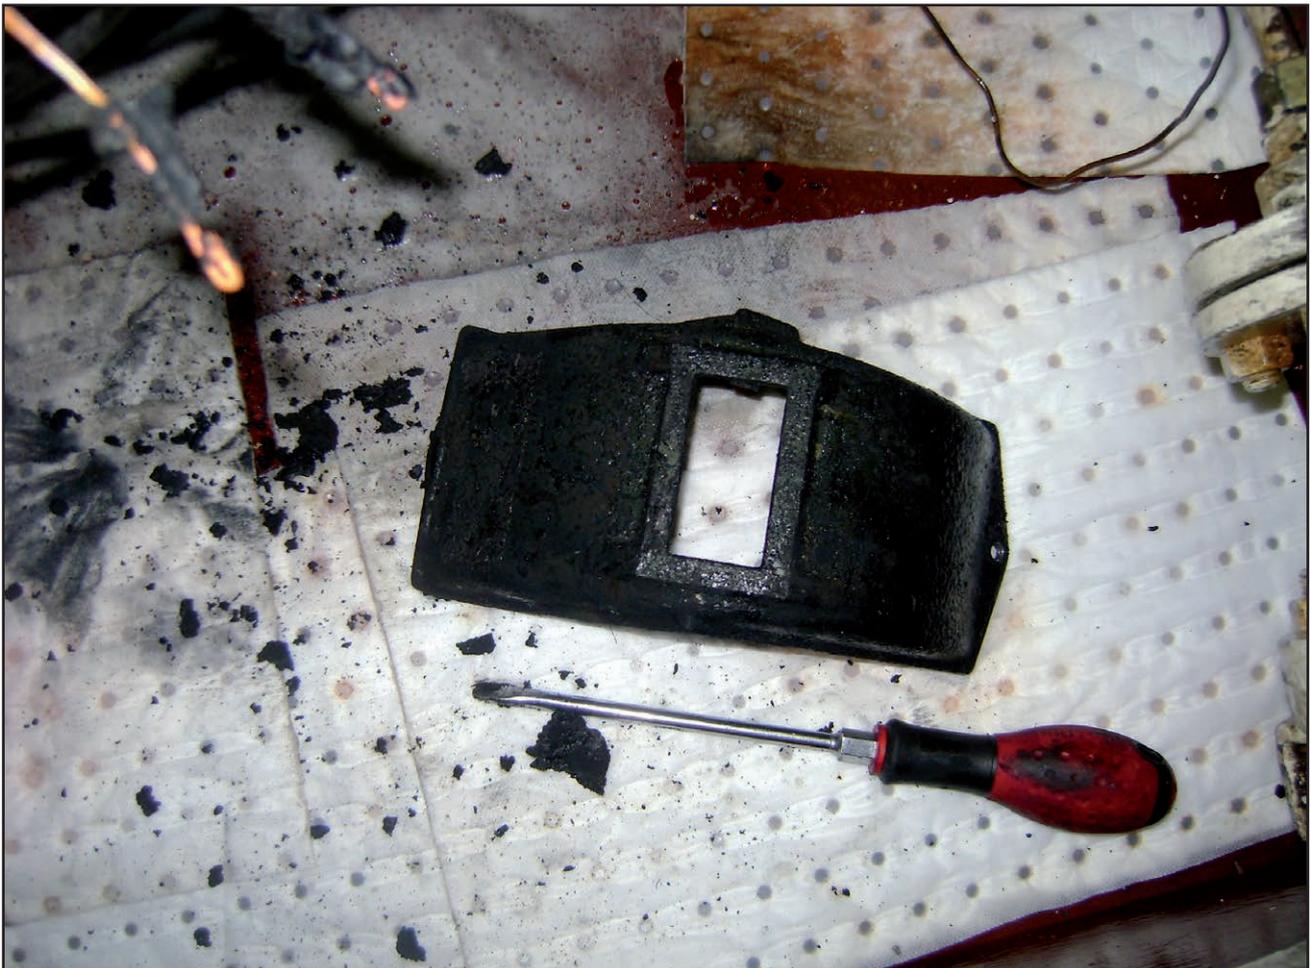
Shortly after the boiler began operating, the engine room fire alarm activated, indicating a fire in the vicinity of the auxiliary boiler. The vessel's engineers were mustered and sent to the engine room to investigate. When they approached the auxiliary boiler they saw flames inside the burner casing and smoke entering the engine room through the burner unit's

Figure 1: The burner unit's melted sight glass

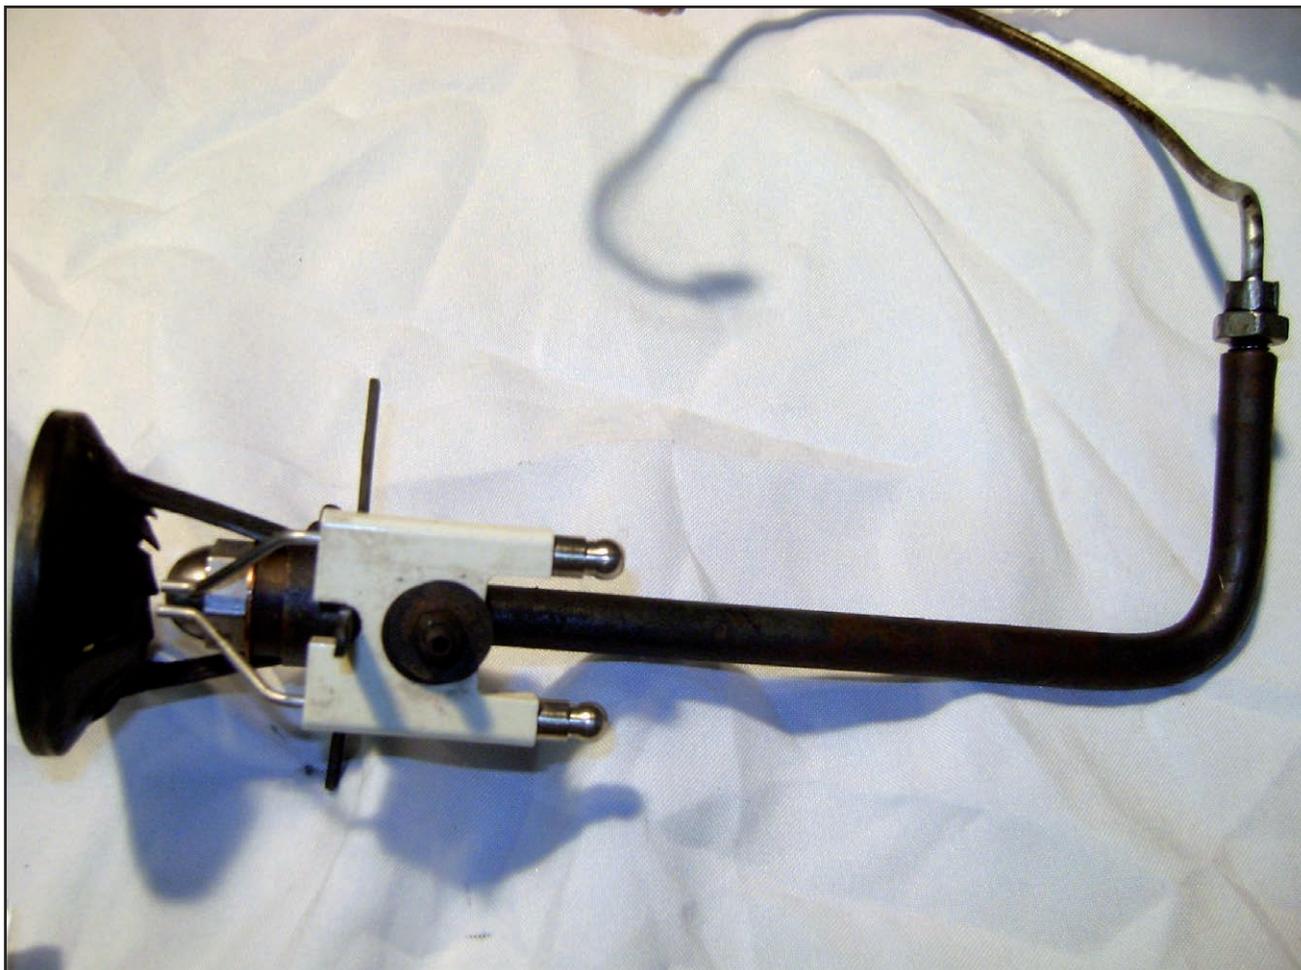
When the boiler was examined, the engineers found that the internal fuel supply pipe to the burner nozzle (Figure 2) was leaking at a compression fitting. When the pipe was removed, one of its compression fittings was found to be worn and damaged to the point it could no longer provide a seal against the fuel pressure. Fortunately, in this case, the consequences of the fire were not serious. However, boiler explosions, including those resulting in fatalities, have occurred when there has been fuel leakage into a boiler furnace.

Figure 2: The leaking internal fuel supply pipe to the burner nozzle

1. Regular inspections of the boiler burner unit required the routine removal and refitting of the fuel supply pipe. This provided the opportunity for the condition of the pipe fittings to be assessed. However, as in this case, it also introduced the risk of damaging the seals. All work carried out to the fuel pipework and compression fittings should be closely inspected before being fitted; a zero tolerance on wear and damage will help minimize the risk of fuel leakage and the subsequent introduction of a fire danger.

2. Periodic inspections and maintenance are key to ensuring that equipment and machinery are performing correctly, and enable defects to be identified and rectified. Nevertheless, if the maintenance work introduces faults into the system then this is clearly counterproductive. Formal re-start procedures after an inspection should help ensure that leaks and ill-fitting parts are identified and addressed.

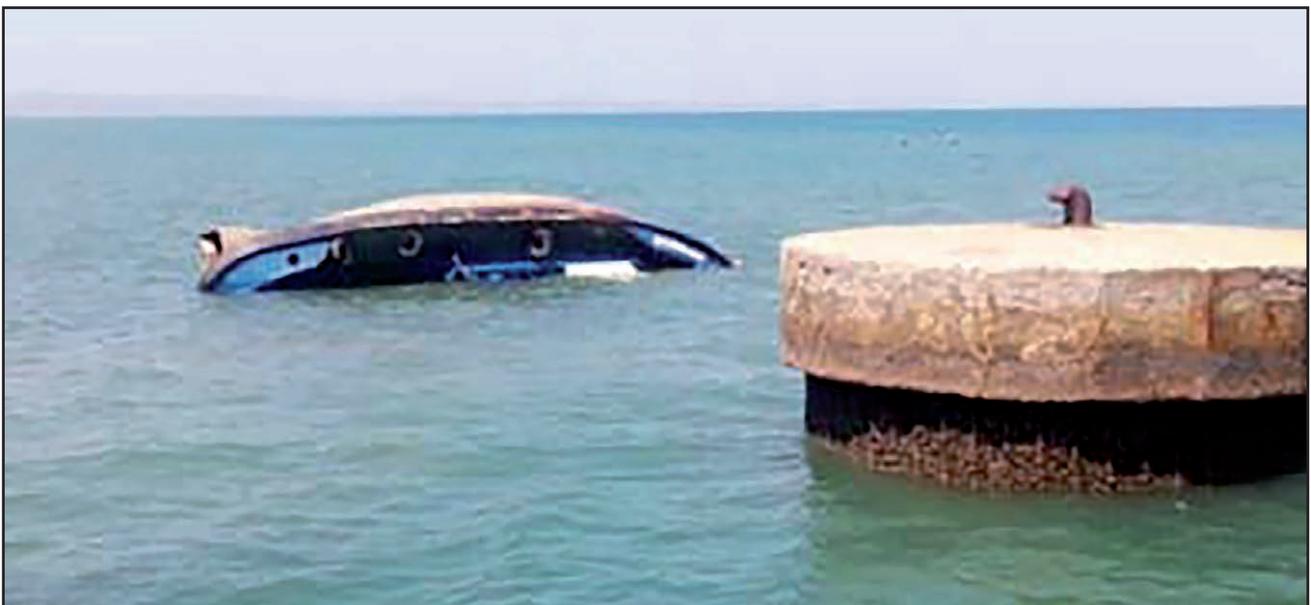
The tug was connected to the ship's port quarter to help pull its stern off the berth. During the manoeuvre, the prevailing wind and tidal conditions caused the ship to move towards an outlying mooring dolphin. To avoid striking it, the ship's master briefly increased ahead speed to 5kts, during which time the tug girted and capsized.

Figure 2: The capsized tug

1. The girting and capsize of tugs is an ever present risk if towing operations are not managed and executed safely.
2. Girting can rapidly lead to a tug capsizing. It occurs when high athwartships towing forces cause a tug to be pulled sideways through the water by the towline. If the tug is unable to manoeuvre out of this position it is likely to capsize. Single screw tugs with a low freeboard are at particular risk of girting.

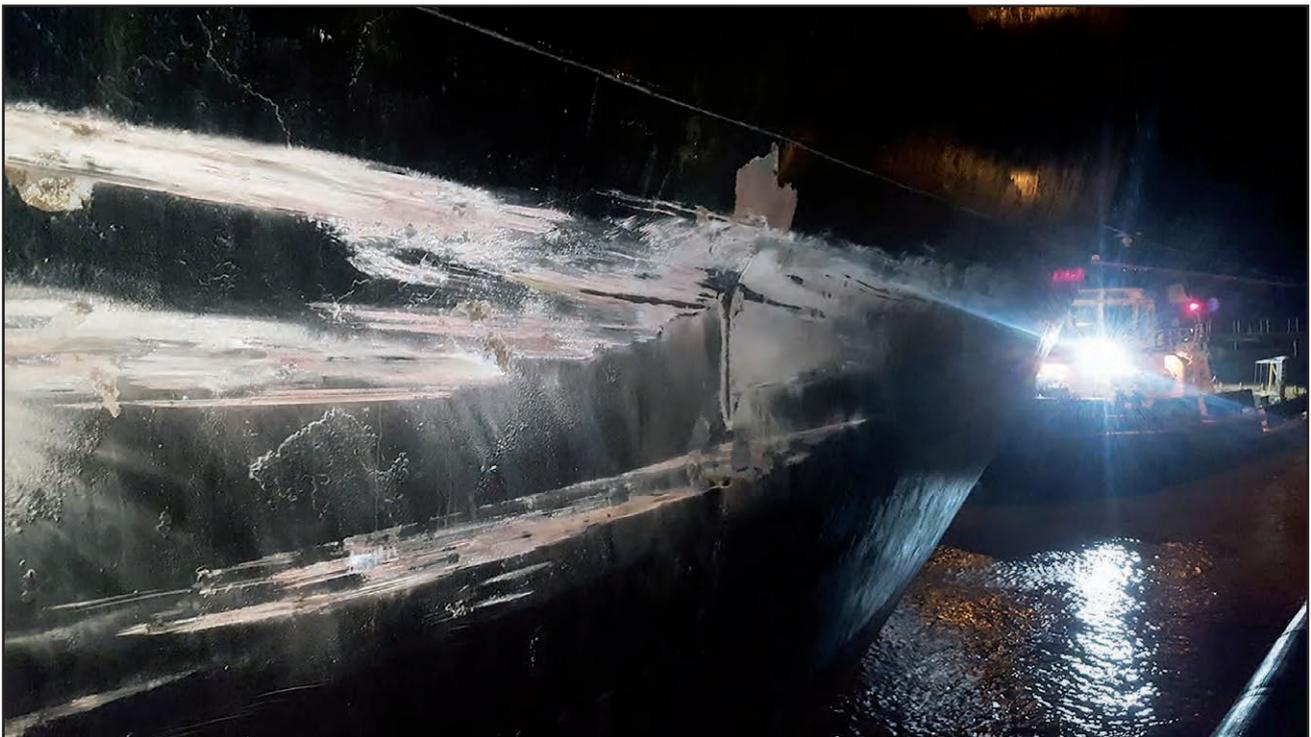
The pilot ordered full astern, and the tug that was helping with alignment moved quickly in an attempt to counter the resulting ship's swing to starboard. However, the ship's port quarter contacted a pier leading up to the lock entrance, causing damage to the ship's port side (Figure 1).

Figure 1: Damage to ship's port side

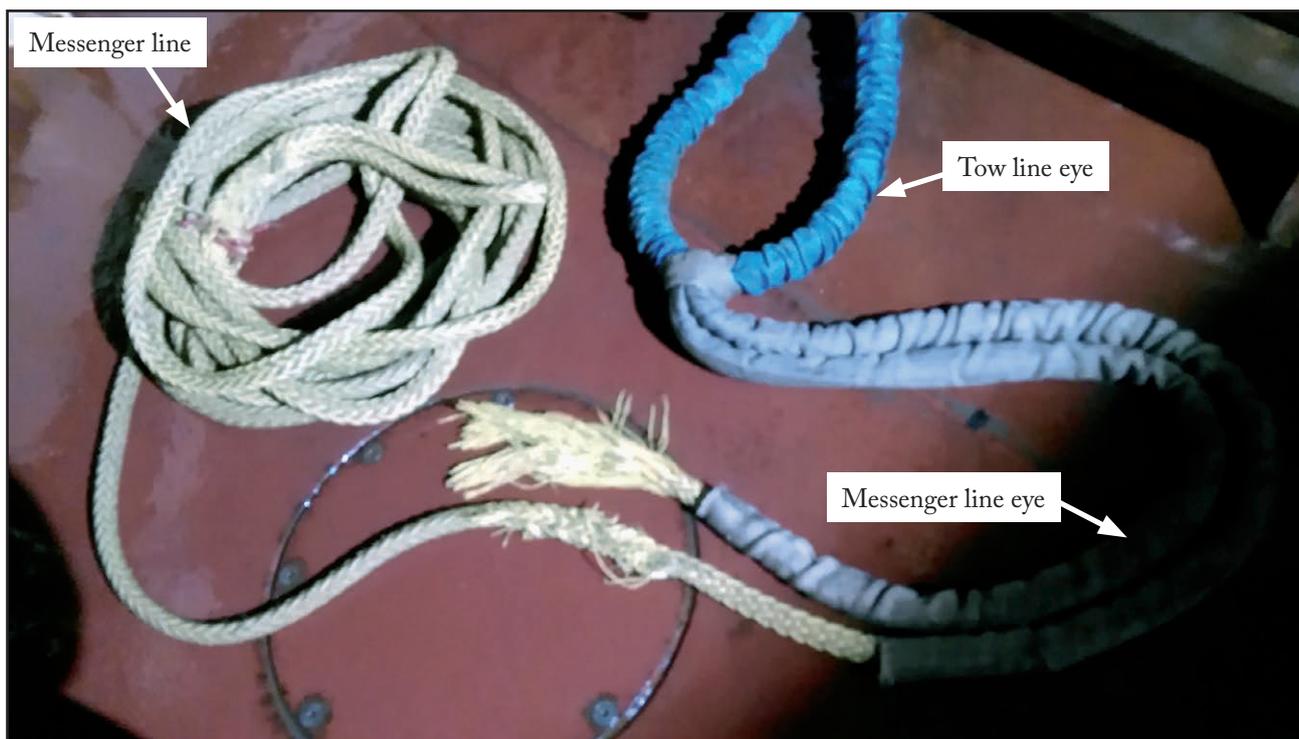
The tug recovered the parted line back on board. The messenger rope's eye, which was connected to the eye of the main towline, had parted (Figure 2). The crew on the bulk carrier's aft mooring deck had mistakenly placed the eye of the messenger rope rather than that of the towline over a bitt to make the towline fast.

Figure 2: Parted messenger line eye

1. The messenger line's eye was similar in size to that of the towline and large enough to be readily placed over the aft deck mooring bitt. Although the cordage used for the messenger was smaller in diameter than the towline, the sleeves used on the eyes of both ropes were similar in appearance and led to the crew mistakenly placing the wrong eye over the bitts. The use of different coloured sleeves might have prevented the confusion.
2. Towing operations in harbour are routine tasks that are potentially hazardous or, as in this case, can lead to avoidable accidents if crew members fail to keep their wits about them at all times.

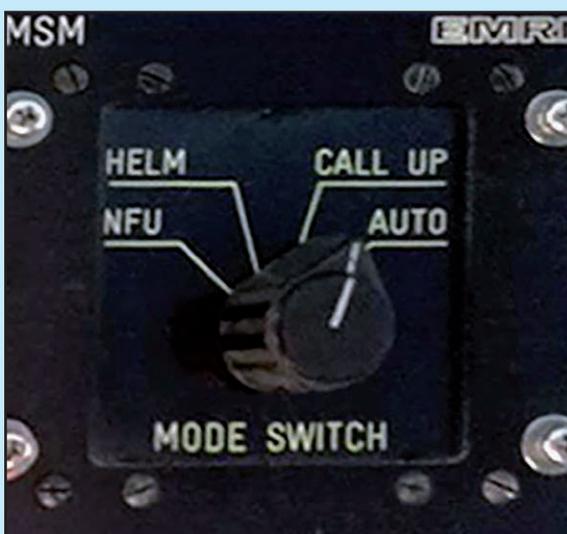
1. The steering mode selector switch at the centreline helm console had four settings: 'auto', 'helm', 'call up' and 'nfu'¹ (Figure 1). The normal procedure when changing from autopilot to manual steering was to change the selector switch setting from 'auto' to 'call up'. The 'call up' setting allowed the vessel to be steered manually from the centreline helm console, and when a selector button was pressed on the bridge wing, to then be steered from the bridge wing. On this occasion, the selector switch was inadvertently changed to the 'helm' setting, which allowed manual steering from the centreline helm console only.

Figure 1: Steering mode selector switch

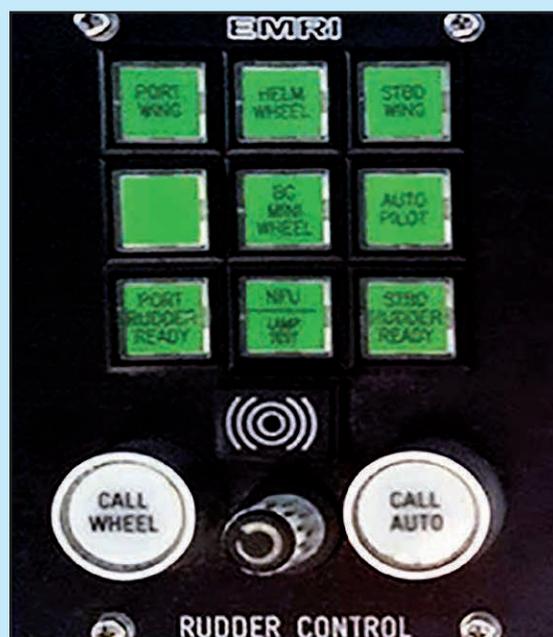
The bridge team no longer recognised the value provided by the indicator light panel.

Figure 2: Helm control station indicator light panel

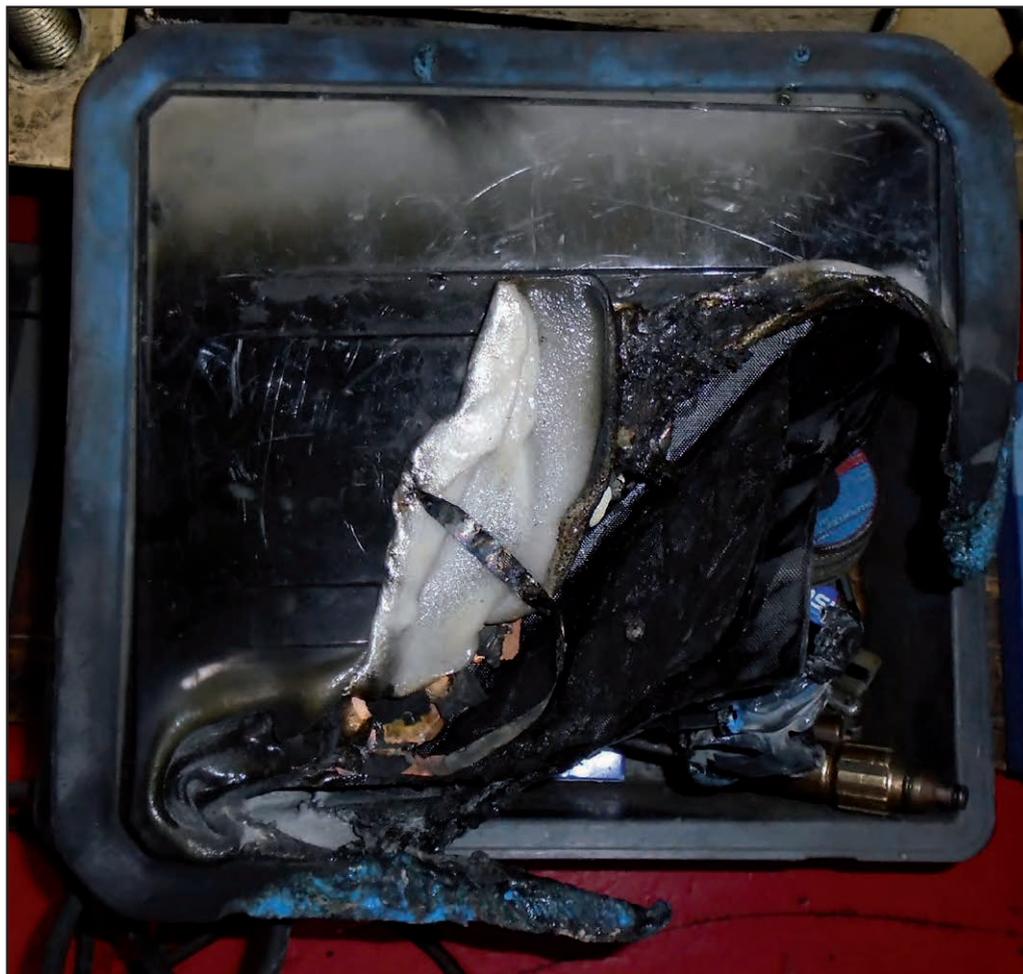
Investigations revealed that a portable light unit, used earlier in the day, had been left at the bottom of the boiler and that sparks from the cutting process had caused the unit to ignite. The contractors had reacted quickly and had extinguished the fire using fire-fighting equipment that had been located close to the work-site as part of the PTW requirements.

Figure 2: Damaged light unit

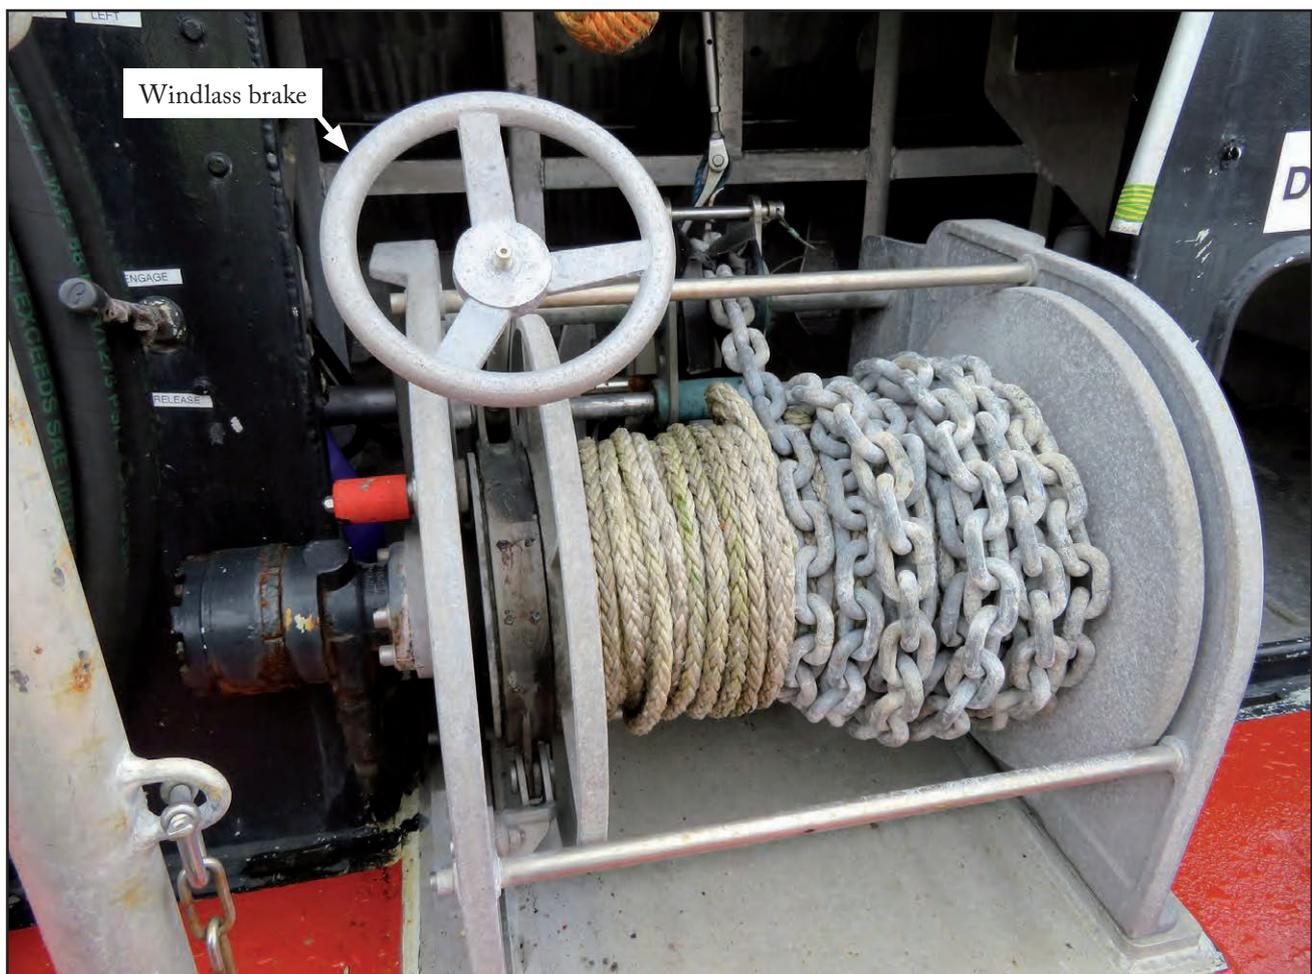
About 4 hours later, the low fuel pressure alarm on the starboard engine sounded. In response, the master ordered his crewman to prepare the anchor for letting go. As the crewman arrived on the forecastle, the engine stopped and the order was given to let go the anchor. However, when the crewman released the windlass the anchor failed to 'free fall' (see figure).

Figure: The windlass and brake

2. One of the most significant safety issues identified in this incident was the crew's inability to anchor the vessel in an emergency. The post-incident inspection by the anchor windlass manufacturer revealed that the aluminium windlass bearings were clogged with dirt and, although it could still be operated under power, the debris prevented the anchor being 'let go' in the 'free fall' mode. A subsequent fleet-wide inspection revealed a similar defect in other vessels. This issue had not been previously exposed by either class or regulatory inspection. Following its investigations, the vessel operator introduced a planned maintenance routine that required weekly fresh water wash down of the windlass, anchor 'free fall' mode tests and an annual overhaul.

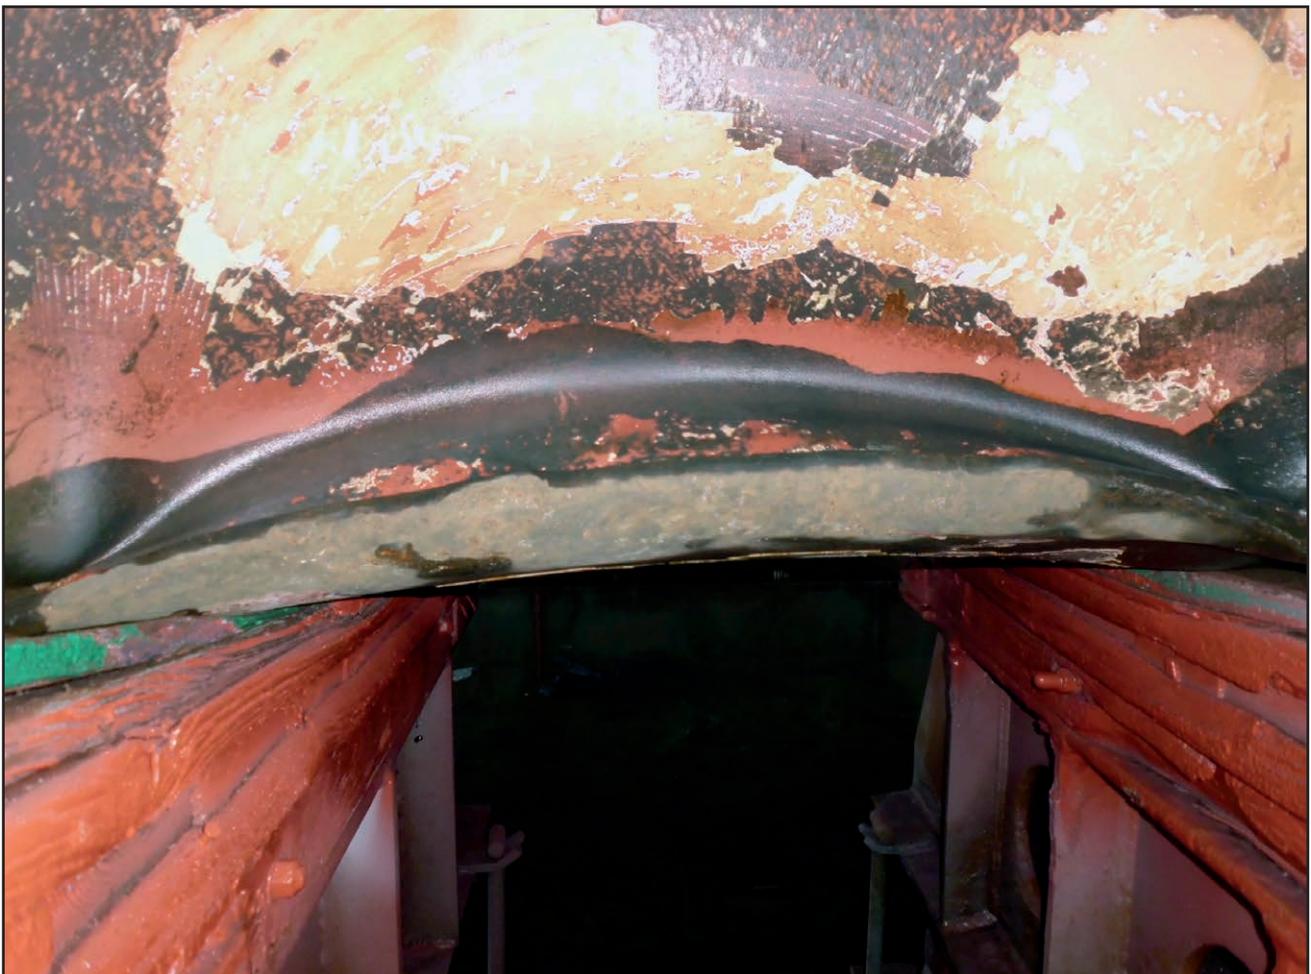
Figure: Hull indentation

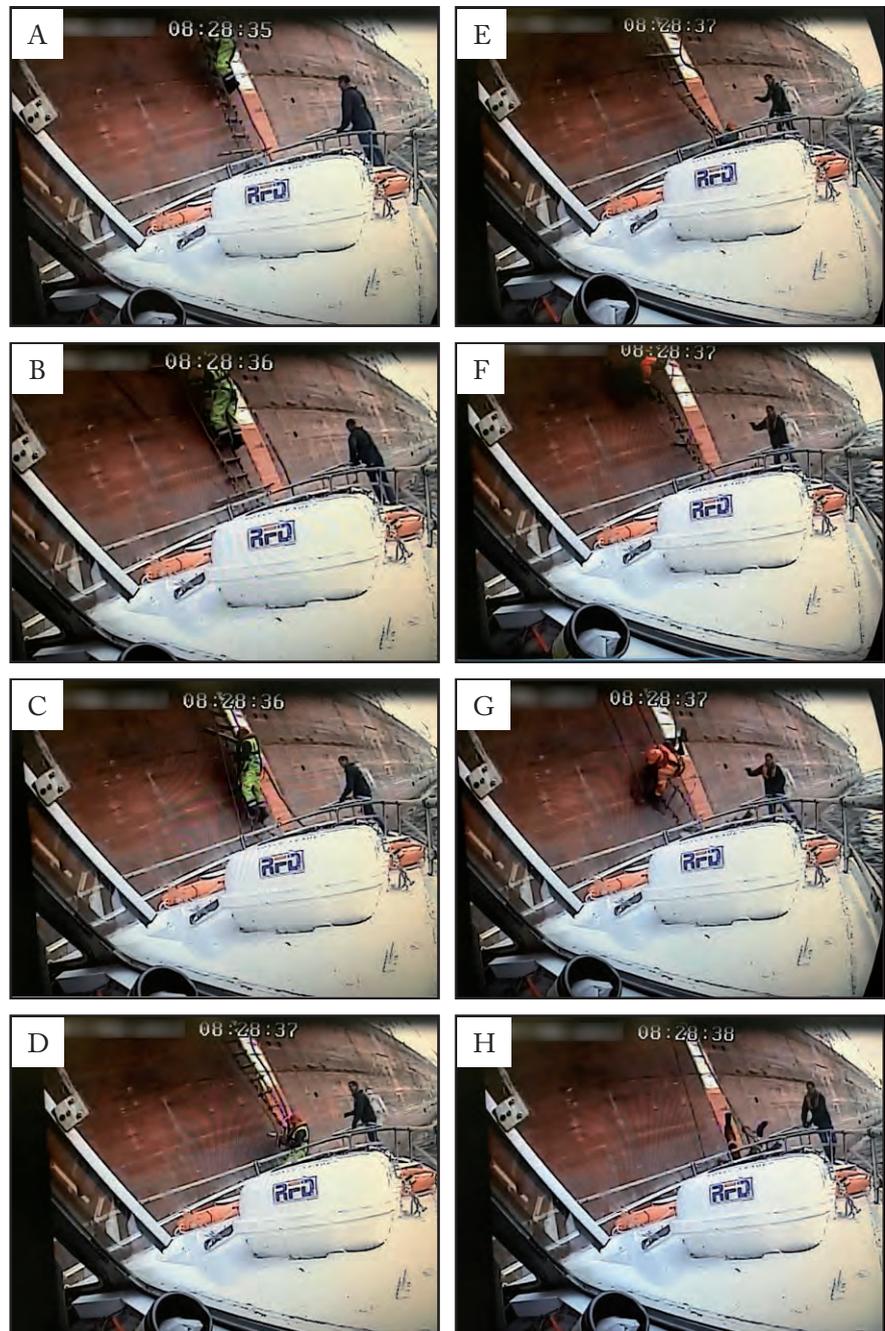
The three technicians proceeded to walk down the accommodation ladder to the top of the pilot ladder. With the pilot boat in position alongside the ship's side, the first technician began to descend the pilot ladder. The first technician was about 1.5m from the pilot boat's deck when the second technician stepped onto the pilot ladder. The pilot ladder immediately failed. Both of the ladder side ropes parted, and both technicians fell approximately 1.5m and 7m respectively (Figure 1). Both were subsequently taken to hospital by ambulance, but fortunately neither sustained serious injuries.

Figure 1: Stills from CCTV showing failure sequence

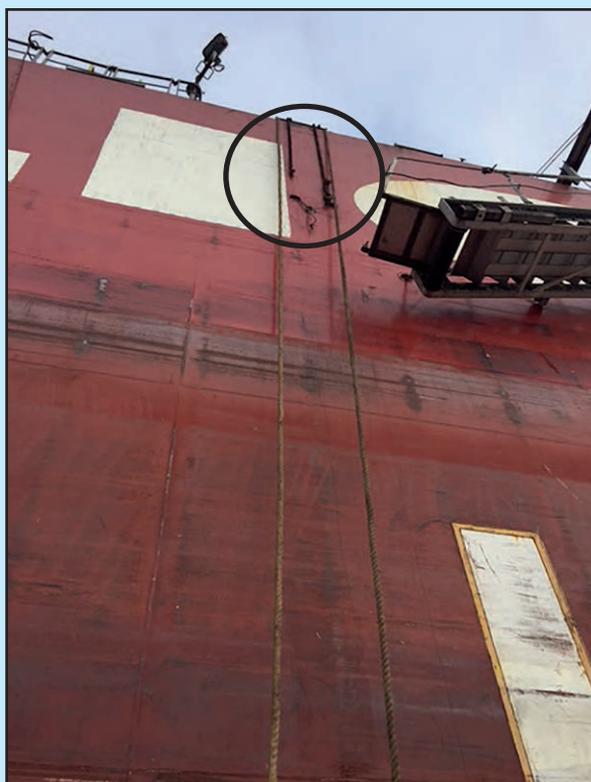
The pilot ladder that had failed was only 15 months old. An internal investigation by the company found that the pilot ladder side ropes had failed through exposure to salt deposits and sunlight (Figure 2), which the ship's crew had not identified.

Figure 2: Ladder rigged position, showing broken section

In this case, the relatively new pilot ladder had not been properly maintained and stowed, and deterioration to the pilot ladder side ropes had not been identified. Do not store ladders on an open deck where the ropes are exposed to contaminants or elements that can degrade the ropes (Figure 3). After use, ladders should ideally be hung up clear of the deck

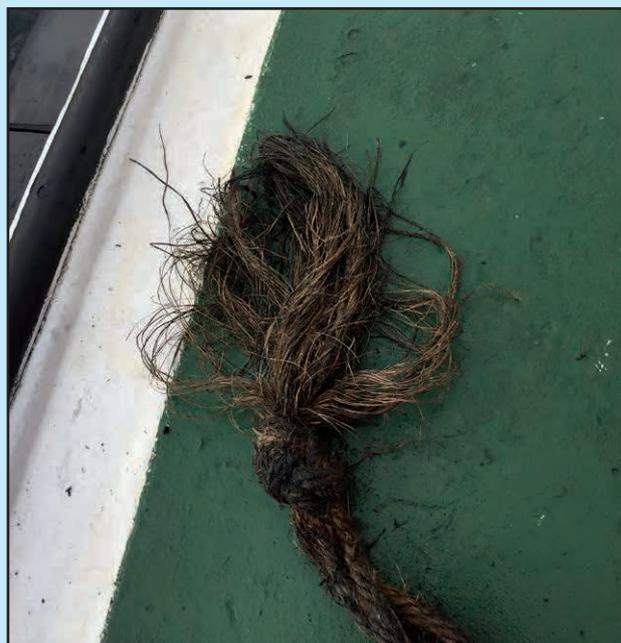
Figure 3: Ladder side rope showing contamination

and stored wherever possible in a clean, dry environment. They must also be protected from oil, chemicals, paint, or any other source of contamination that could affect their strength.

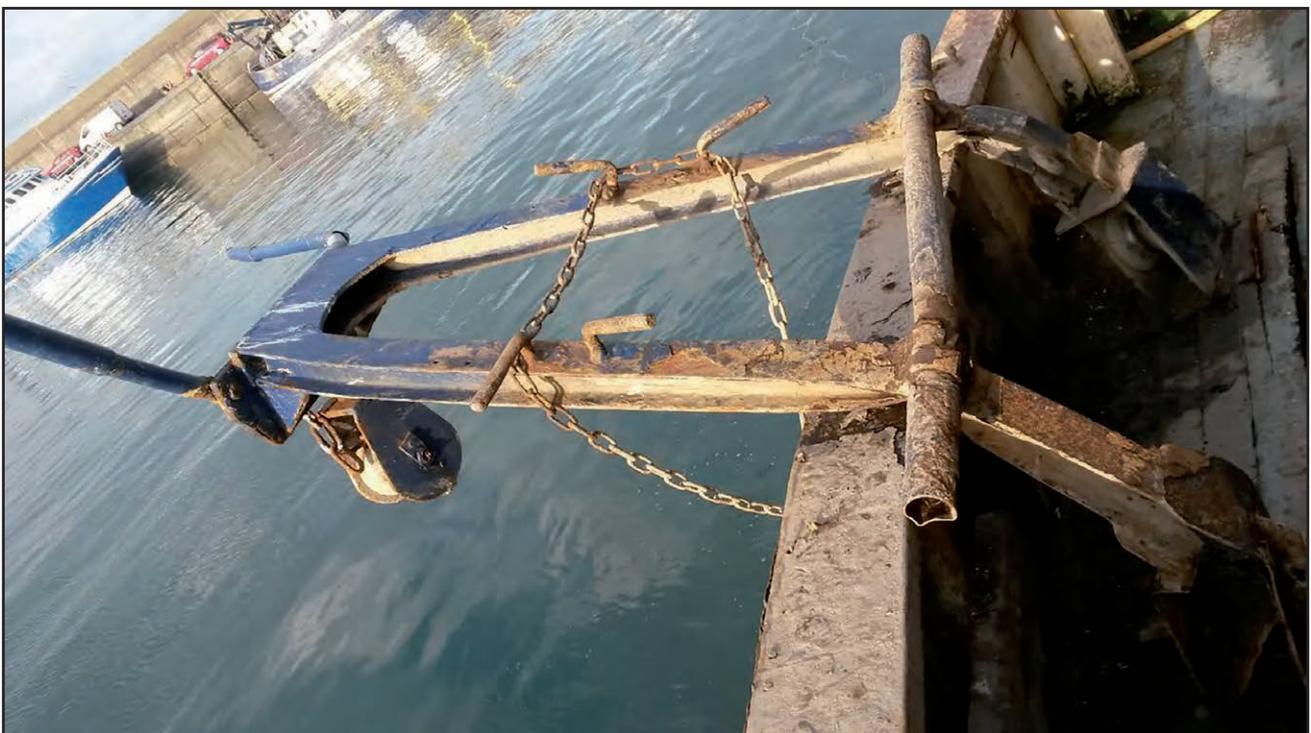
Figure: Damage to the prawn trawler's port gallows (looking from aft to forward)

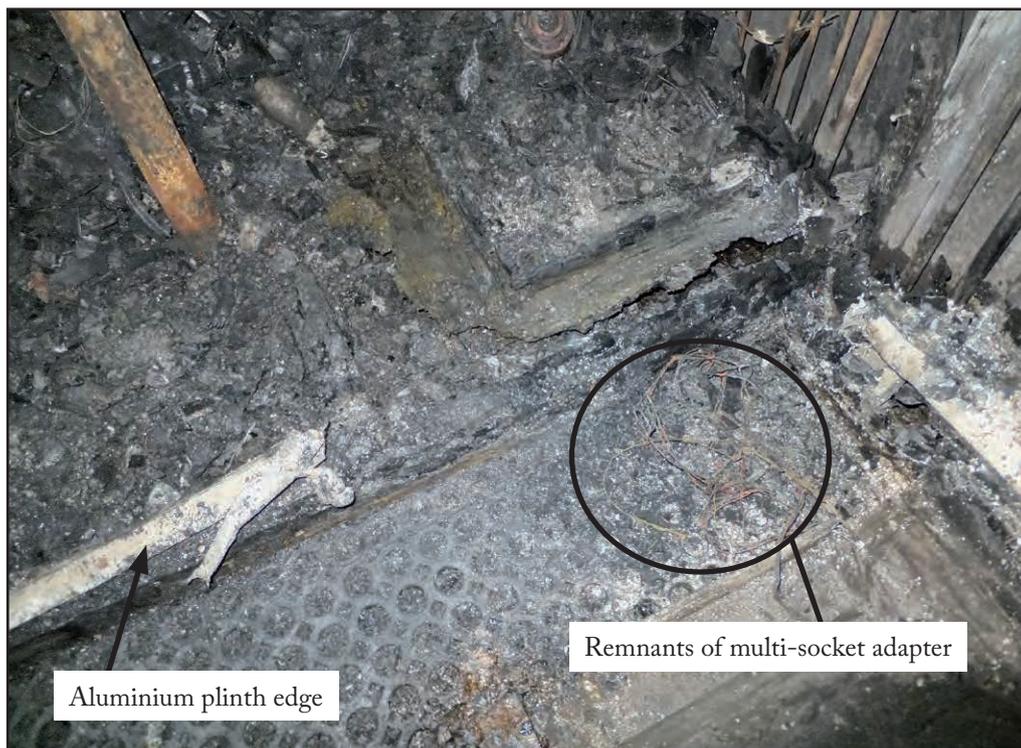
Figure 2: Remnants of multi-socket adapter

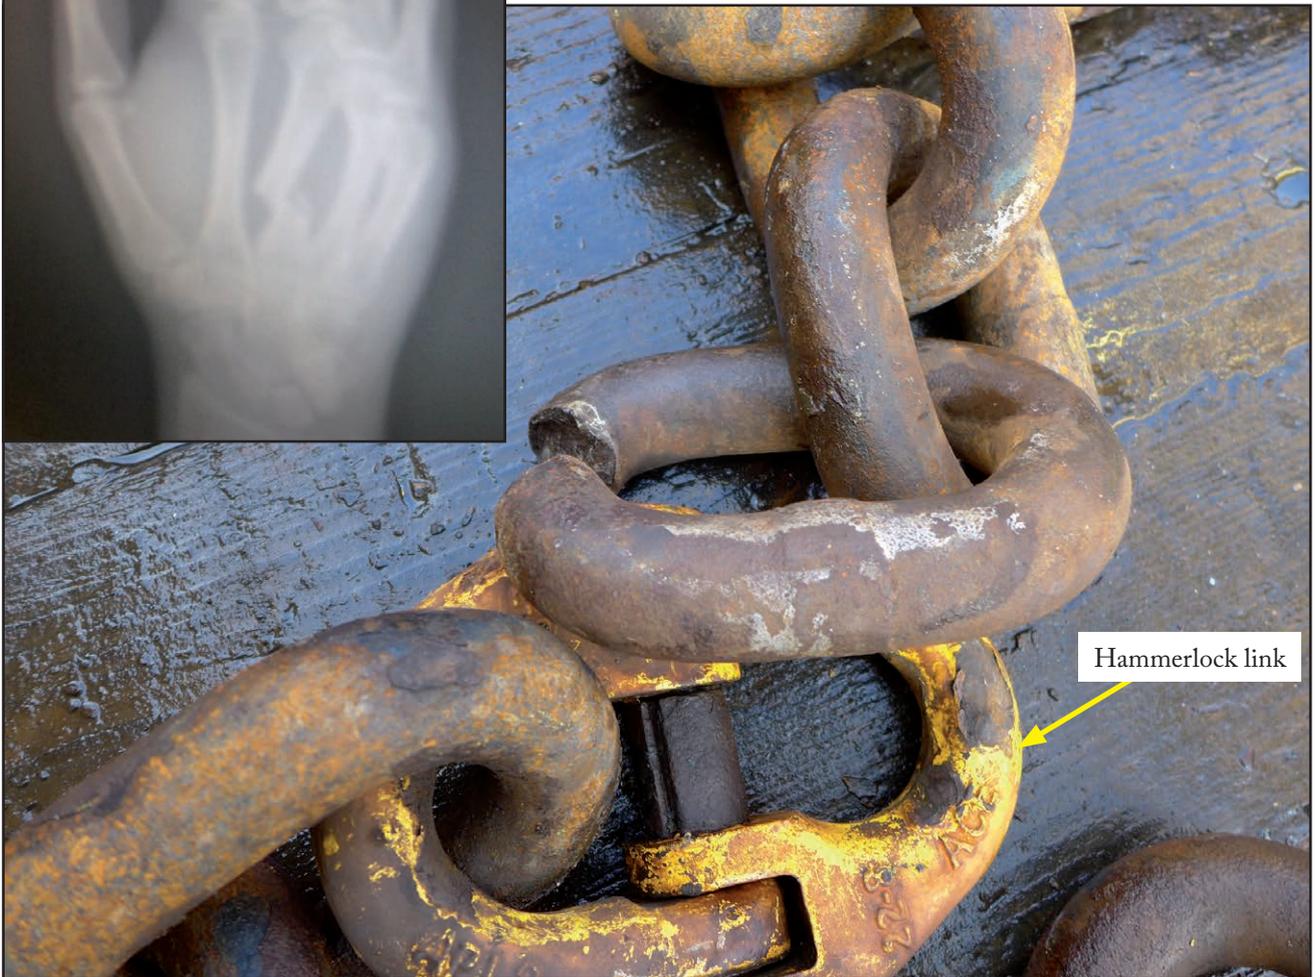
The accident was caused by the failure of a length of chain from which the block was suspended. One end of the chain was attached to a quick release wire and the other end was looped through the block and fastened onto itself with a hammerlock link (Figure 3). However, the two chain links joined by the hammerlock were not in the same plane, forcing them together under load, causing a twisting force (Figure 3). The starboard side chain had been linked without introducing such a twist and showed no signs of failure.

Figure 3: The twisted chain

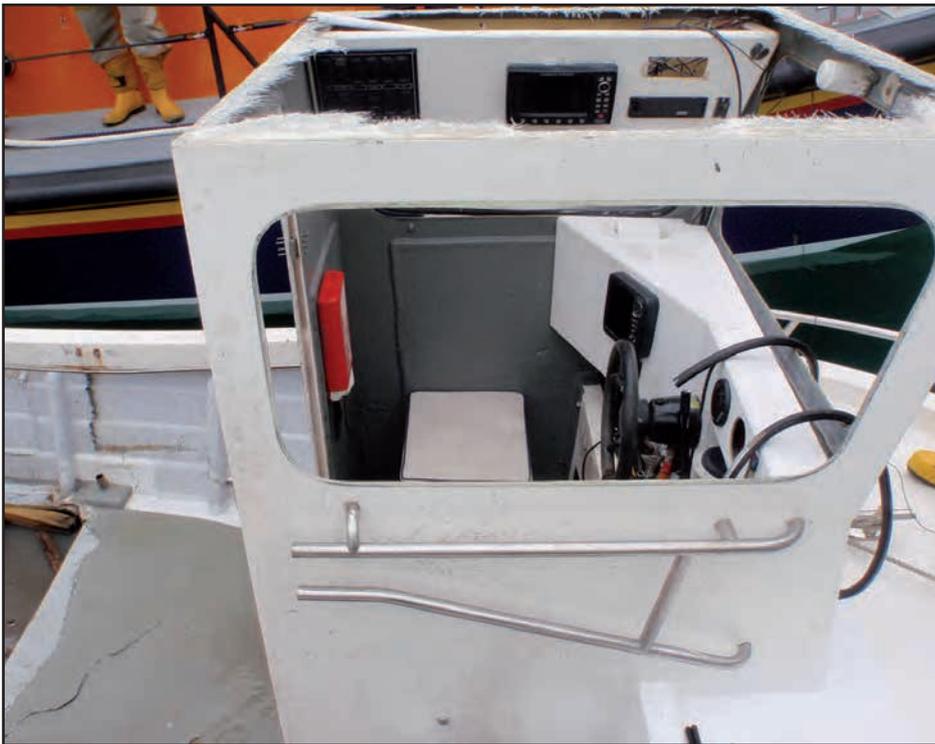
Figure 1: Wheelhouse with missing roof and windows

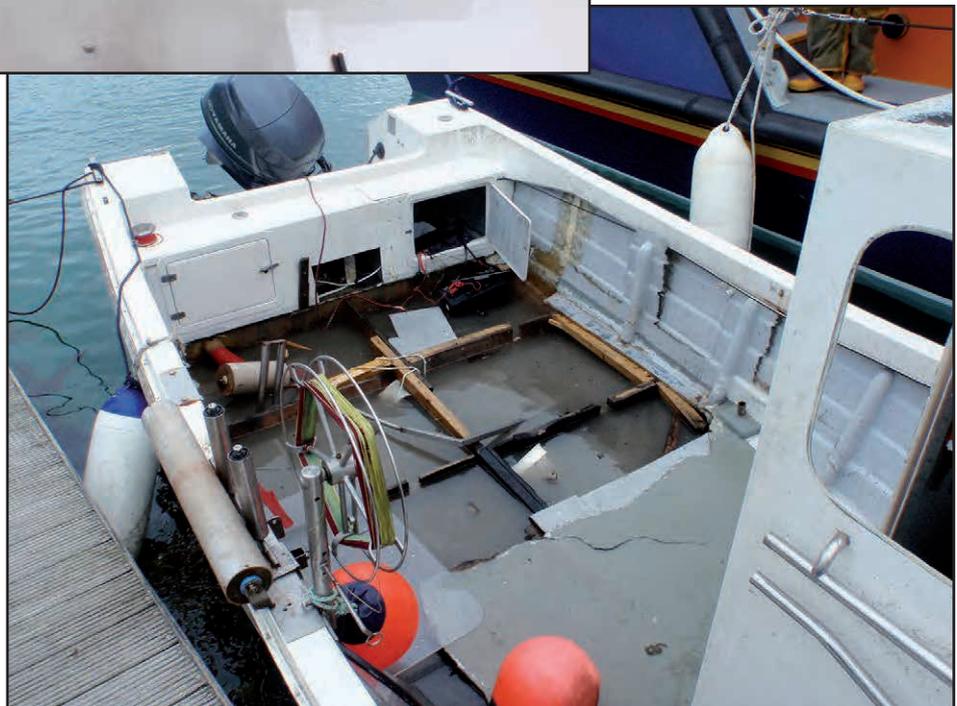
It is likely that a leak between the flush deck fitting and the fuel tank allowed petrol to leak into the vessel's bilge when the tank was filled the evening before departure (Figure 2).

Figure 2: Layout of the vessel

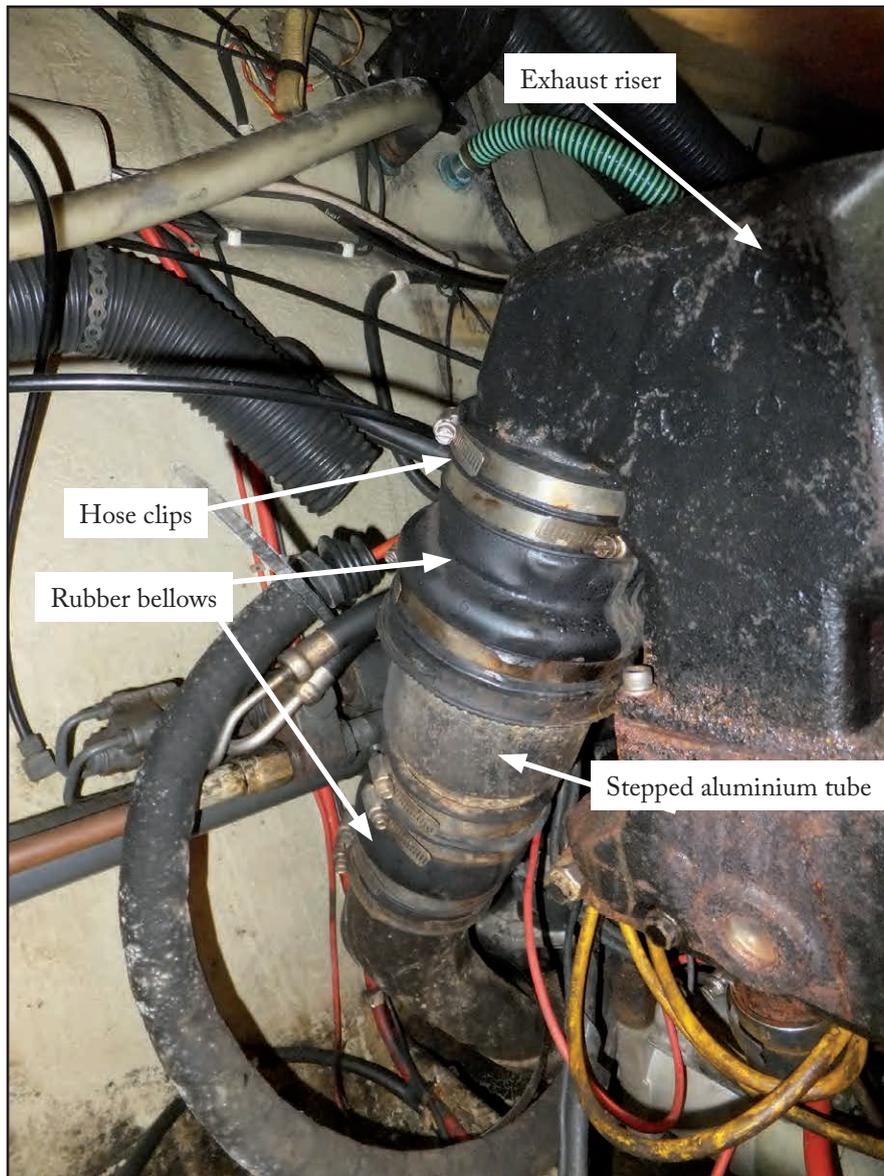
On examination, it was determined that at least two of the flexible rubber bellows of the boat's wet exhaust system were leaking, allowing water and exhaust gas into the boat (Figure 2).

Figure 2: Exhaust riser and rubber bellows

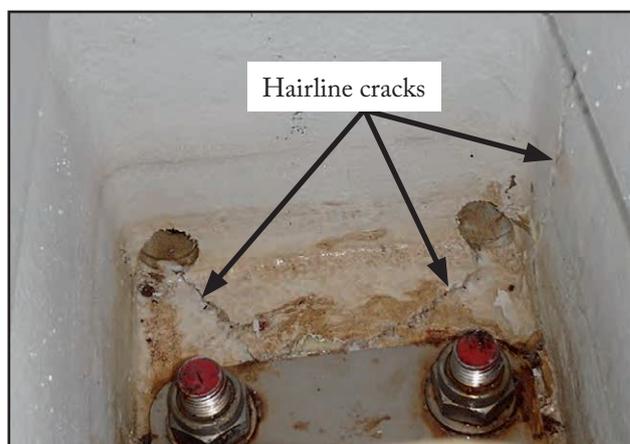
Figure 1: Hairline cracks around the yacht's keel bolts

During the night, the skipper started hearing a clunking sound each time the boat rolled and assessed it to be movement of the keel; a significant development that led to the decision to abandon the boat. When the merchant vessel arrived on scene, the skipper drove the yacht alongside and the crew transferred to the safety of the ship (Figure 2). The yacht was then cut free, with a hull valve left open in order that it would flood and sink.
