**MARINE ACCIDENT
INVESTIGATION BRANCH**

SAFETY DIGEST

**Lessons from Marine
Accident Reports
1/2018**

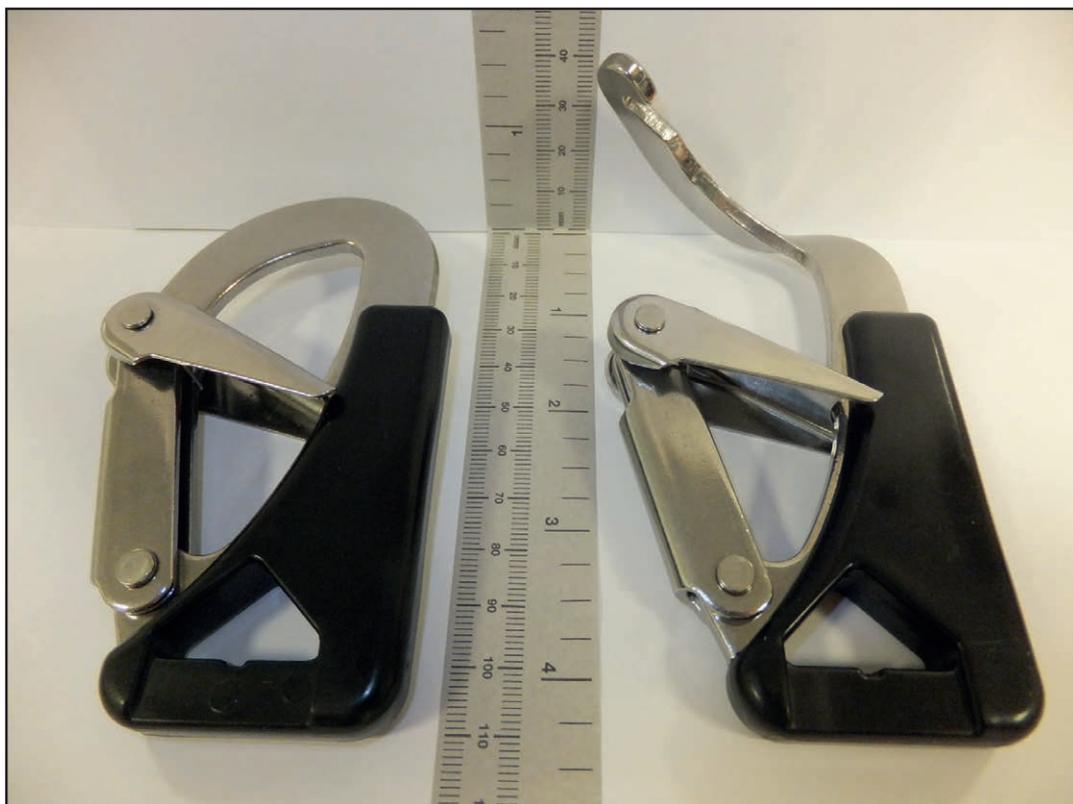
Figure 2: Example of a tether hook and a tether hook after lateral loading
