**Lessons from Marine
Accident Reports
2/2018**

SAFETY DIGEST
Lessons from Marine Accident Reports
No 2/2018

October 2018

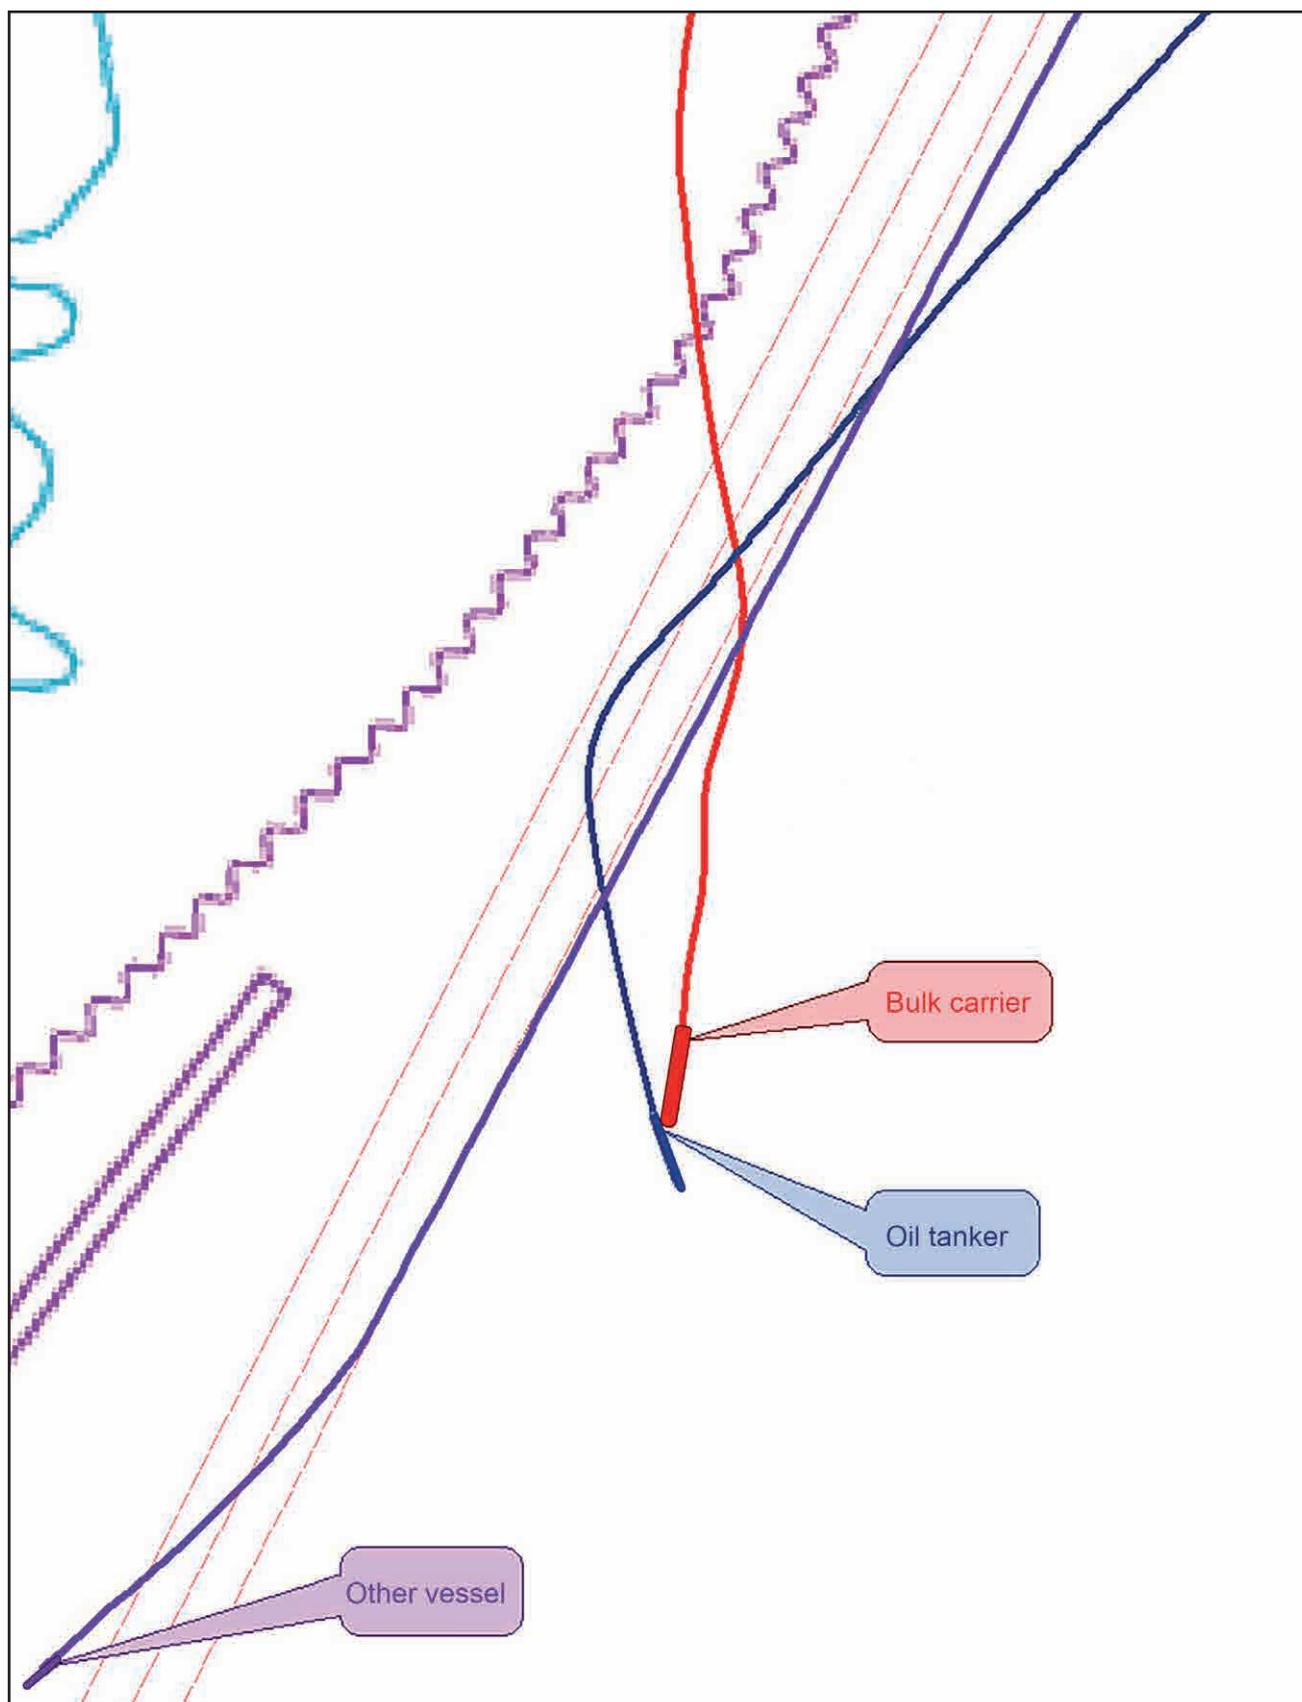
The bulk carrier's master was alarmed to see the oil tanker alter to port across his bow at such close range. Unsure of what to do, and thinking that he had been instructed to pass to port, the bulk carrier's master made a series of helm movements in a vain attempt to avoid a collision. However, due to the proximity of the vessels (see figure) there was nothing that could be done to avoid the accident. Both vessels were severely damaged but there were no injuries and no pollution.

Figure: Tracks of the vessels leading up to the collision

1. **Communications should improve understanding; they should not muddy the waters. In this case, the conversation was carried out in neither party's native language, and confusion arose when an assumed action was not verified. The use of standard marine communication protocol might have enabled the information to be passed in a clear manner.**
2. **Manoeuvring should only be carried out once you are fully aware of what is around you. Assumptions should not be made, and checking sea room ahead and astern is not only good practice but it should also be common sense.**
3. **Good bridge team management is a vital tool in any navigational situation. Ensure that every member of the team is aware of the plan, their role in it, and that they are empowered to monitor the actions of others in the team.**

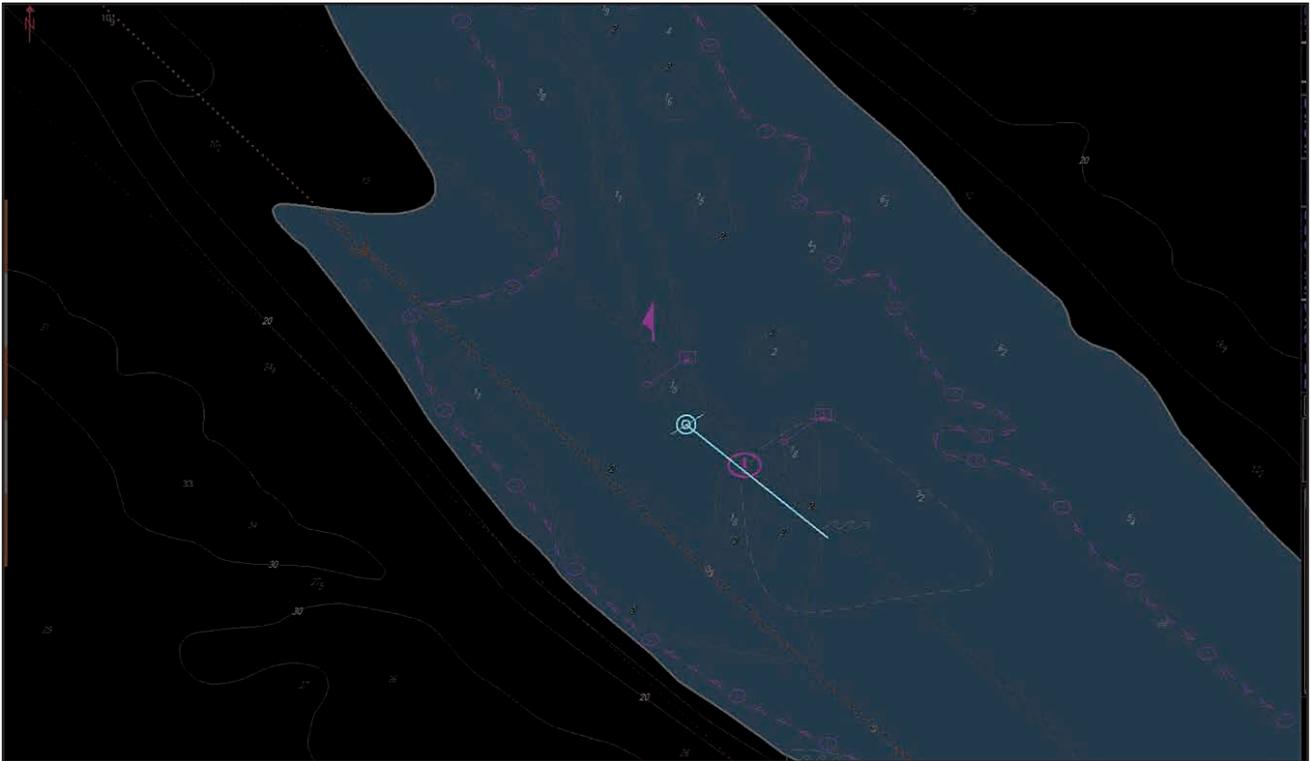
Subsequent inspection of the ECDIS indicated that the system's 'safety frame' or 'look ahead' was inactive and that its audible alarm had been disabled. Consequently, no alarm was generated when the vessel passed over the safety contour (10m) (Figure 2).

Figure 2: Reconstruction of ECDIS display (zoomed in and 'all')

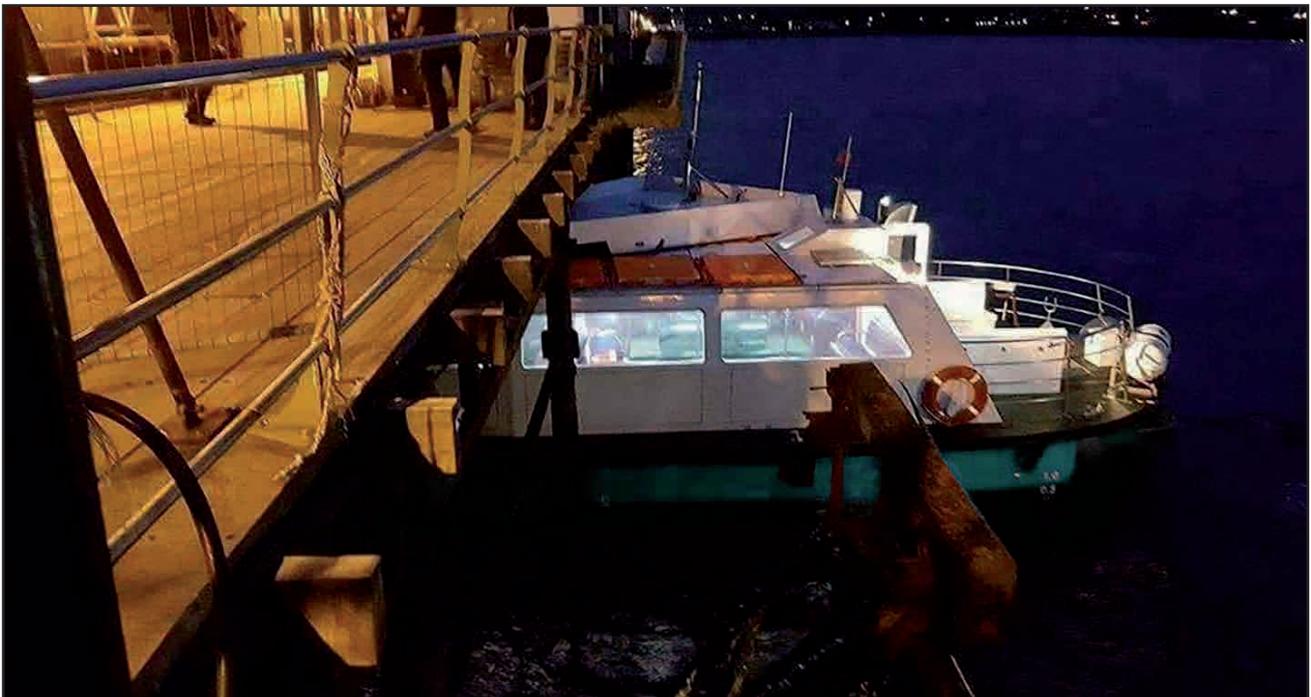
The wheelhouse of a small water jet propelled passenger ferry was severely damaged when the ferry overshot its intended berth and ran under a pier (Figure 1). The skipper suffered minor abrasions from the impact but the two other crewmen and the 15 passengers escaped injury.

Figure 1: Vessel wedged under pier

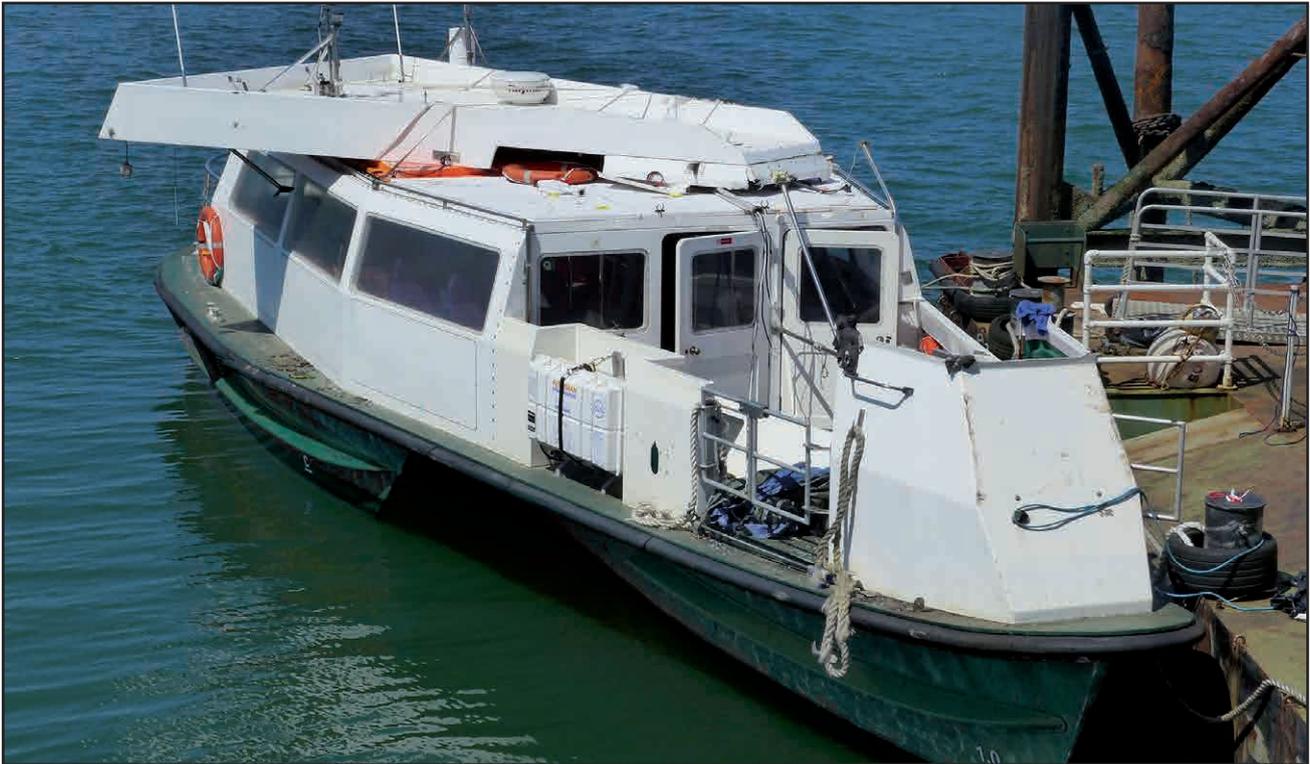
The force of the collision demolished the wheelhouse (Figure 2) and covered the skipper in debris. None of the passengers were injured as they had remained seated as instructed during a safety brief given before departure. Following the collision with the pier, the passengers donned lifejackets and the skipper used a hand-held VHF radio to inform the local VTS that the ferry was wedged (Figure 2). Nearby vessels arrived quickly to evacuate the passengers and the crew ashore.

Figure 2: Ferry post-collision showing the demolished wheelhouse

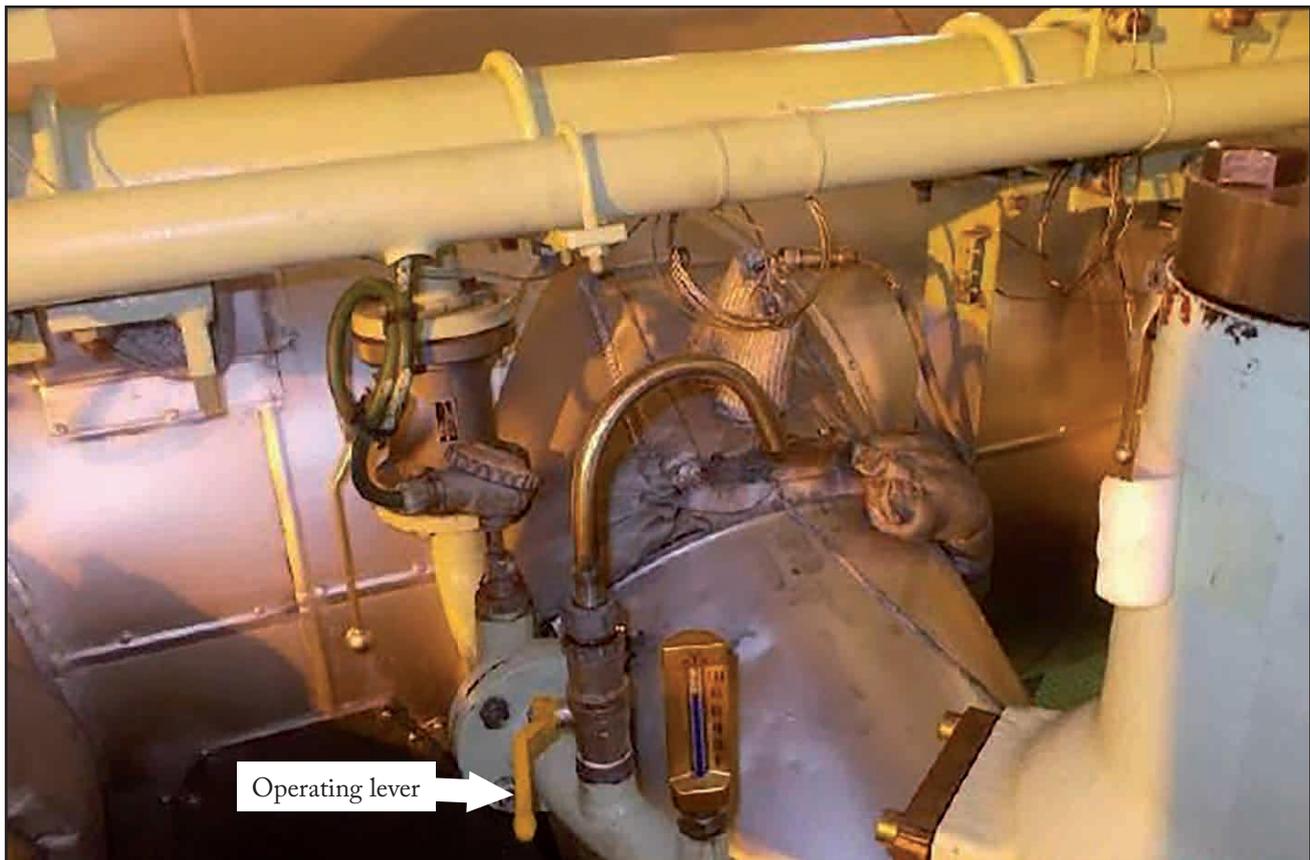
Figure 2: Vent valve operating lever

Following the accident, the company took immediate action to remove the vent valve operating levers on all its vessels with similar engines. This was a temporary measure until proper securing or blanking arrangements could be put in place.

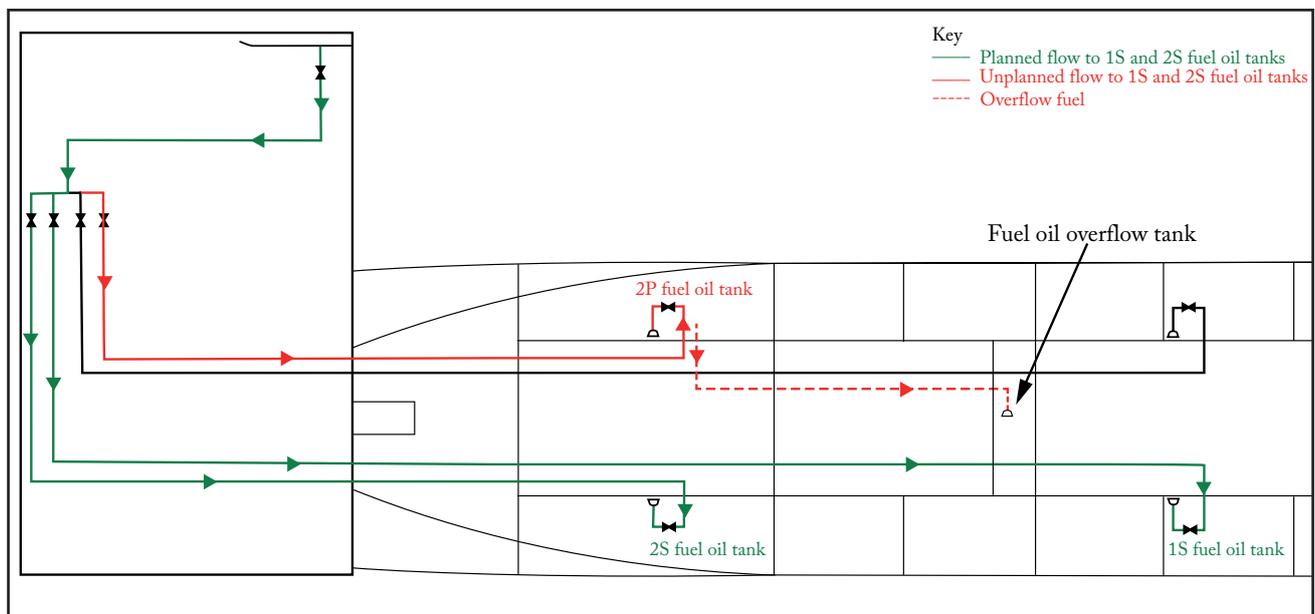
It was subsequently discovered that two valves aligned to another fuel tank were not fully closed. One valve was jammed with some debris and the other not fully tightened, which allowed fuel to flow into a tank that was already 80% full, eventually causing it to overflow.

Figure: Illustration to show the flow of fuel oil at the time of bunkering

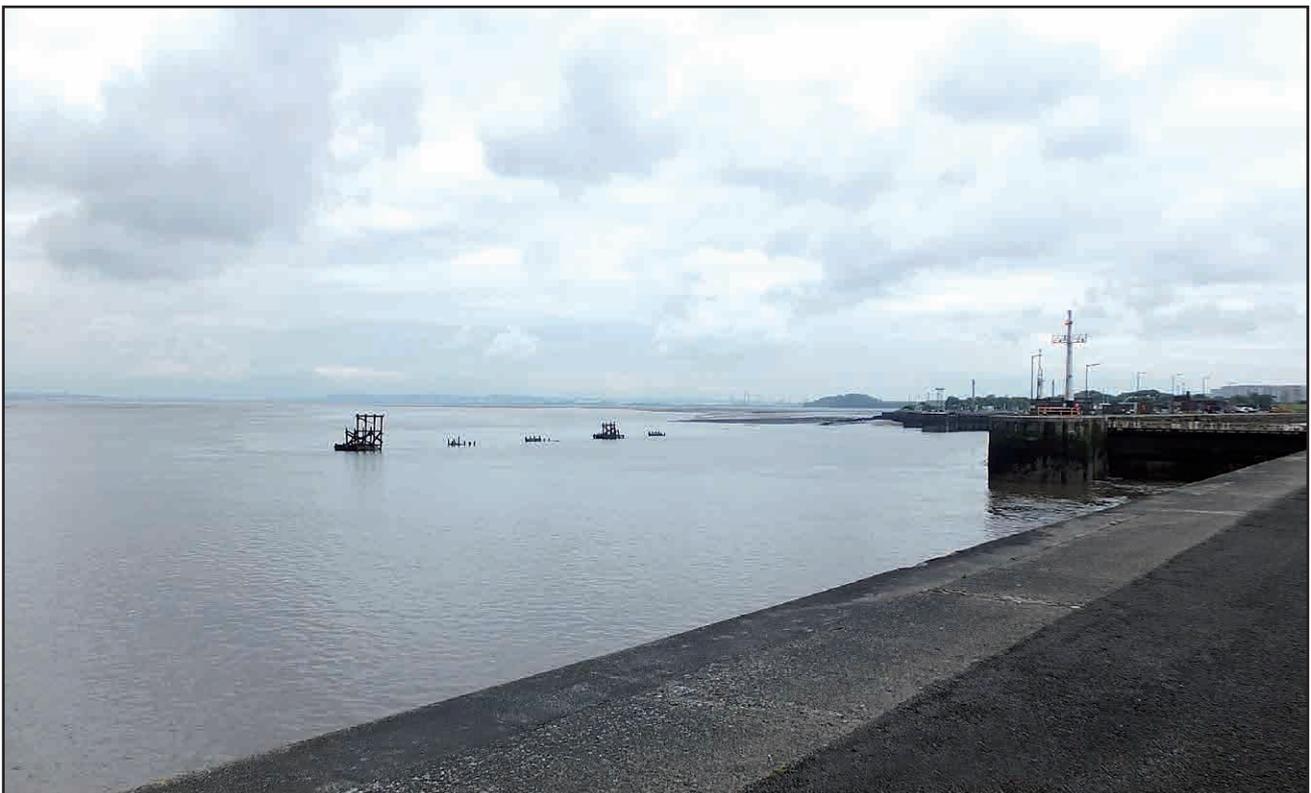
The ferry had run over the submerged remains of a mooring dolphin, which was the northerly-most of several charted derelict dolphins on the eastern side of the approach to the lock (Figure 1). The ferry's port propeller, shaft, stern seal and rudder were damaged by the contact (Figure 2).

Figure 1: View of exposed dolphins

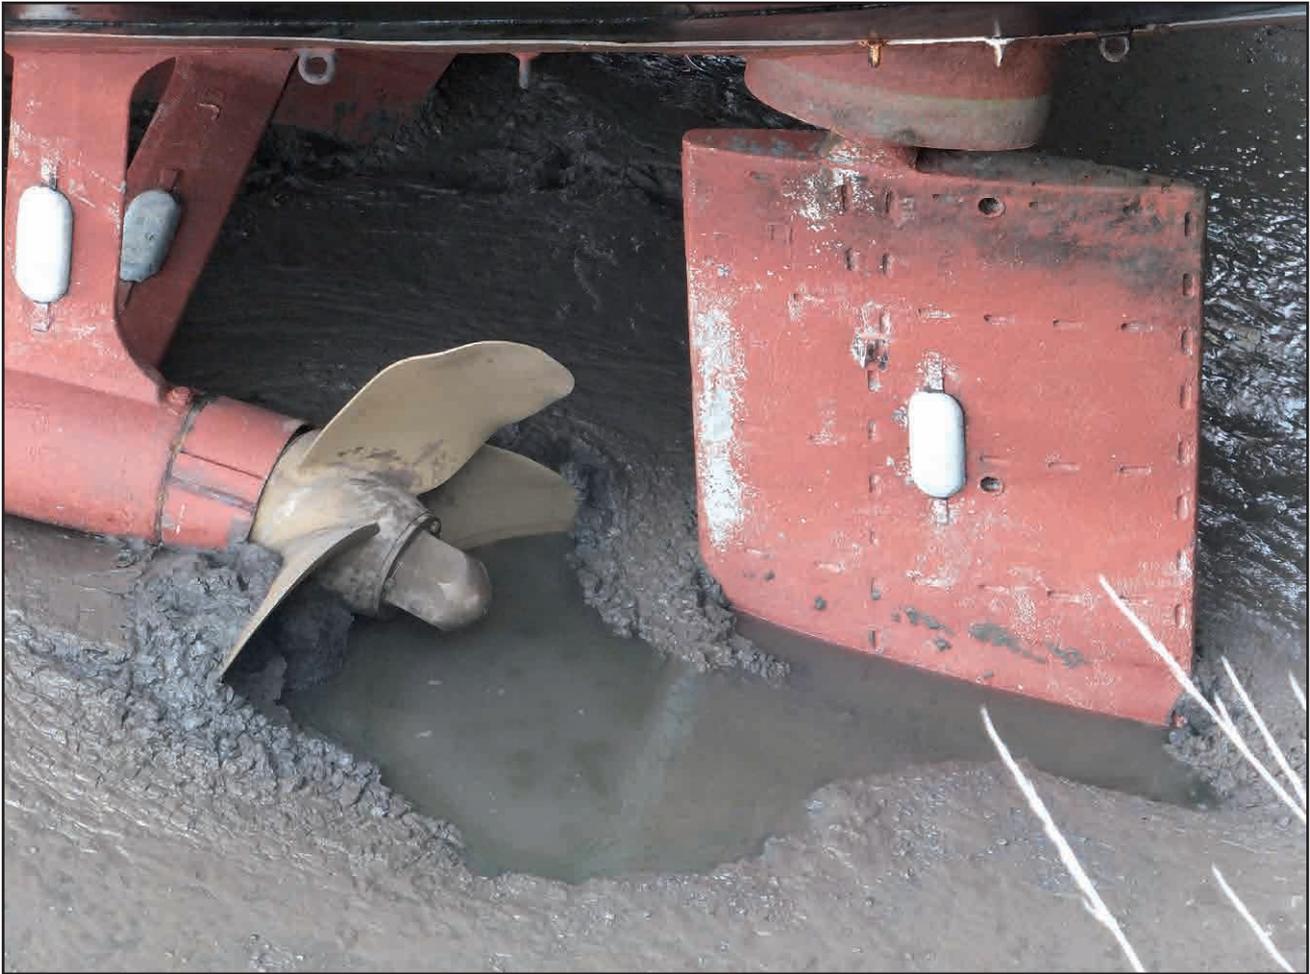
Figure 2: Damaged propeller and rudder

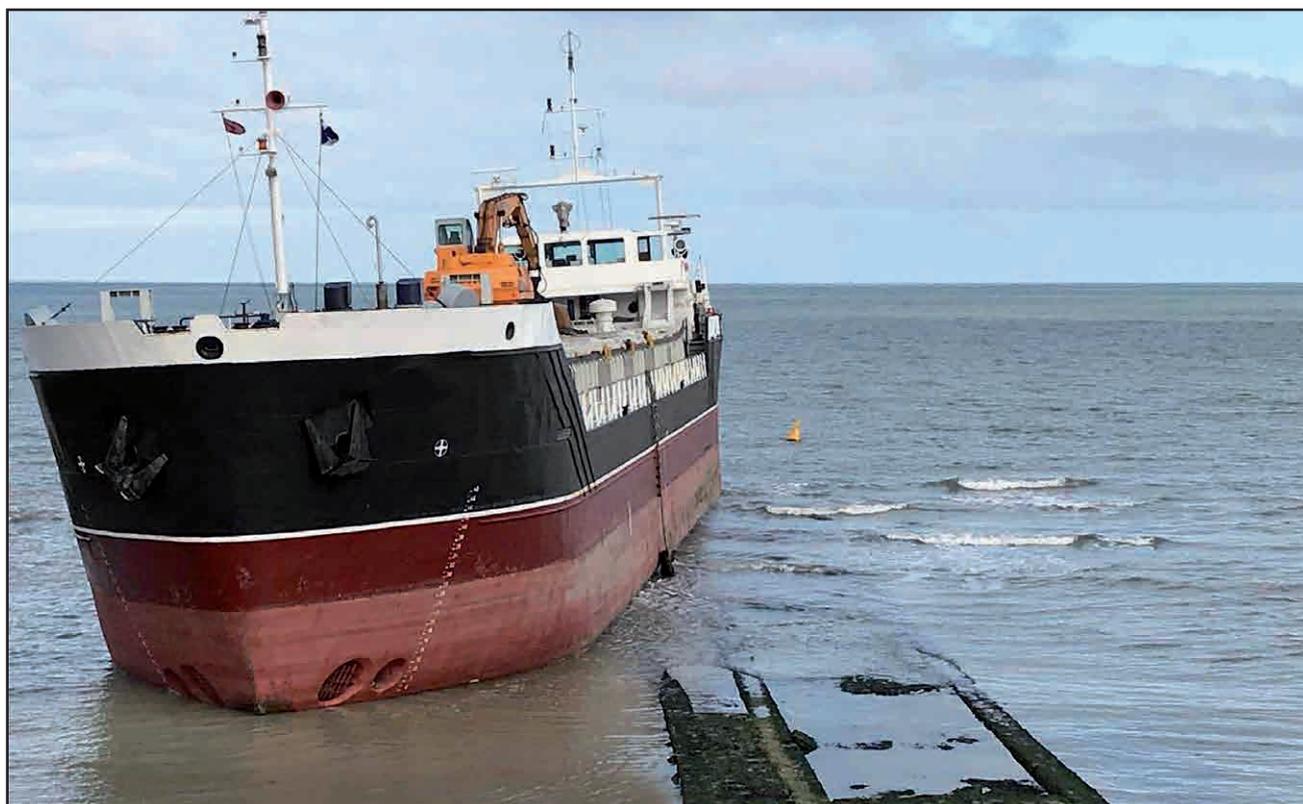
As the ship continued to head to the south, the VTSO soon became concerned that it was closing the shore, and repeatedly advised the chief officer to alter course. However, although the chief officer acknowledged the VTSO's warnings, he took no action. It was dark, and the chief officer had become overwhelmed by the situation and had lost track of the ship's position. The ship grounded at a speed of 7kts on a falling tide and remained high and dry for 12 hours (see figure).

Figure: The cargo ship aground

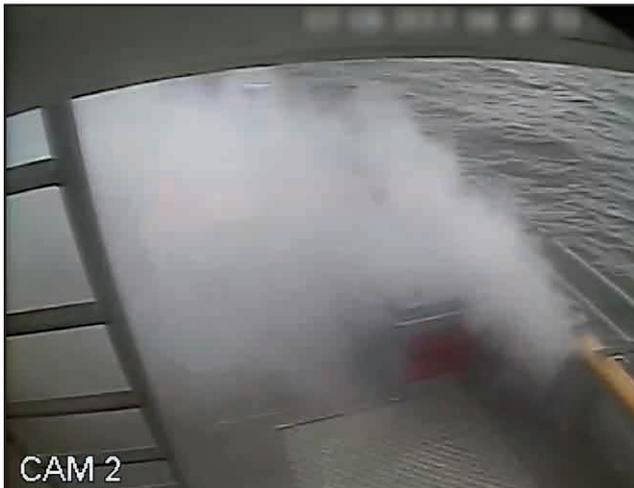
Figure 2: Fire extinguishing powder billowing from the natural air vent

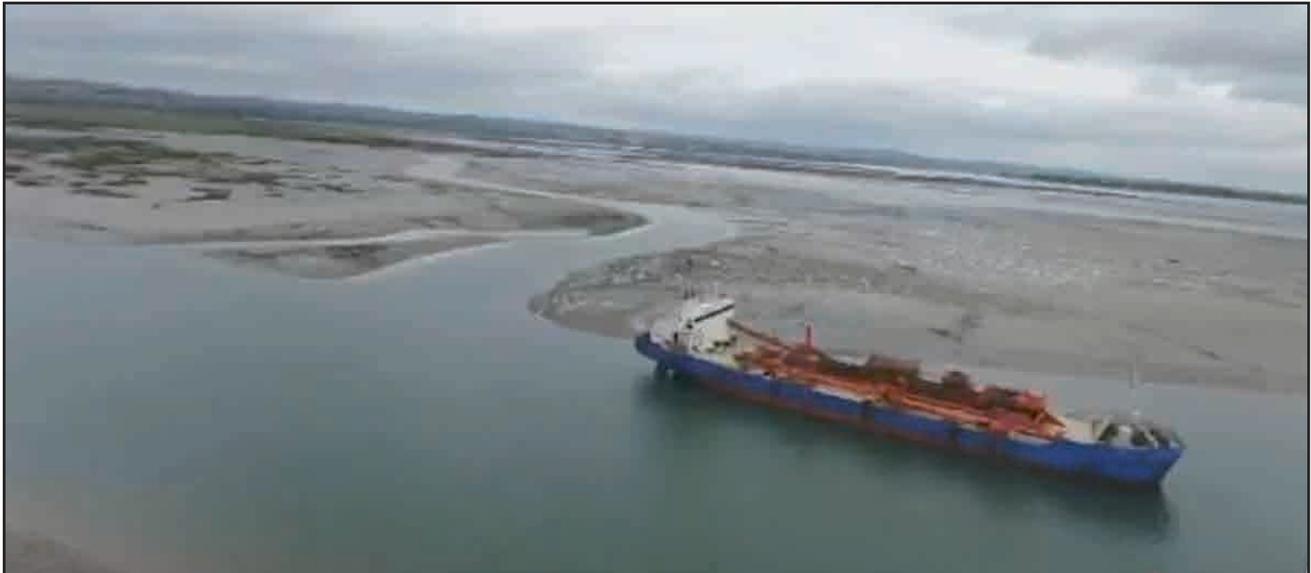
Figure 2: The dredger aground on the bank opposite the berth

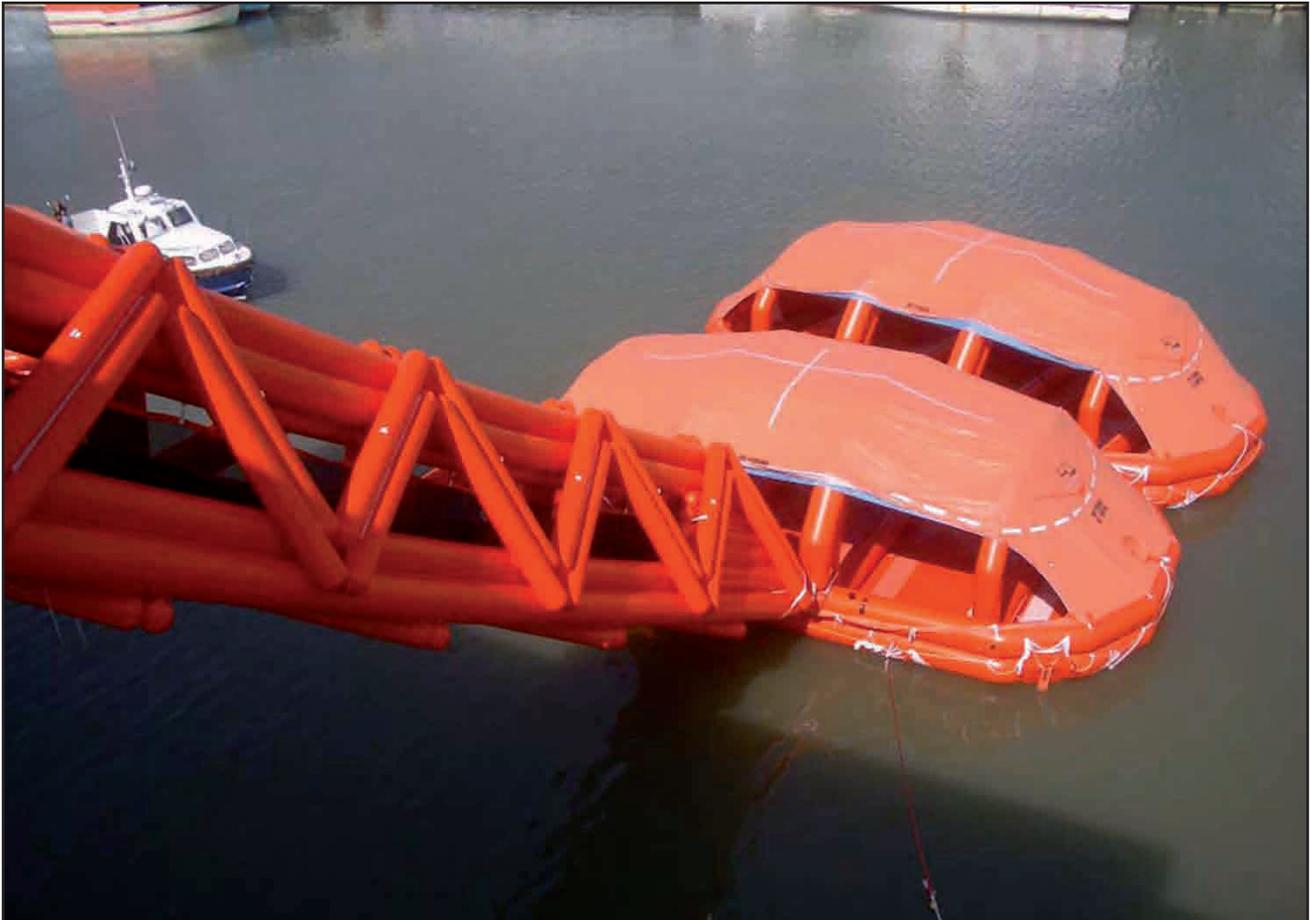
As the third test subject began his descent, pressure applied through one elbow, lifted him up, further reducing friction and causing a rapid increase in speed. As the subject entered the raft his feet became entangled in an overlap between the coir mats, causing him to flip forward and fall face-down into the raft. The force of his body turning against his trapped feet resulted in a fractured ankle.

Figure 1: Deployed MES

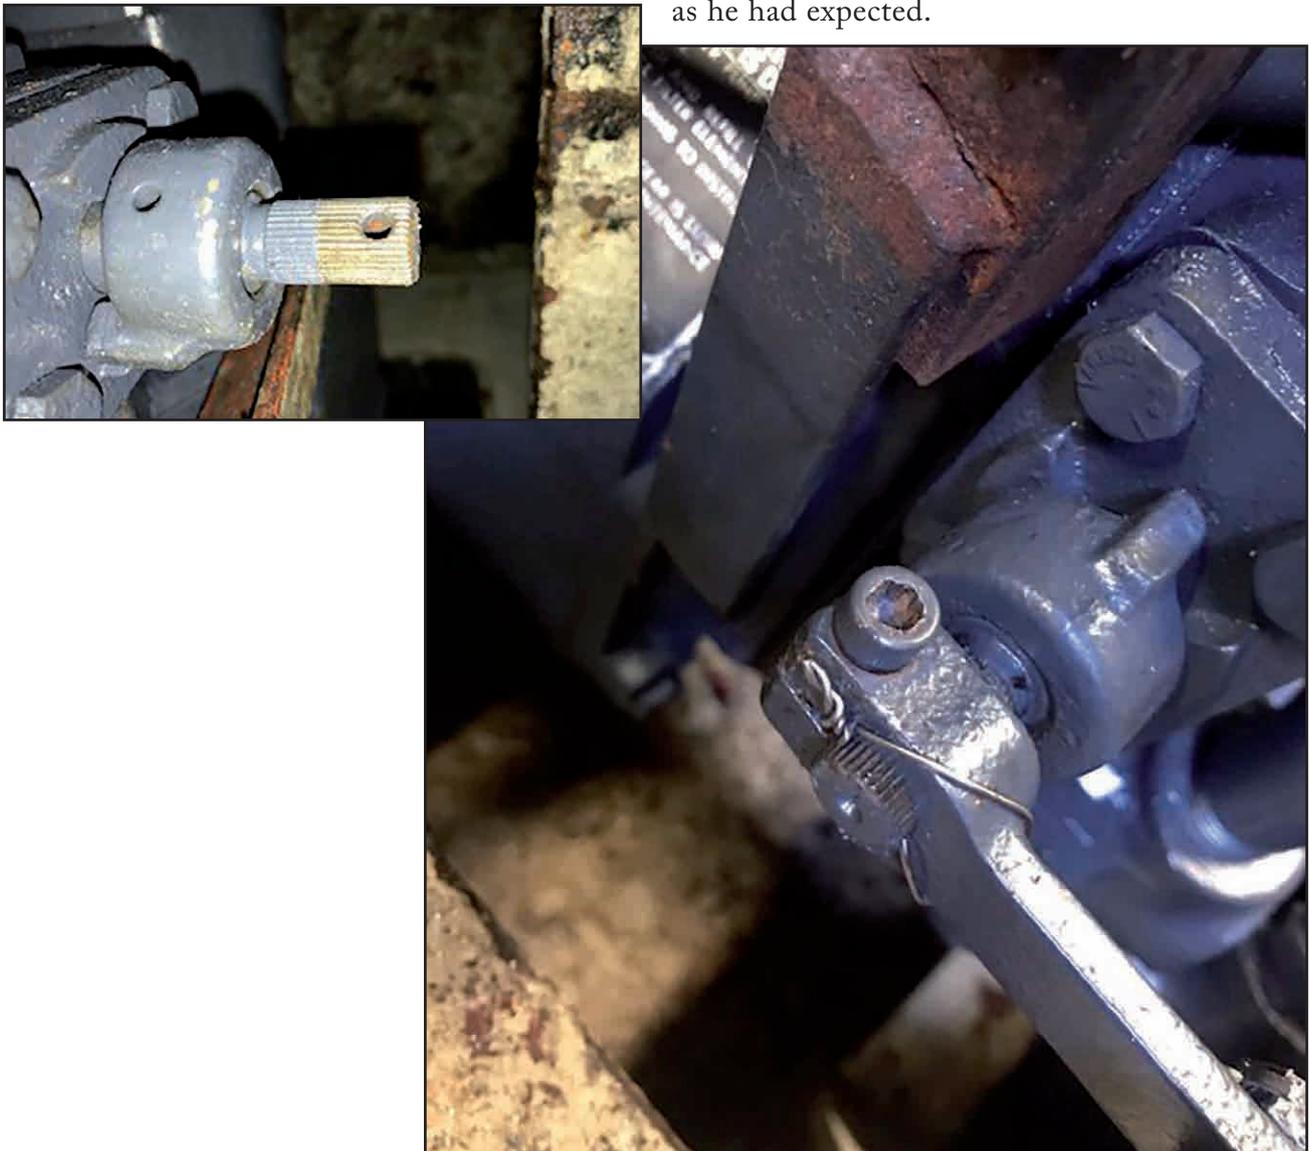
An inspection by a local engineering company discovered that the linkage between the starboard engine gearbox and the gear shift mechanism had disconnected, so the crew were unable to alter the direction of drive (Figure 1). The port engine, having reversed, applied reverse thrust while the starboard engine continued to apply ahead thrust. This caused the vessel to swing to port and make contact with the pier. Unfortunately, the console with the remote controls for the engines did not have any indications for propeller direction (Figure 2) so the master was unable to understand why the vessel was not responding as he had expected.

Figure 1: Gear shift mechanism linkage (inset: linkage disconnected in service)

1. Mechanical linkages are prone to detach or fail, especially when used repeatedly. Check and tighten them as required. Where possible, use self-locking nuts and split pins to prevent such incidents.
2. Simple instruments or gauges in the wheelhouse showing the running direction and speed of rotation of the propellers can provide immediate feedback to the person manoeuvring the vessel.
3. If you have twin screw propulsion, include the loss of one engine in your risk assessment and consider how you may be able to recover from such a situation in an emergency.

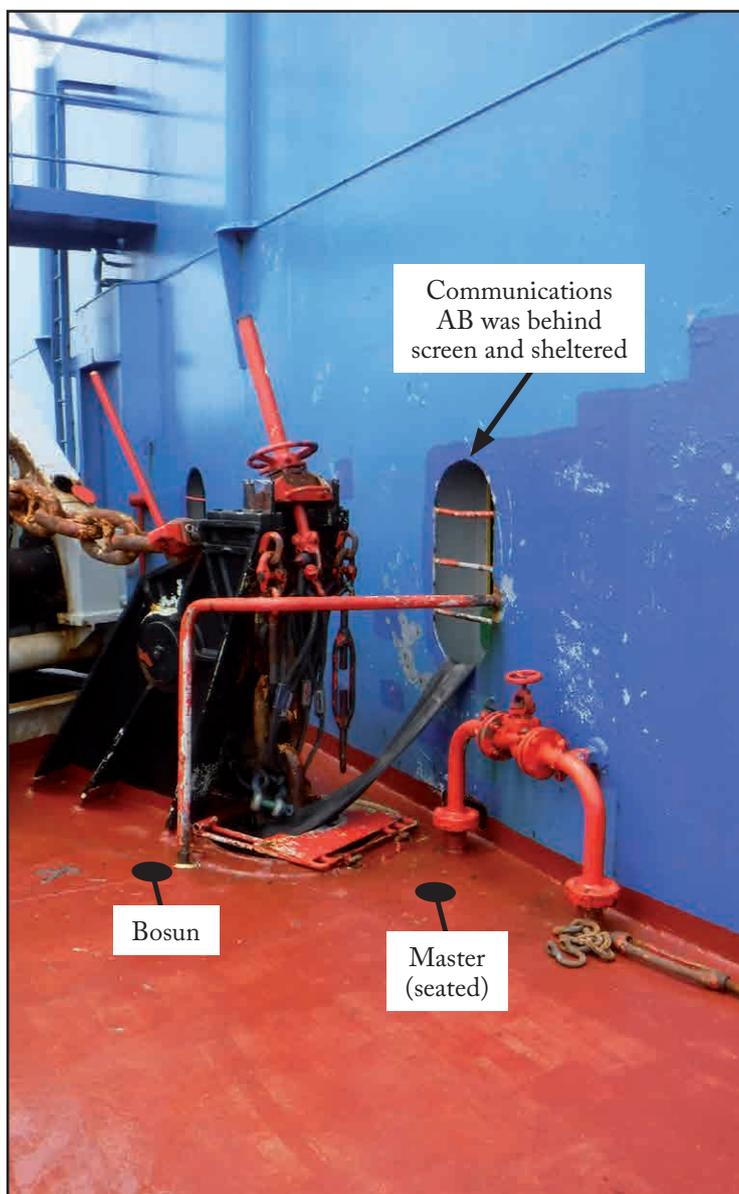
As the master and bosun started working next to the port anchor cable (see figure), the vessel pitched into a very large wave, which resulted in a full bore of water rushing violently up the port hawse pipe. The master was thrown back by the force of the water and struck in the face by the loose hawse pipe cover. The master sustained

Figure: Fore deck area around the port hawse pipe showing the locations of the crew at the time of the accident

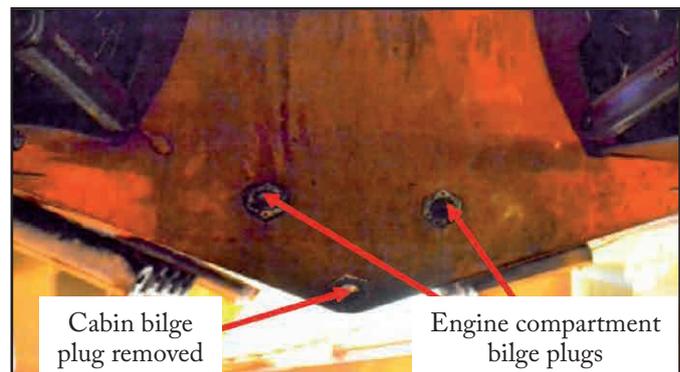
The owners of the ERV carried out an extensive investigation and tests, and concluded that the most likely cause of the accident was that the three drain plugs on the hull of the daughter craft were not in place when it was launched (see figure). The automatic bilge pump had worked correctly, but it did not have a running light indication. The tests conducted with identical daughter craft demonstrated that all the bilge pumps operated together could cope with the ingress of water from three open drain plugs. Subsequently, the company blanked off the drain plugs of all the daughter craft in its fleet.

Figure: Plugs on the hull of the ERV

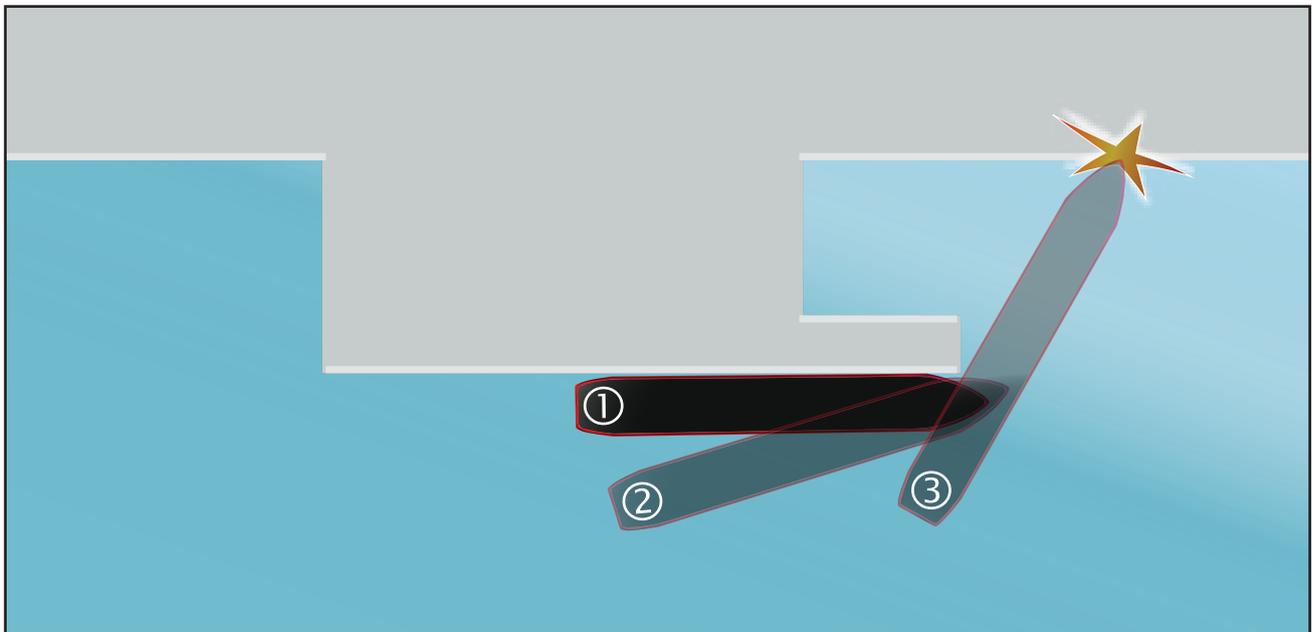
Figure 2: The engines mistakenly put to full ahead rather than full astern cause the ship to strike the quay

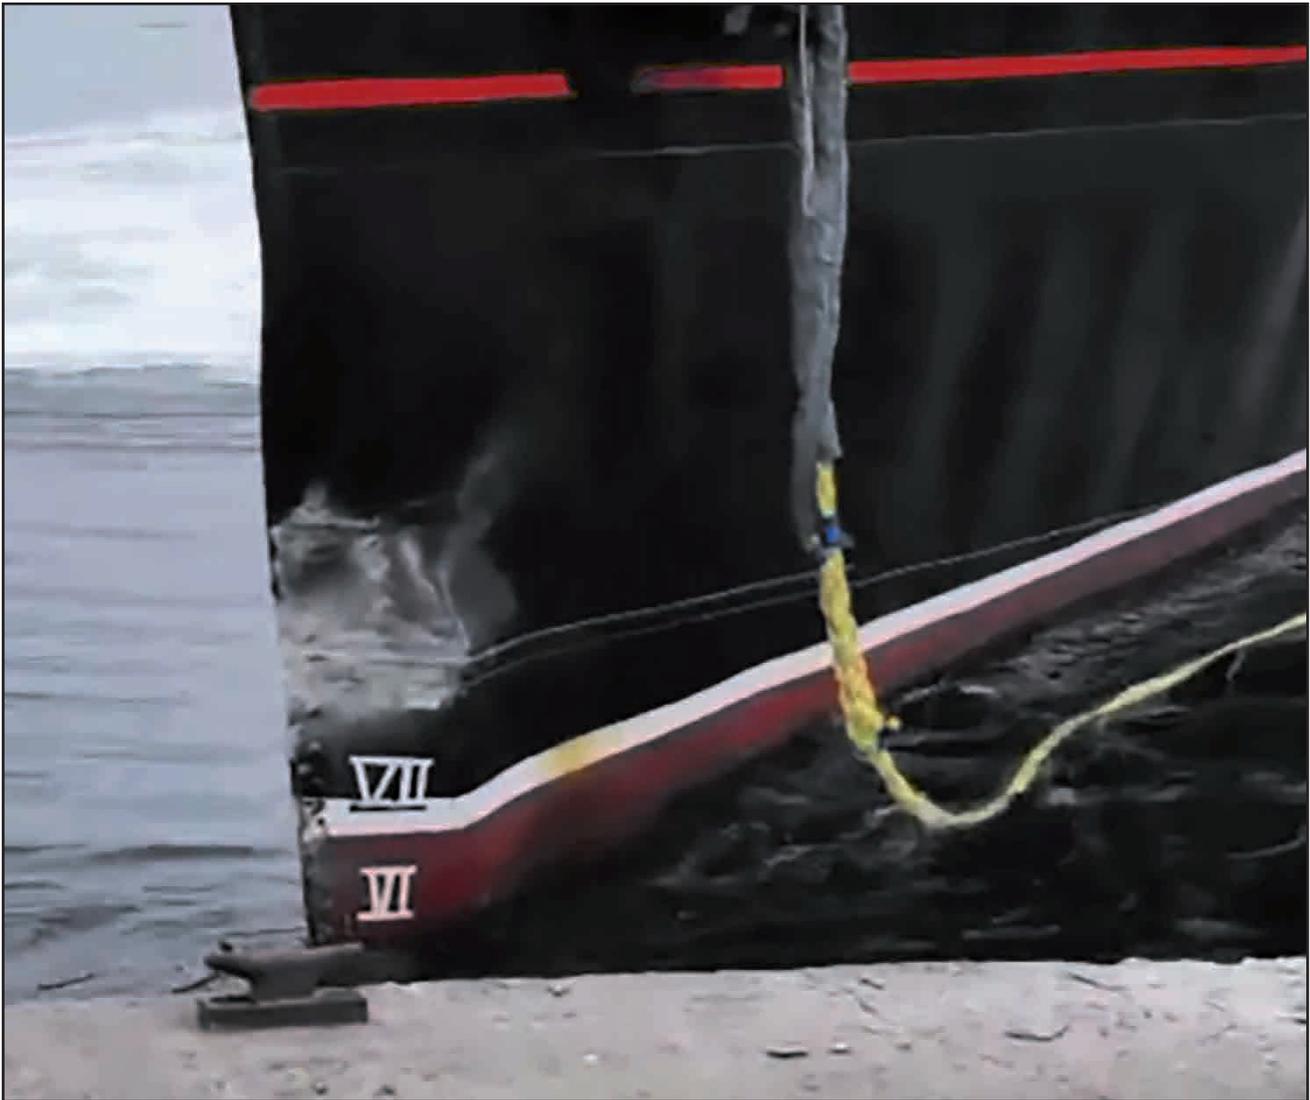
Figure 3: Damage to the bow post collision

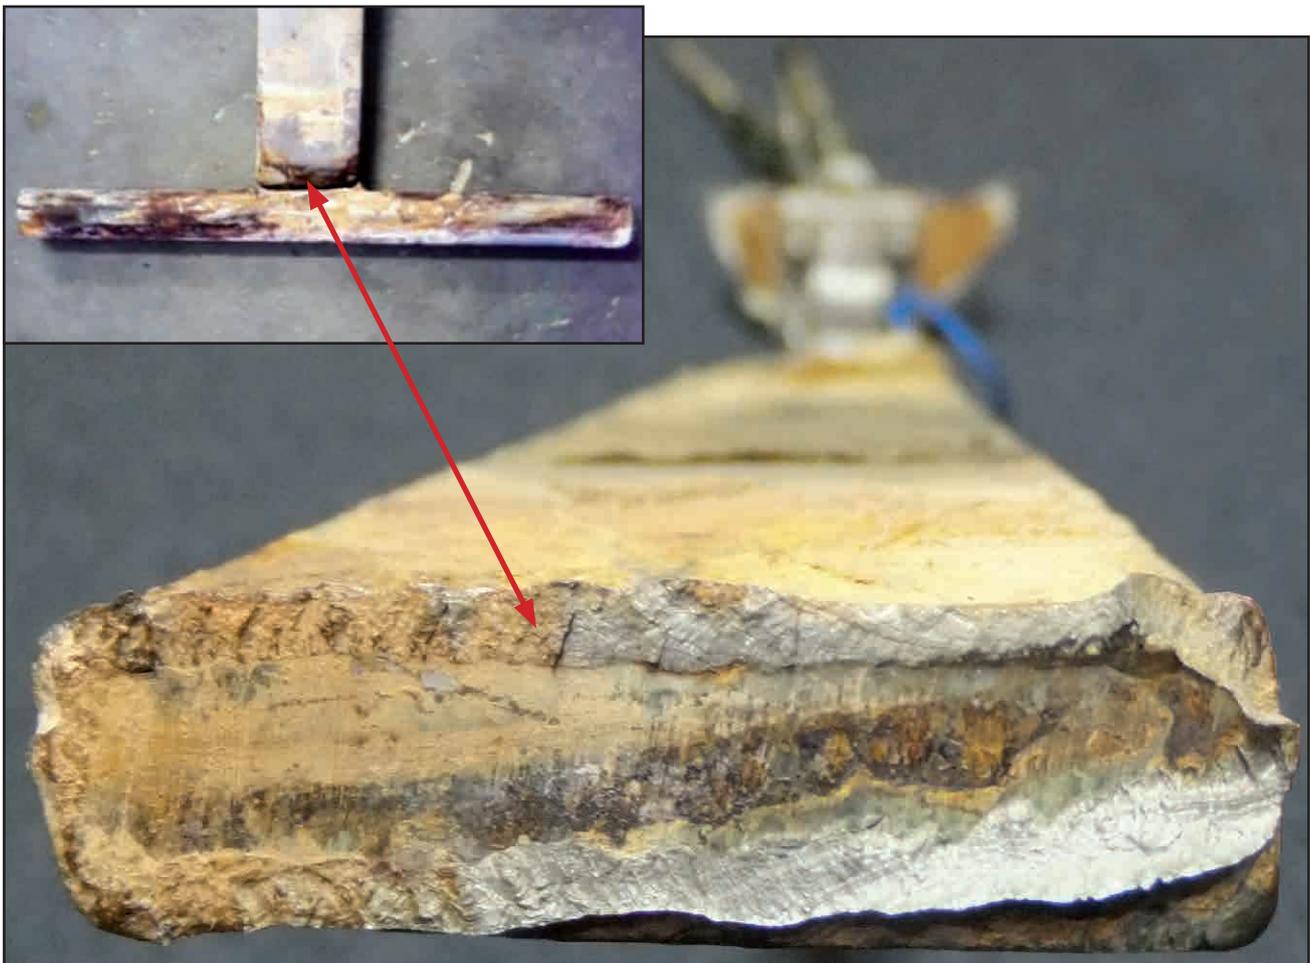
This boat had been in commercial ownership for a number of years and had covered a lot of miles. The cyclic loading on the tie bar would therefore have been high, and ultimately led to the failure of the welded joint.

Figure 3: Tie bar fracture close up (inset: the overall tie bar)

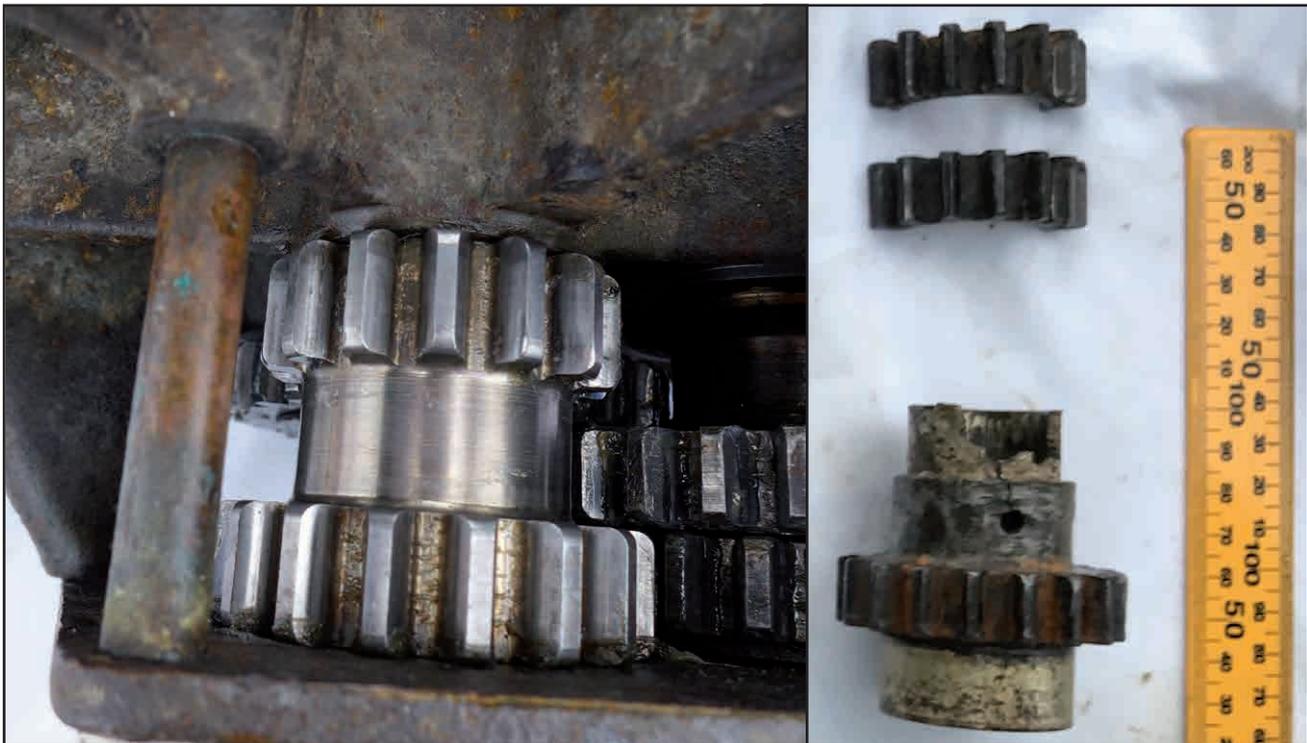
The failed pinion was formed of two parts, whereas the same component on the port side winch was a single part (Figure 2). The coffee-grinders were assessed to be original to the vessel and there was no paperwork to support or explain their installation, maintenance or any repairs.

Figure 2: Port and starboard side winch pinions

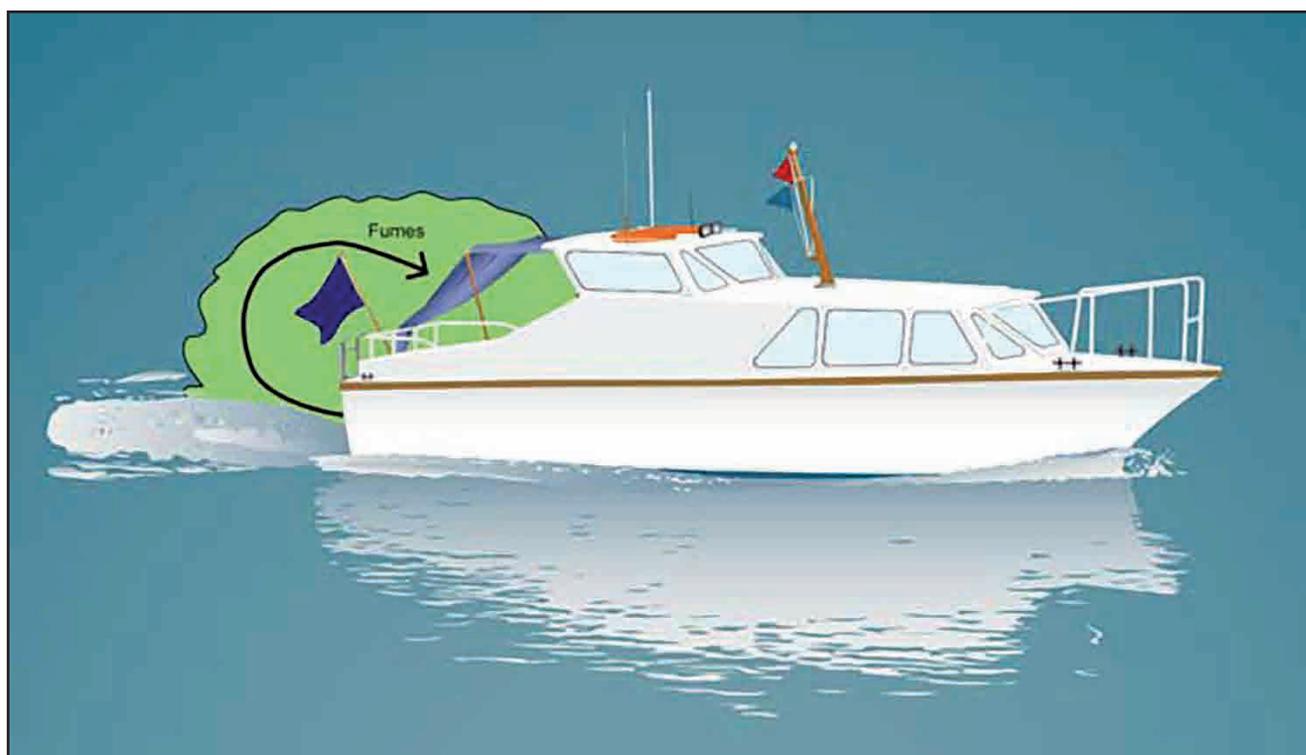
The post-mortem examination showed that the owner and his partner had died of carbon monoxide poisoning.

Figure 2: Diagram showing 'station wagon effect'
