**Lessons from Marine
Accident Reports
2/2018**

SAFETY DIGEST
Lessons from Marine Accident Reports
No 2/2018

October 2018

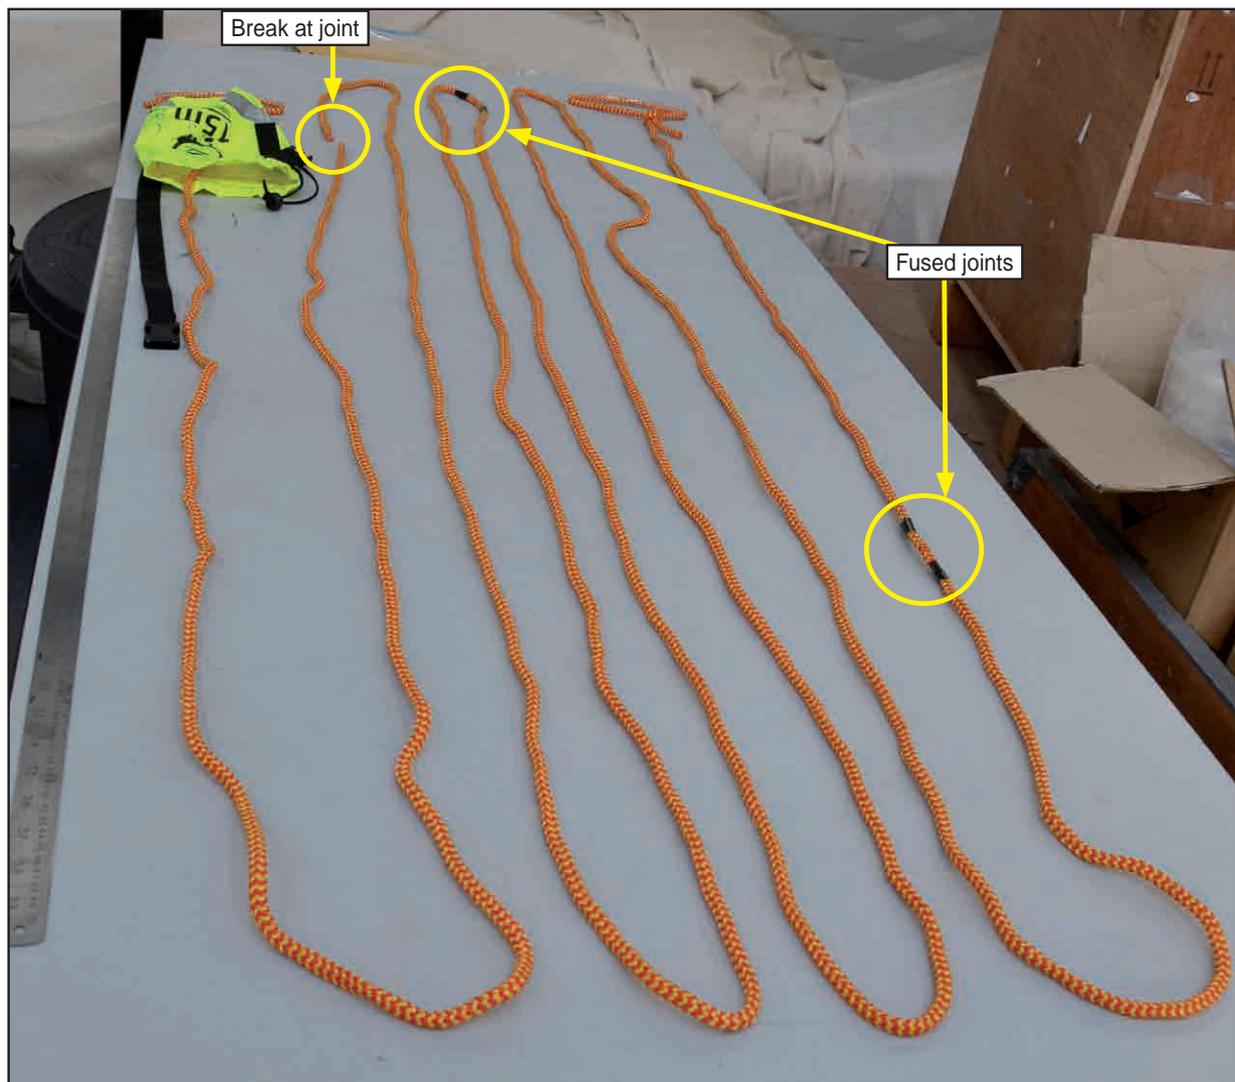
On inspection, the defective RIBER throw bag rescue lines identified by Warrington Rowing Club were found to have been made up of sections of polypropylene rope fused together, which broke easily at the joint when put under tension. One line was constructed of two sections of rope fused together, the other was constructed of four sections of rope, resulting in three fused joints in its 15m length (**Figure 3**). Intact and joined sections of one of the defective rescue lines were tested to determine the line's minimum breaking load. The intact section failed at 256 kgf (kilogramme force) and the joined sections failed between 19 and 23 kgf.

Figure 3: 15m rescue line with three joints

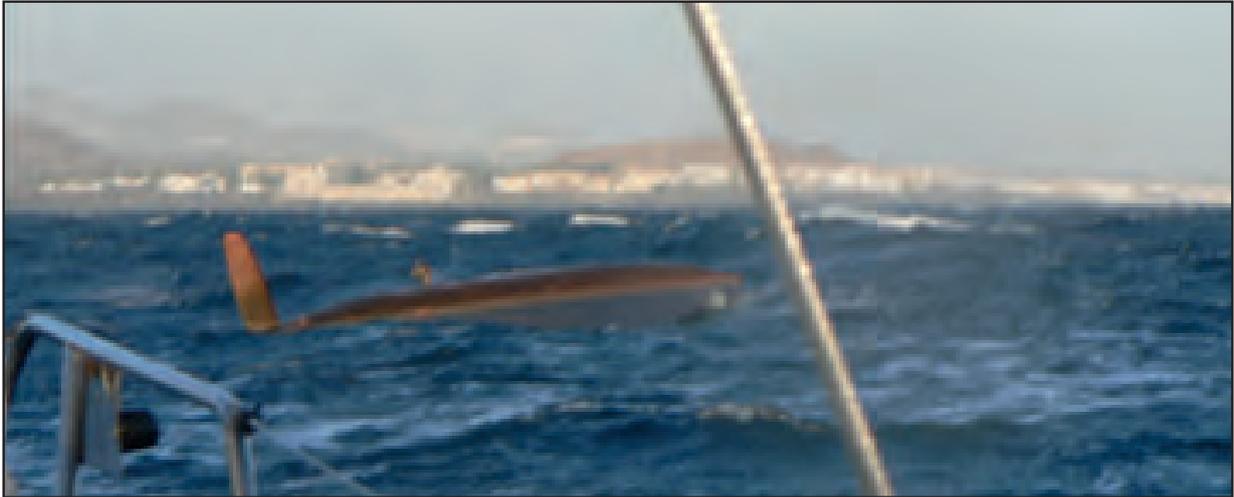
The MAIB is investigating the keel failure and capsizing of the UK registered commercial yacht *Tyger of London* (**Figure 1**) while on passage from La Gomera to Tenerife, on 7 December 2017. The five persons on board were rescued from the water by the crew of a nearby yacht.

Figure 1: *Tyger of London* post-capsize

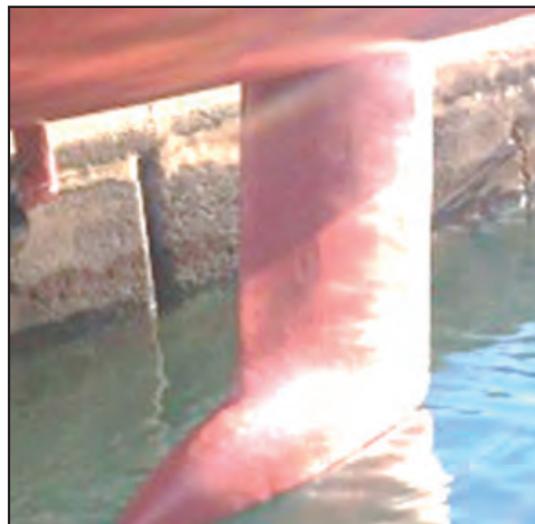
Tyger of London was fitted with the 'shallow draught, lead keel', which is the subject of this safety bulletin.

Figure 2b: Shallow draught, lead keel, fitted to *Tyger of London*, subject of this safety bulletin
