TO: Mike Samulski, EPA-AA
FROM: Jim Carroll, Southwest Research Institute
SUBJECT: Weekly Progress Report for Work Assignment 1-5, EPA Contract EP-C-05-018
Period From: March 24, 2006 To: March 30, 2006

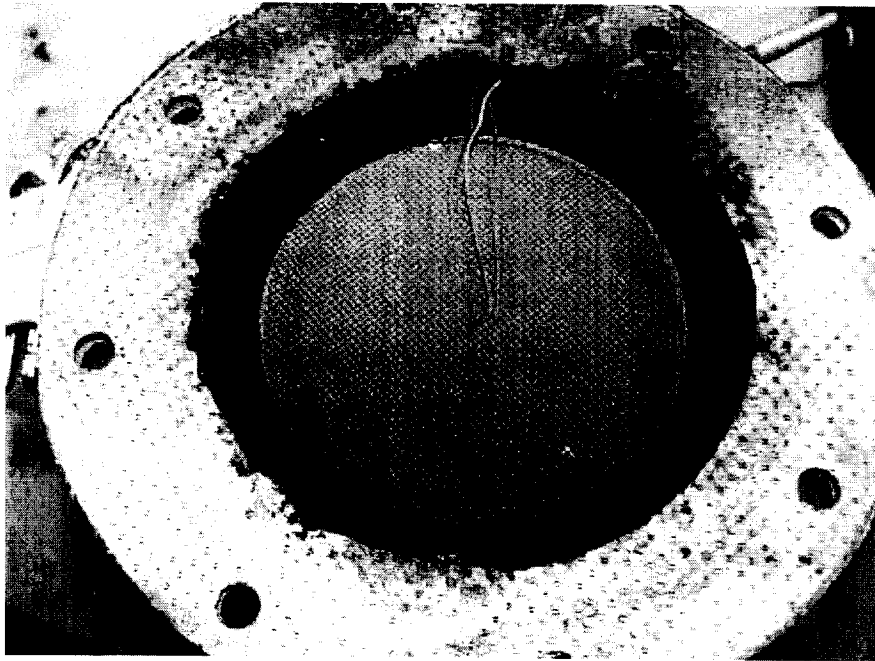
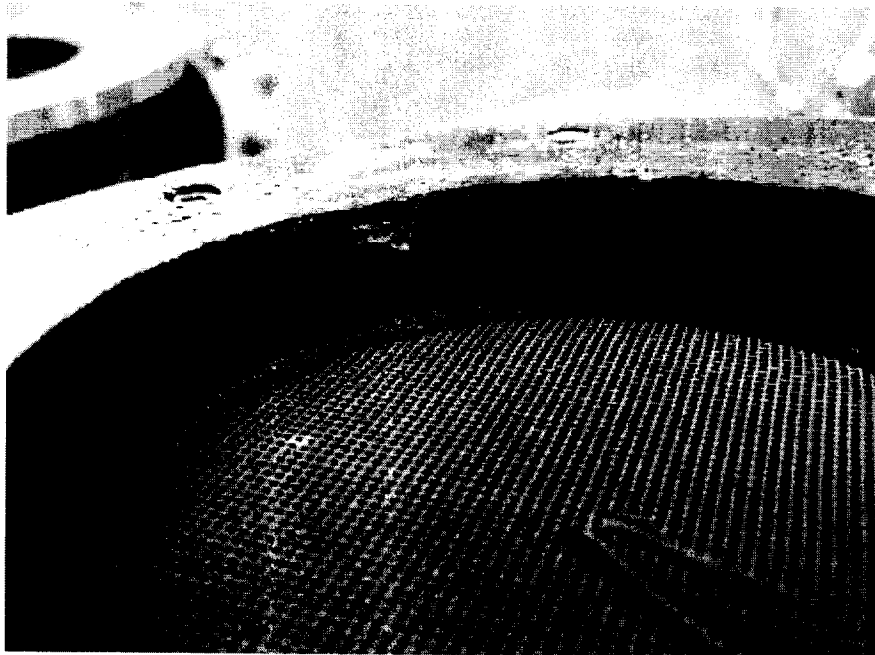
Figures 1 through 5 show the left converter and the outlet section to the bullhorn, and Figures 6 through 10 show the right side exhaust system. There is no evidence of stains or salt residue to indicate that saltwater has collected within the exhaust system. However, Figures 1 and 2 show where precipitate has formed along the weld of the catalyst canister's inlet. Figures 3 and 4 show precipitates at the outlet of the catalyst canister, and show that the Monel (70% nickel, 30% copper) wire mesh seal around the end of the catalyst substrate is starting to fray away. In addition, the Monel has become extremely fragile. A slight touch to the Monel is enough to break it off, and it turns to a dust-like consistency with only a little pressure. SwRI will subject the Monel to microscopic and elemental analyses to find the cause of the metal degradation.

Figure 1. Maxum 4.3L Left Converter Inlet

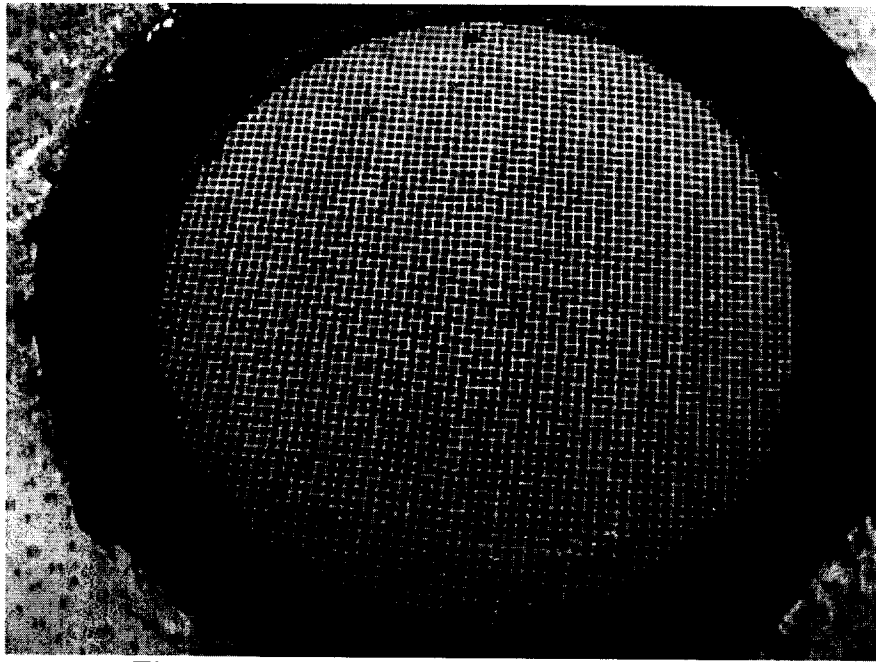
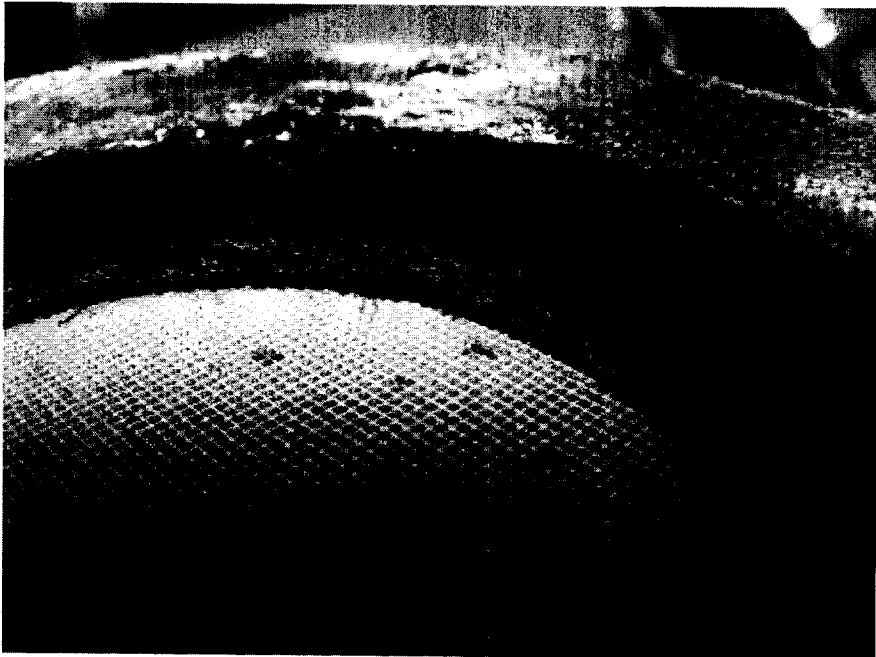
Figure 3. Maxum 4.3L Left Converter Outlet

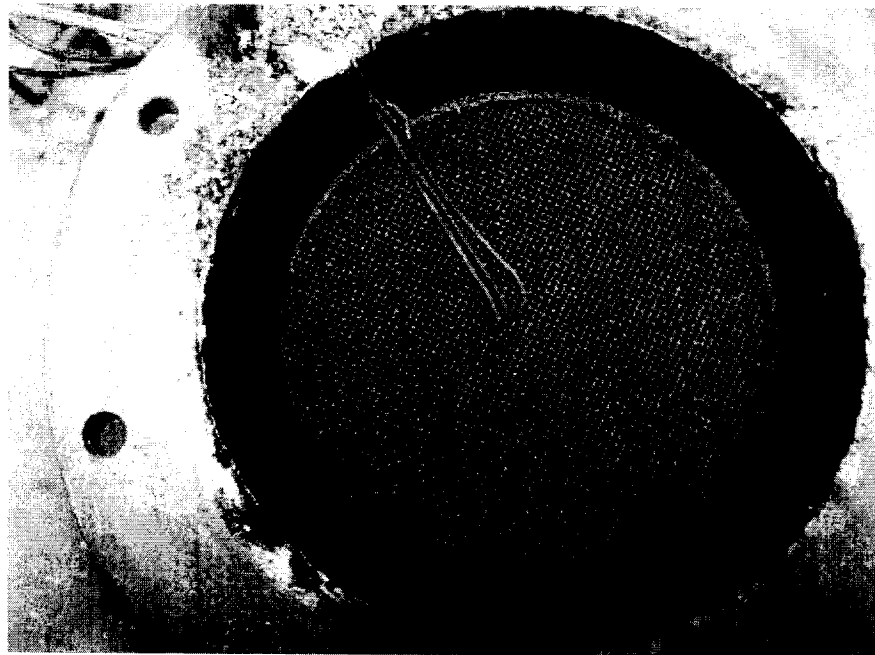
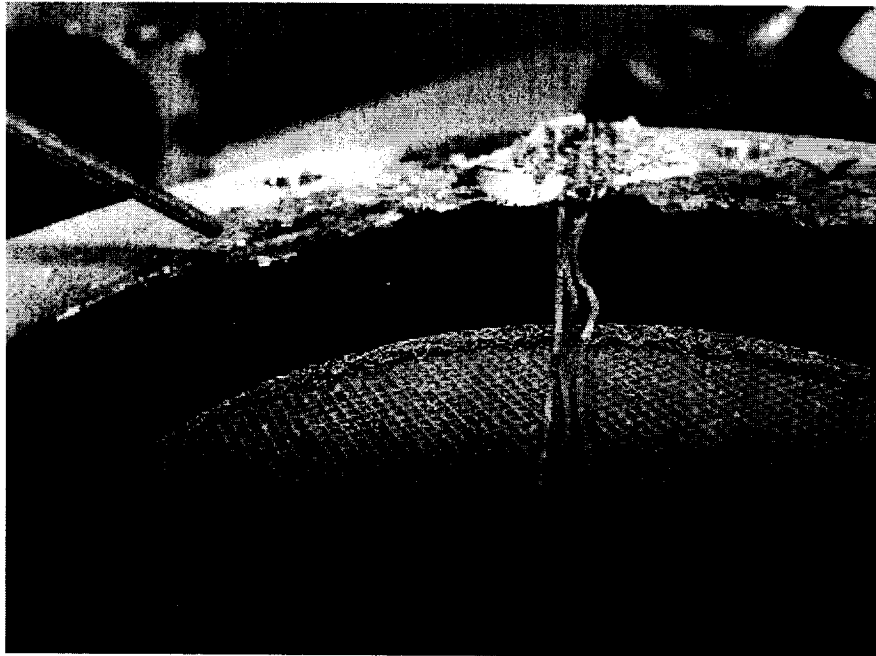
Figure 6. Maxum 4.3L Right Converter Inlet

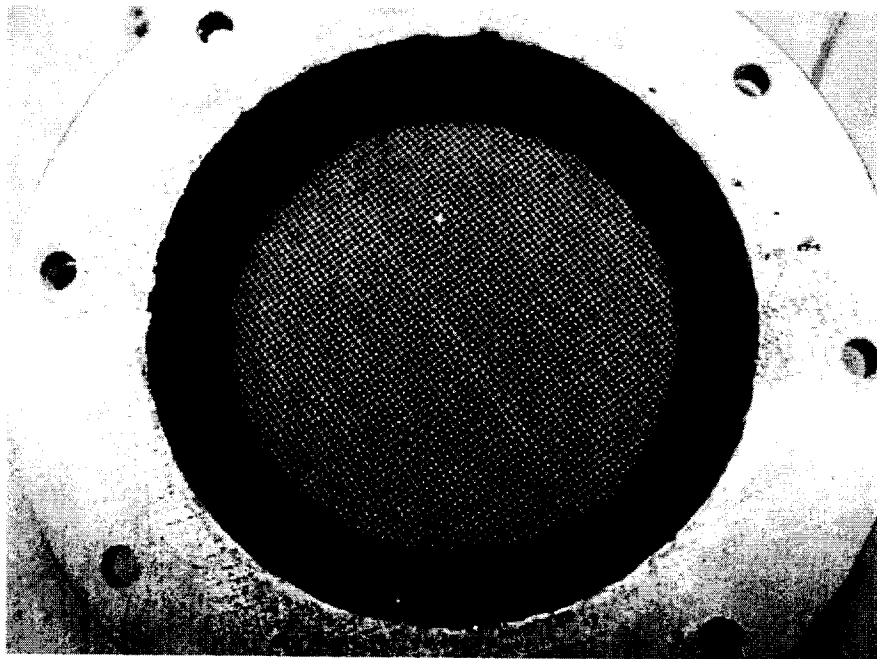
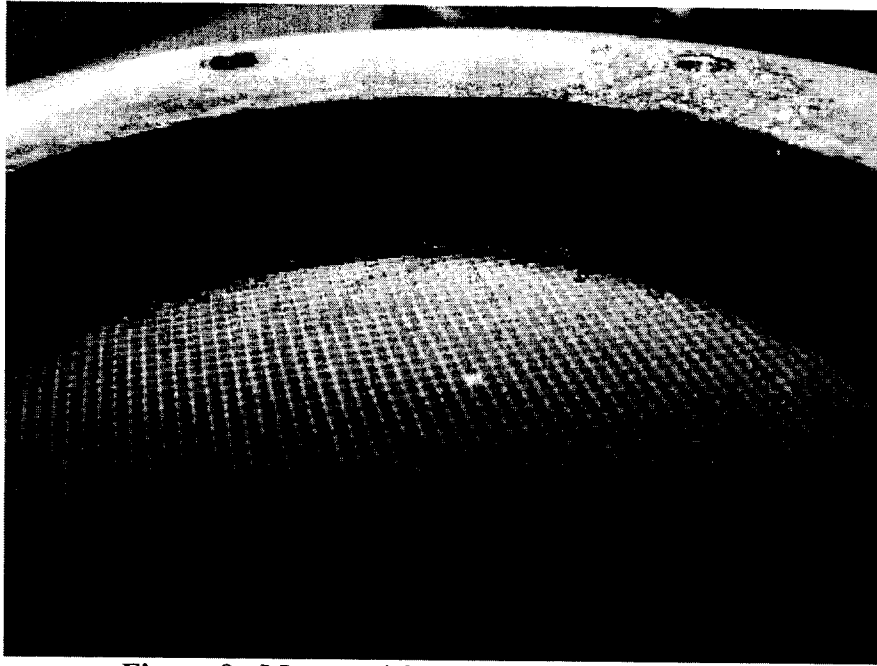
Figure 8. Maxum 4.3L Right Converter Outlet

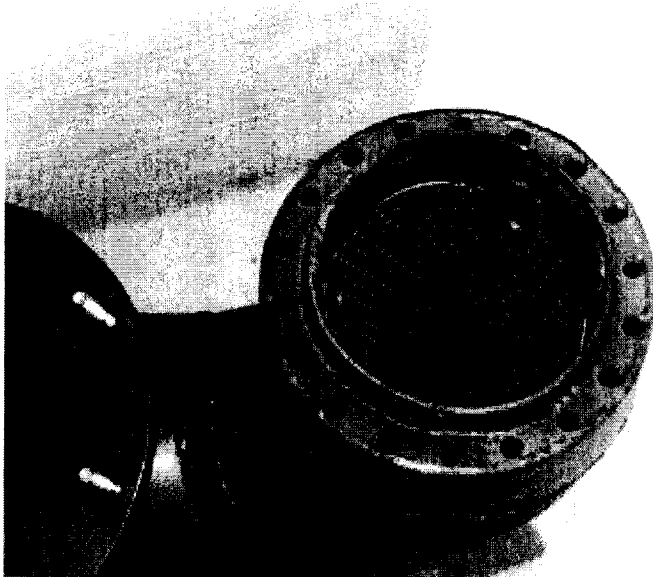
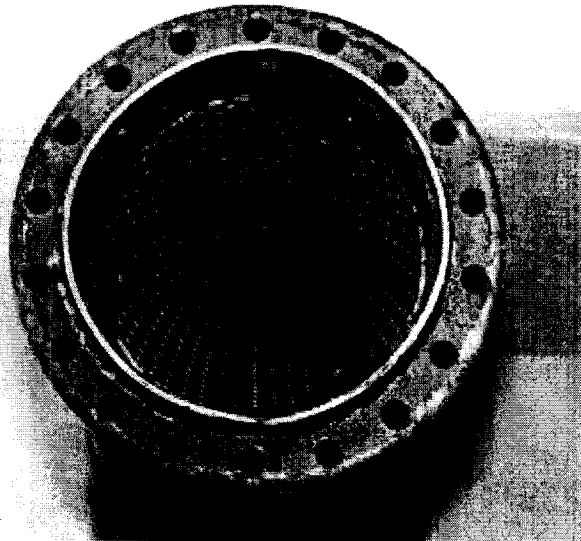
Photographs of new exhaust system parts for the SeaRay and Maxum engines are shown below. Figures 1 and 2 show the re-fabricated 316L stainless steel catalyst outlets for the Maxum engine, and the saltwater demister installed within the exhaust pipe. These parts were solution annealed and then sealed internally with Permabond HL 126. Figures 3 and 4 contrast the original freshwater exhaust system for the SeaRay engine with the new saltwater design. Figure 4 also shows the closed-loop cooling system installed on the top front of the engine. Figures 5, 6, 7, and 8 show the 316L stainless steel exhaust connections which are mounted after the catalyst of the SeaRay 220 engine. Figure 7 shows how the outer tube of the riser had to be cut and welded in order to match the radius of the inner exhaust tube. Figure 8 shows the smooth inner exhaust tube which only has welds at the flanges on both ends to reduce the number of potential corrosion formation sites in the steel.

FIGURE 1. MAXUM EXHAUST RISER

FIGURE 2. MAXUM EXHAUST RISER WITH DE-MISTER INSERT

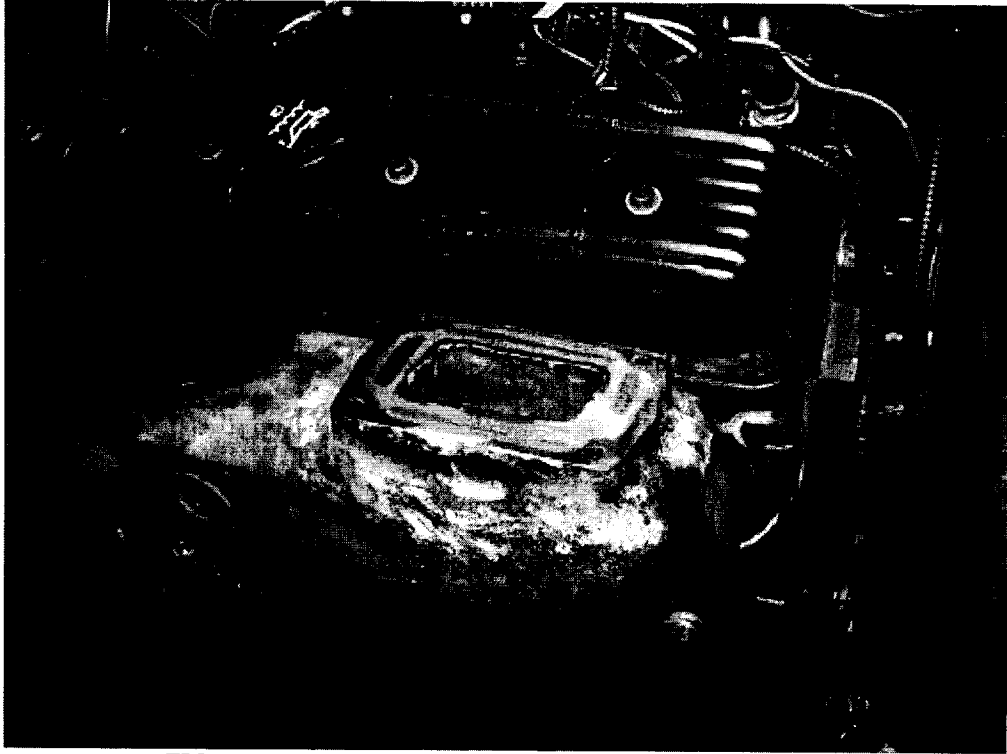
Figure 1 shows a manifold flange that had its coolant passages filled with silicon-bronze welding rod.

**FIGURE 1. FILLED AND SEALED COOLANT PASSAGES
AT 5.7L V8 MANIFOLD FLANGE**

We then decided to try silicon-bronze welding rod to fill the coolant passages because less energy is needed for welding them and thus the heat load on the manifold would be reduced. Small pieces of steel were cut and fit into the coolant passages to partially block the passage and create an initial bridge for the welding material to span. Using silicon-bronze rod, the cast-iron manifolds did not crack during cooling.
