The National Marine Manufacturers Association / American Boat and Yacht Council / BoatUS Engine Cut-Off Lanyard Test Program

Final Report

August 19, 2011

NMMA/ABYC/BoatUS Lanyard Application Test Report

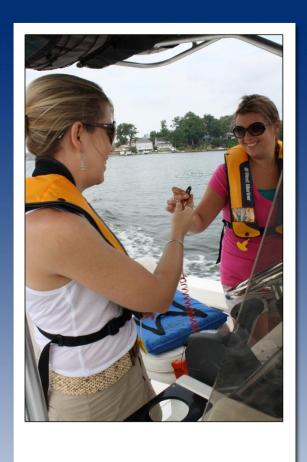
Mako Operator Lanyard Switch

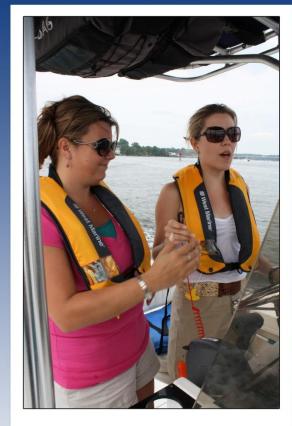
Sea Doo Operator Lanyard Switch
