**MARINE ACCIDENT
INVESTIGATION BRANCH**

SAFETY DIGEST

**Lessons from Marine
Accident Reports
1/2018**

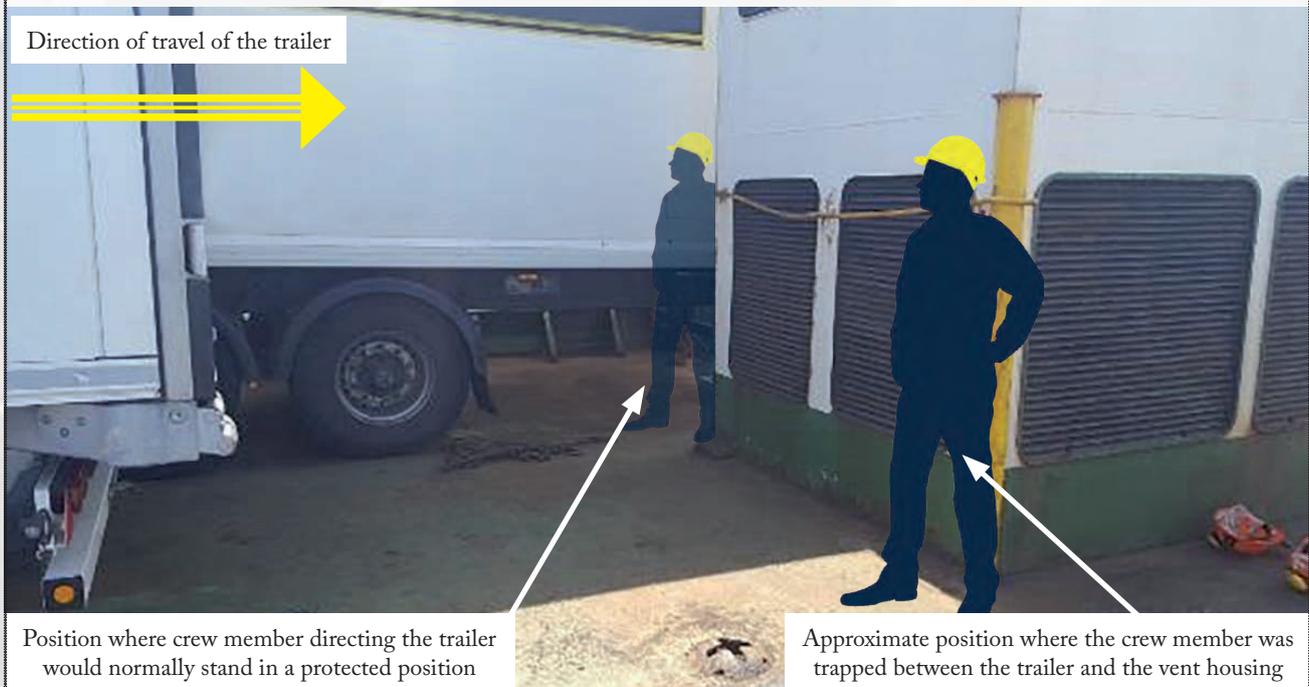
The tug driver reversed the trailer, jack-knifing to the left and right to achieve a straight trajectory and line the trailer up with the freight already parked. He was expecting to hear a whistle signal from the banksman when the trailer reached the correct position. Meanwhile, the crew member acting as the banksman had moved from a position of safety and was crushed between the rear of the trailer and a vent housing. The whistle signal instructing the tug driver to stop was not given.

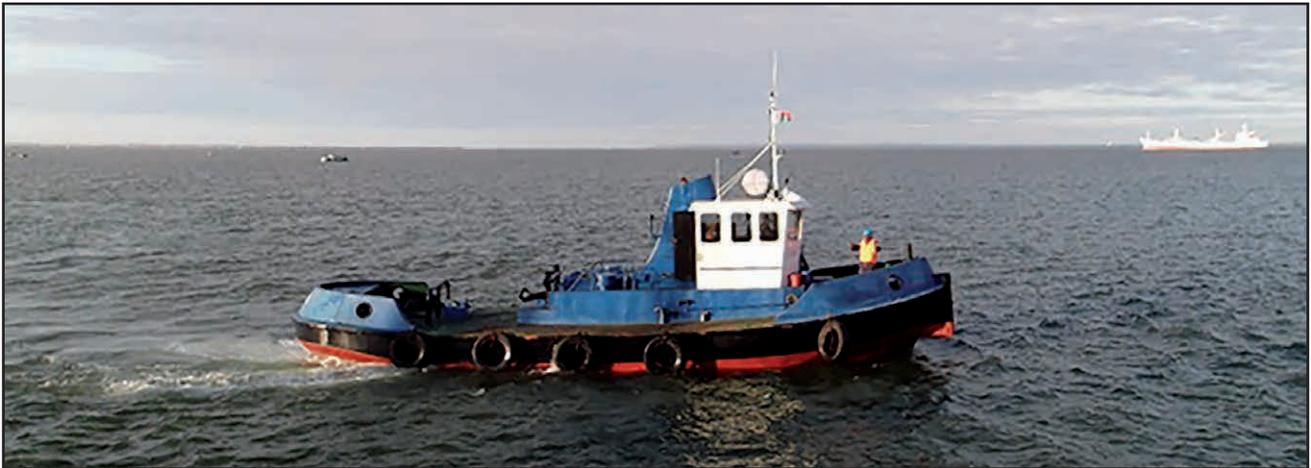
The tug was connected to the ship's port quarter to help pull its stern off the berth. During the manoeuvre, the prevailing wind and tidal conditions caused the ship to move towards an outlying mooring dolphin. To avoid striking it, the ship's master briefly increased ahead speed to 5kts, during which time the tug girted and capsized.

Figure 1: The tug

1. The girting and capsize of tugs is an ever present risk if towing operations are not managed and executed safely.
2. Girting can rapidly lead to a tug capsizing. It occurs when high athwartships towing forces cause a tug to be pulled sideways through the water by the towline. If the tug is unable to manoeuvre out of this position it is likely to capsize. Single screw tugs with a low freeboard are at particular risk of girting.

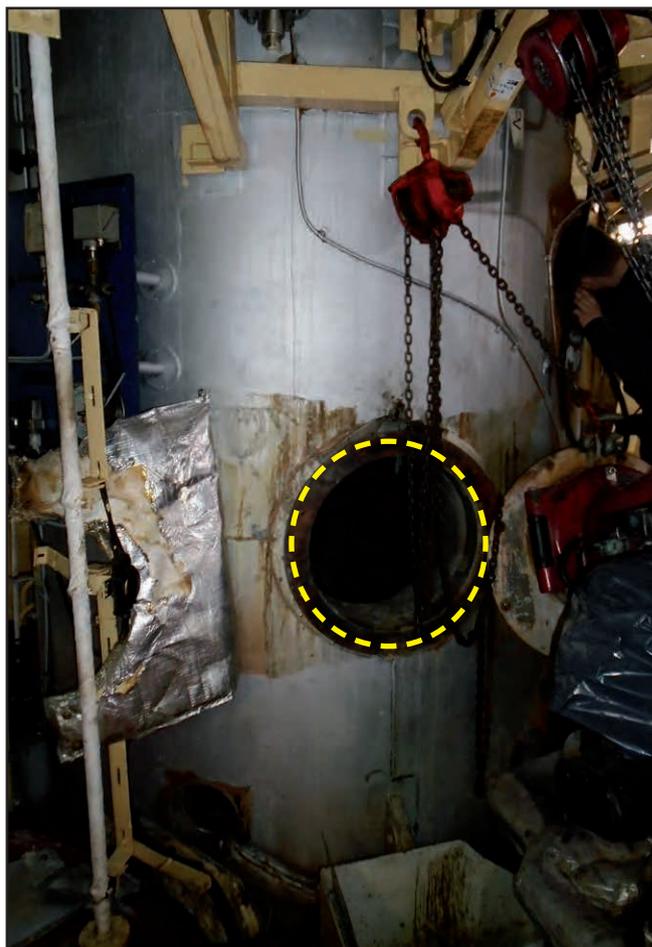
A ro-ro ferry was operating to a normal schedule with contractors on board to conduct repairs to an auxiliary boiler. The work was planned to start during an evening passage. The repairs involved hot work inside the boiler (Figure 1).

Figure 1: Furnace access

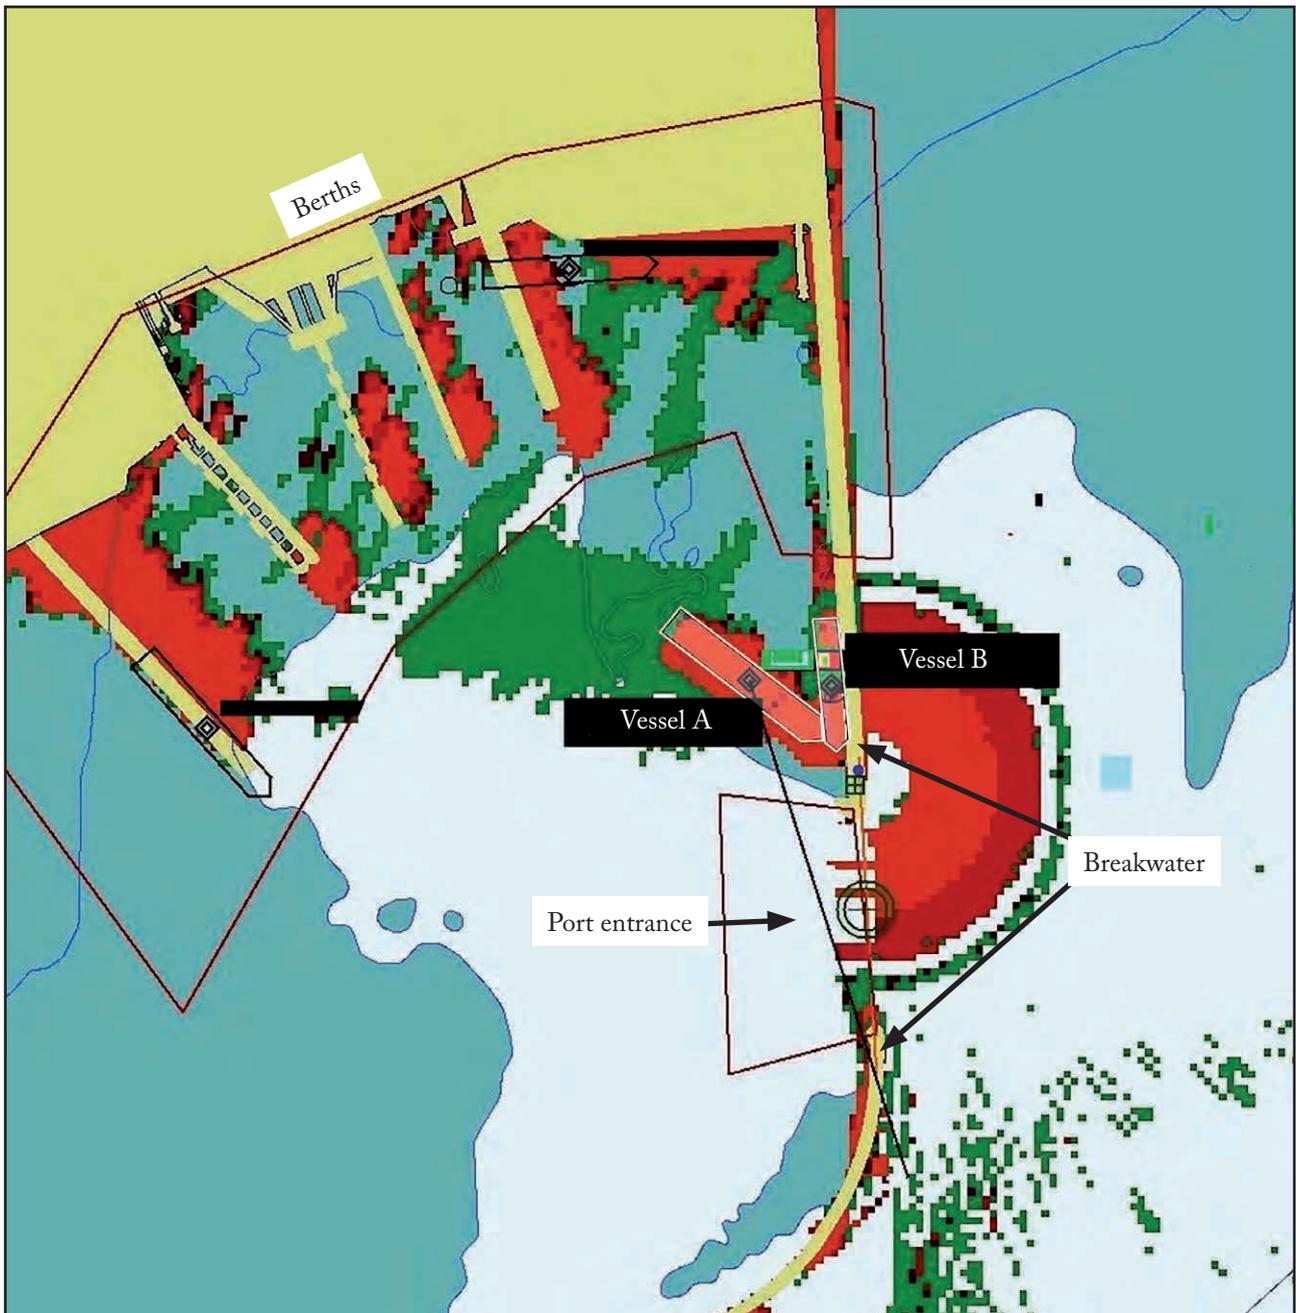
Port control called the ship (see figure - Vessel A) on VHF radio advising of its close proximity to the ship berthed (see figure - Vessel B) on the breakwater ahead. The master activated a pre-recorded message on the public address system instructing passengers and crew to brace for an impending collision. However, the combined effect of the astern propulsion and deployed anchor prevented contact with the ship ahead, but only by 3m.

Figure: Radar picture from port control showing the proximity of the two vessels

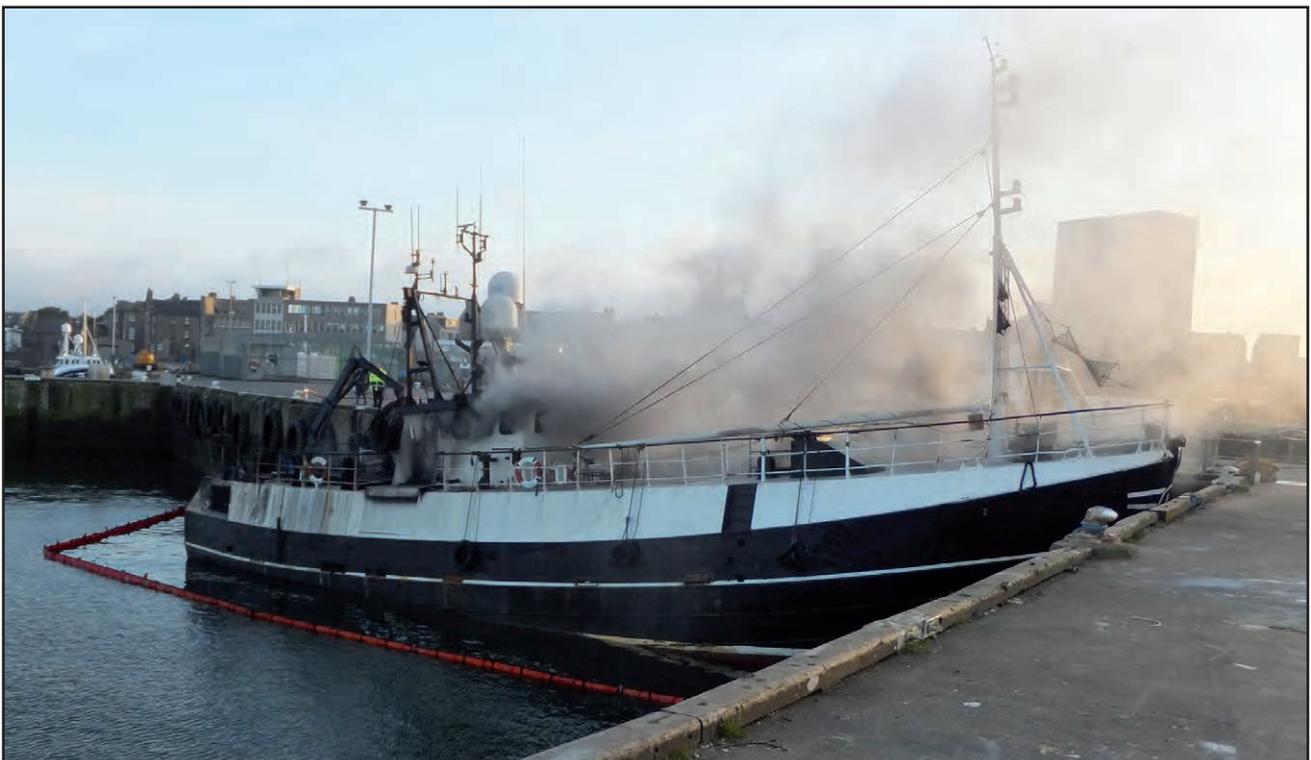
At 0537, with flames emitting from the vessel, the crew of another fishing vessel secured nearby called the emergency services. At 0546, the first fire appliance was on scene and the fire service continued to tackle the blaze until the following day (Figure 1). By this time, the vessel was extensively damaged and it was later declared a constructive total loss.

Figure 1: The fishing vessel on fire

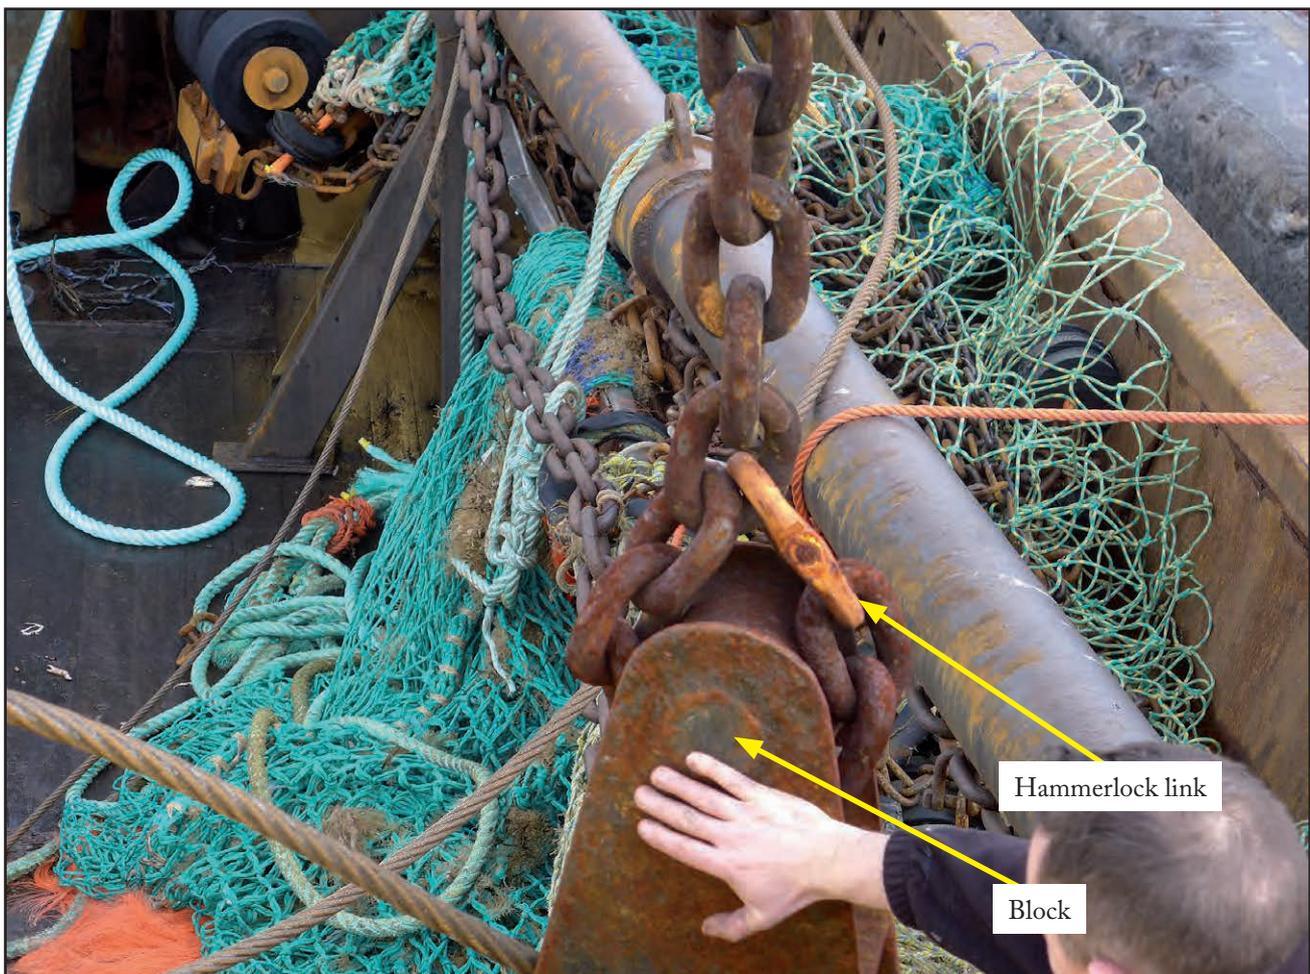
Figure 1: The port tow beam

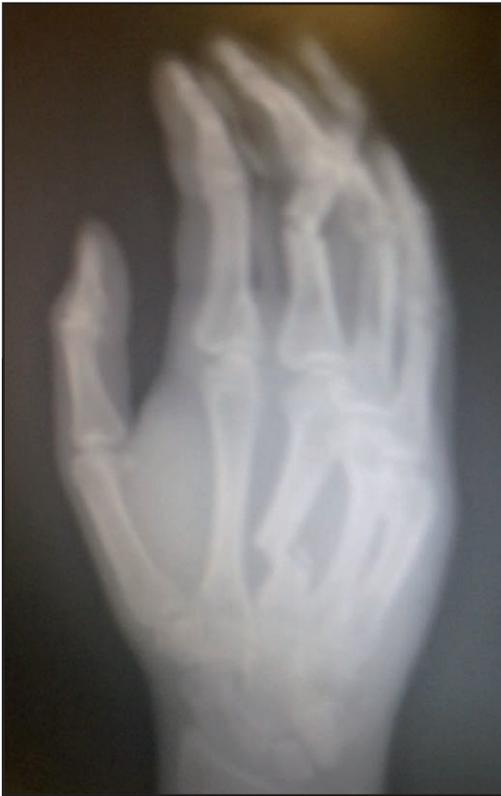
2). Most of the injuries were caused by the bridle chains. It was fortunate that no one was struck by the tow beam or pulley block.

Figure 2: X-ray showing multiple fractures

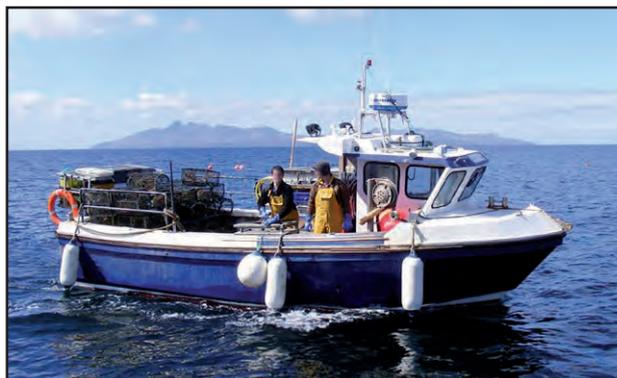
Figure 1: The fishing vessel

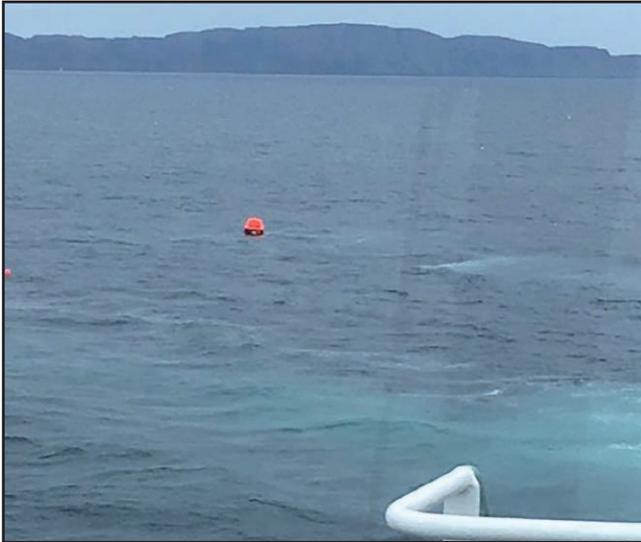
Deciding that his boat could not be saved, the skipper climbed into the liferaft and cast it adrift (Figure 2). A passenger ferry, alerted by the "Mayday" call and tasked by the coastguard, diverted to the scene and launched its fast rescue craft. The ferry's rescue boat crew recovered the skipper from his liferaft and took him back to the ferry, where his condition was assessed. Another nearby fishing vessel picked up the liferaft and stood by the sinking boat (Figure 3) until it sank a few minutes later.

Figure 2: The liferaft

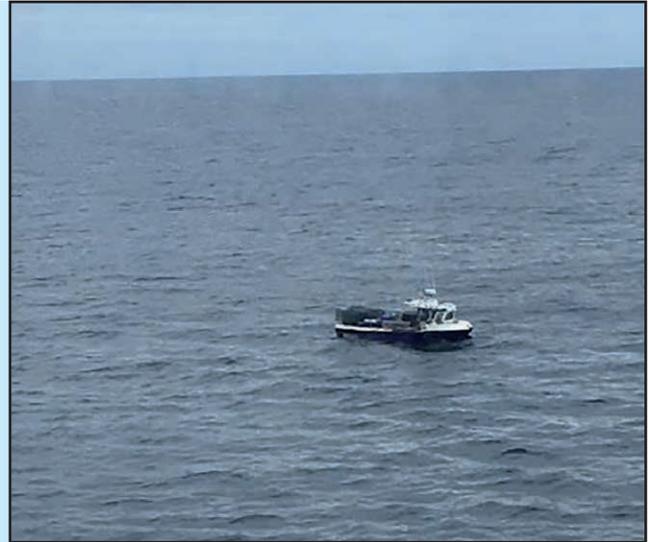
Figure 3: Fishing vessel standing by the sinking boat

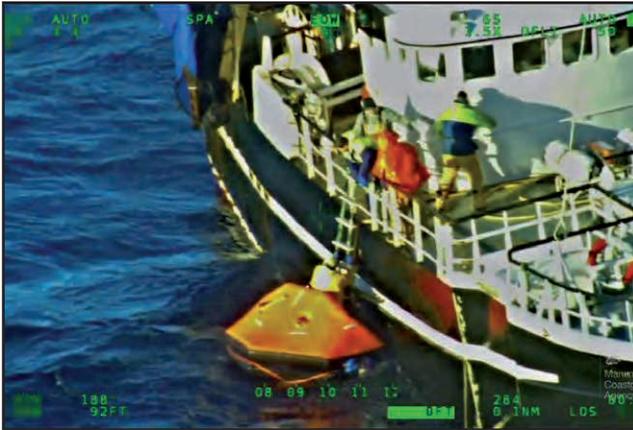
Figure: Recovery of the crew

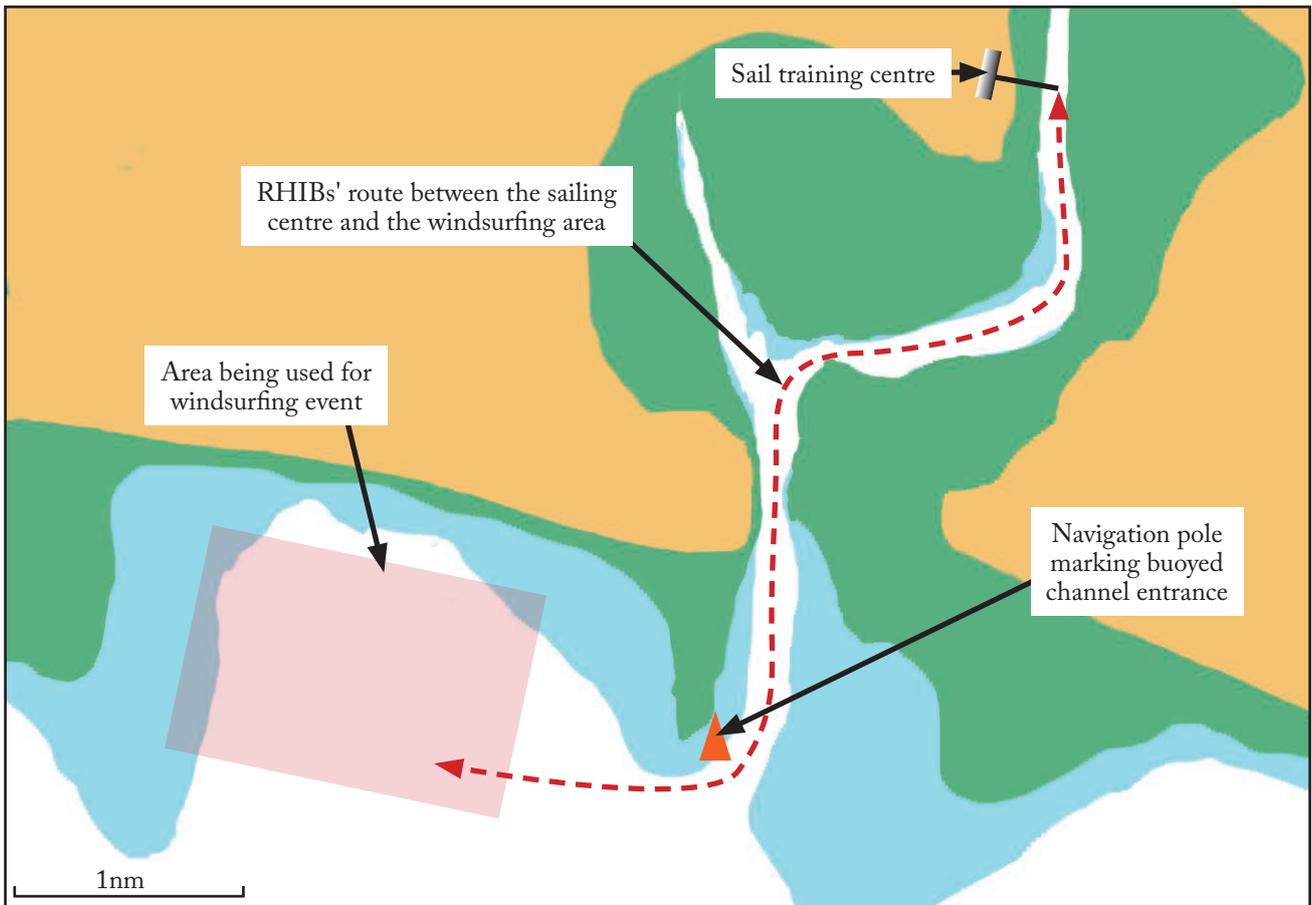
Figure 1: Overview of the area showing the sailing centre, windsurfing area and channel navigation pole

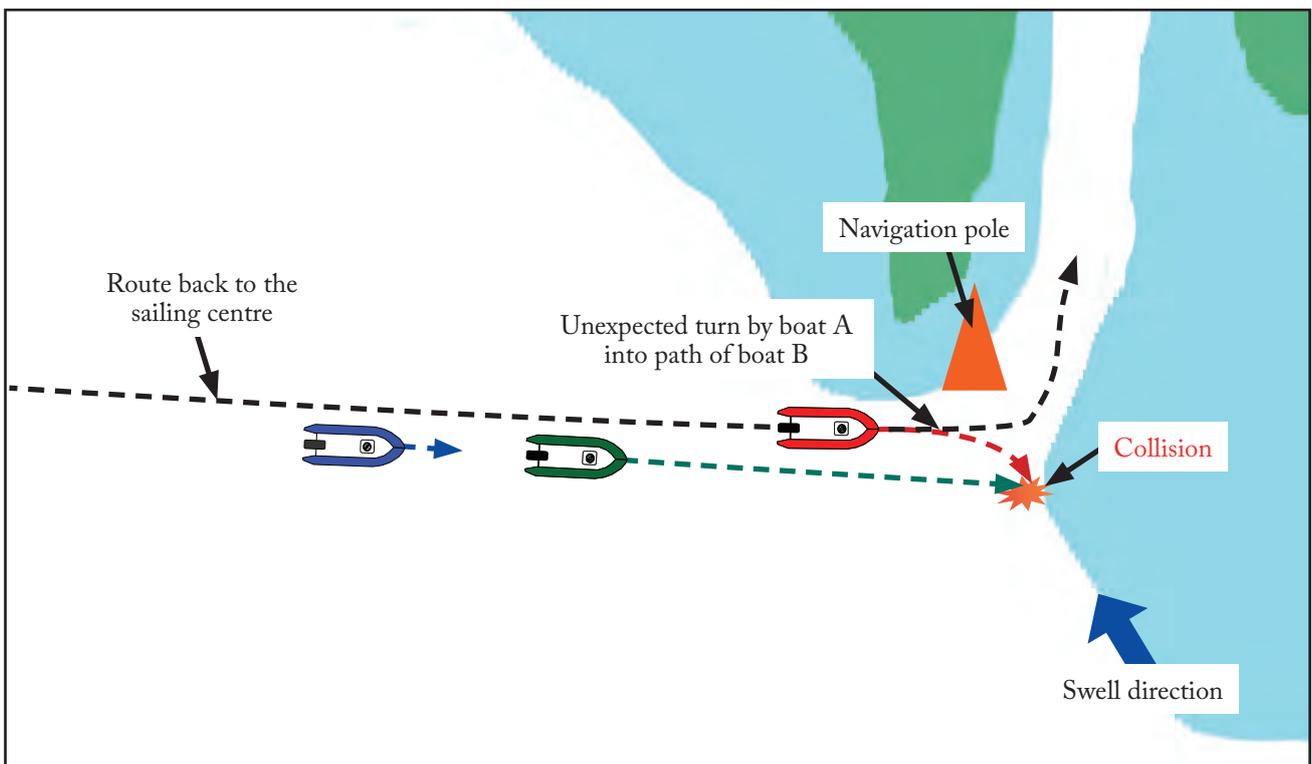
Boat A's manoeuvre brought it directly into the path of boat B, which was still planing at full speed. When the helm of boat B realised what had happened, it was too late to avoid collision (Figure 2) so he pulled the kill cord to stop the engine. Boat B struck boat A violently on its starboard side then rode right over boat A into the sea beyond; all of boat A's four crew were thrown into the water and three were injured, one seriously.

Figure 2: Expected and actual routes of boats A and B leading to collision (not to scale)

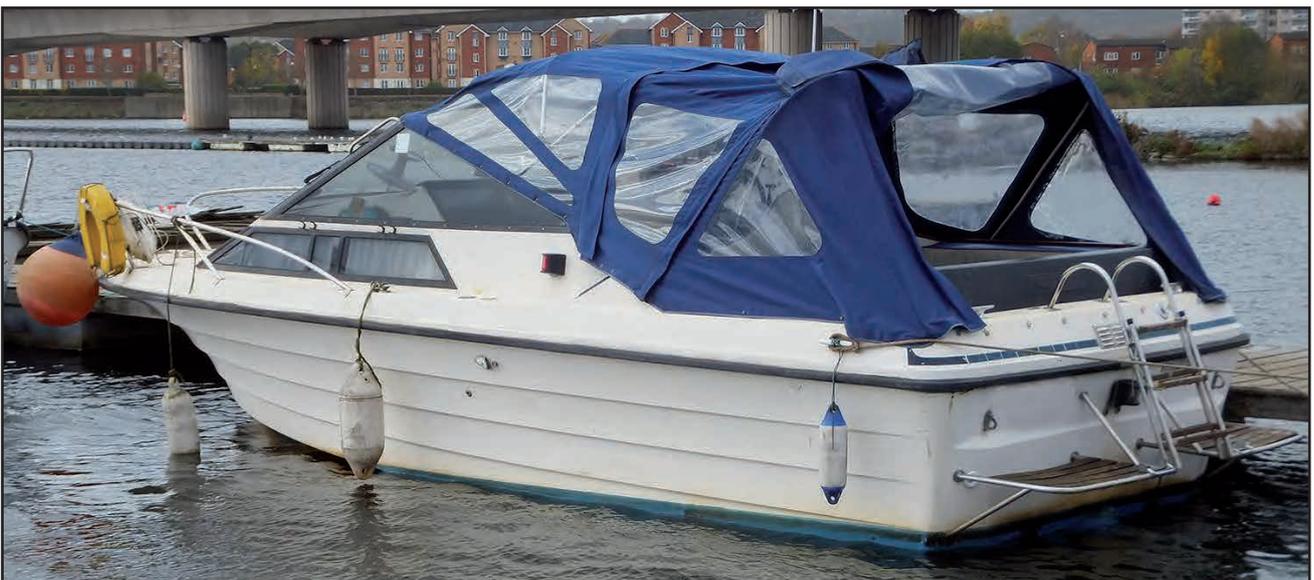
Figure 1: The motor cruiser

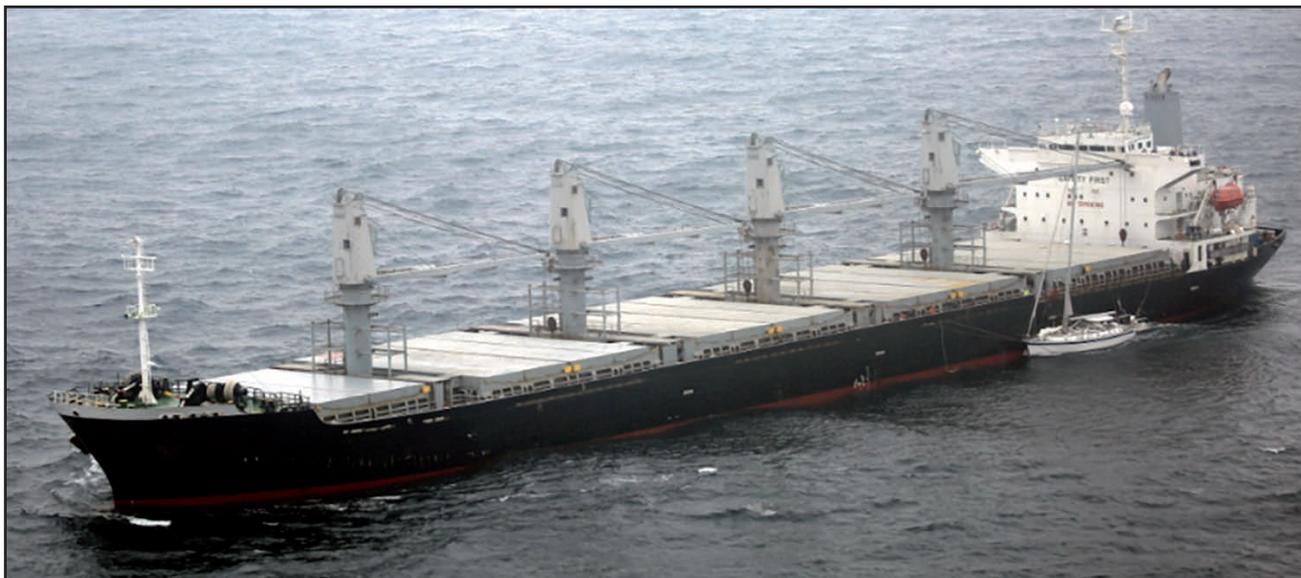
During the night, the skipper started hearing a clunking sound each time the boat rolled and assessed it to be movement of the keel; a significant development that led to the decision to abandon the boat. When the merchant vessel arrived on scene, the skipper drove the yacht alongside and the crew transferred to the safety of the ship (Figure 2). The yacht was then cut free, with a hull valve left open in order that it would flood and sink.

Figure 2: The yacht alongside the rescuing merchant vessel as the crew transferred to safety

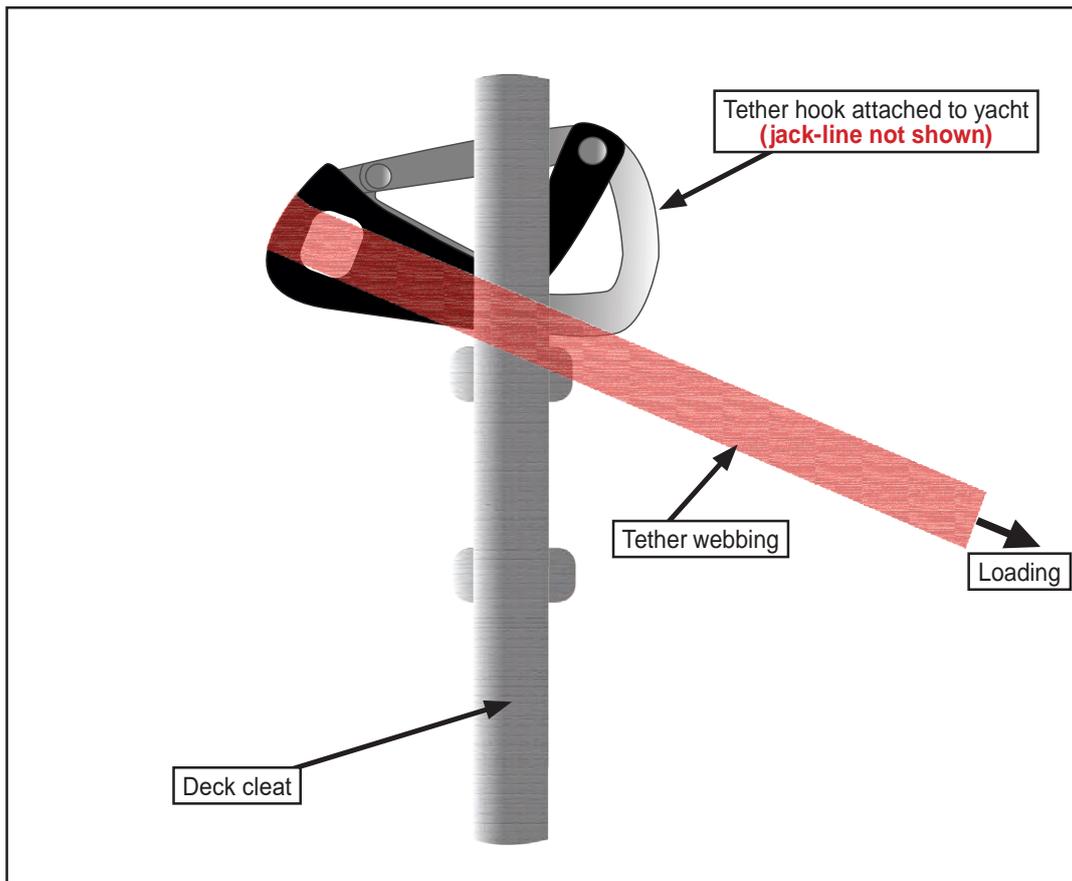
Figure 1: Tether hook under deck cleat

To prevent the strength of a safety harness tether becoming compromised in-service due to lateral loading on the tether hook, the method used to anchor the end of the tether to the vessel should be arranged to ensure that the tether hook cannot become entangled with deck fittings or other equipment.
