**Lessons from Marine
Accident Reports
2/2018**

SAFETY DIGEST
Lessons from Marine Accident Reports
No 2/2018

October 2018

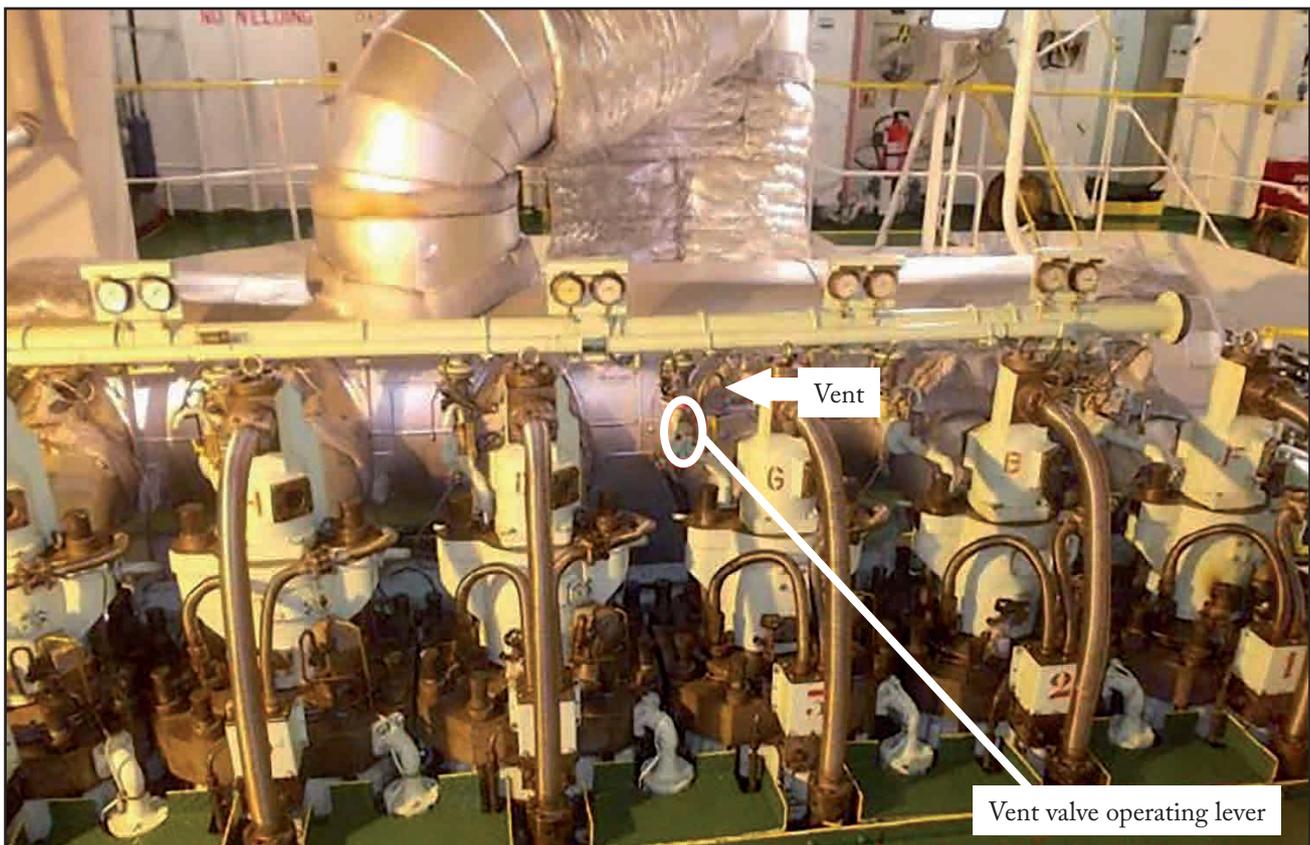
The confined location prevented the second engineer's escape, but the swift actions of the third engineer, who managed to close the valve, saved him from further scalding injuries.

Figure 1: View of main engine cylinder heads

Following the accident, the company took immediate action to remove the vent valve operating levers on all its vessels with similar engines. This was a temporary measure until proper securing or blanking arrangements could be put in place.

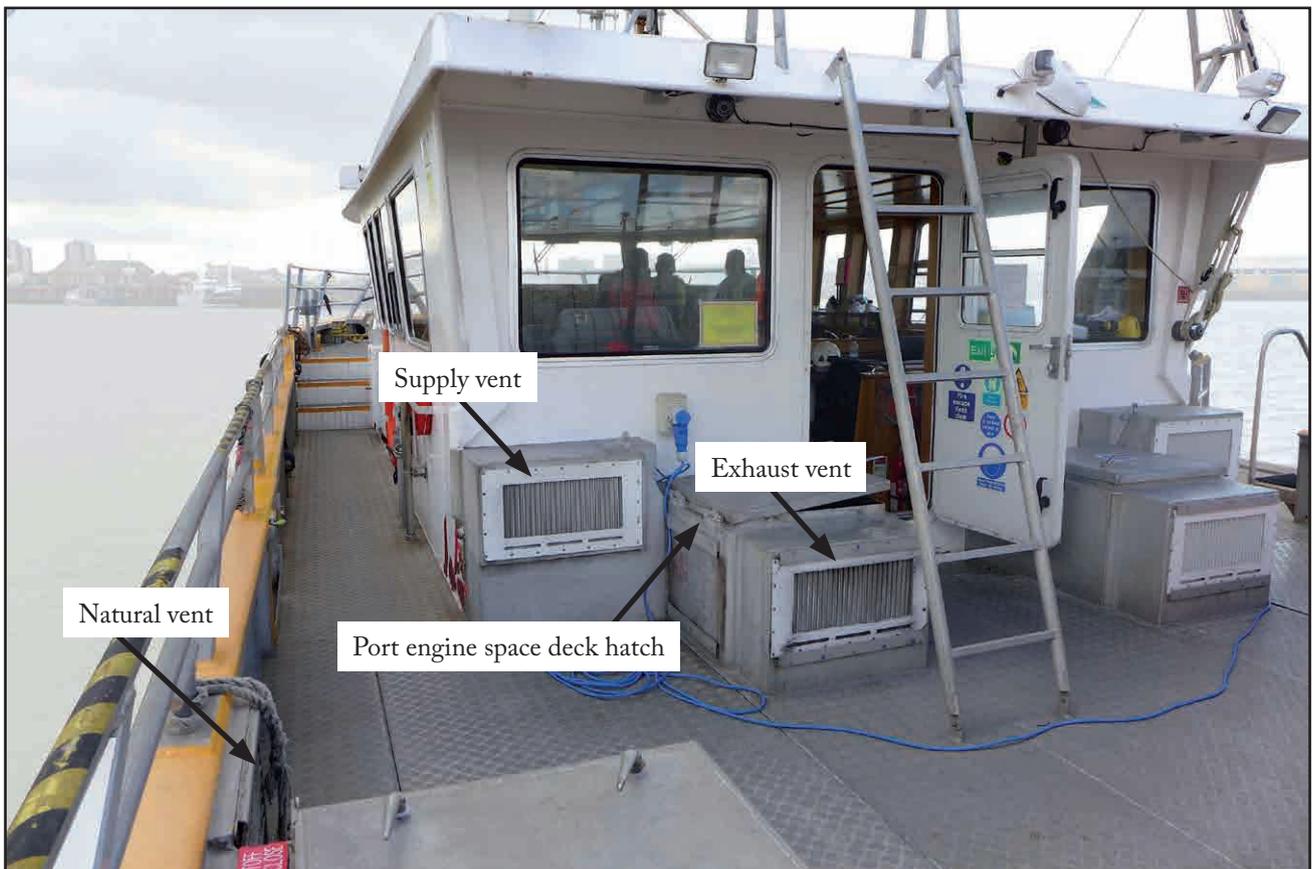
Within 2 minutes of the port engine failure, the crewman had closed the flap on the engine space's supply vent on the aft deck (Figure 1), and activated the fire extinguishing system. The extinguishing medium filled the port engine space, obscuring the flames from view on the CCTV, and a white gaseous cloud billowed from the port engine space's natural air vent (Figure 2). Meanwhile, the technicians mustered on the foredeck and the skipper broadcast a "Mayday" via VHF radio. In response, other crew transfer vessels in the immediate vicinity closed to assist.

Figure 1: Aft deck

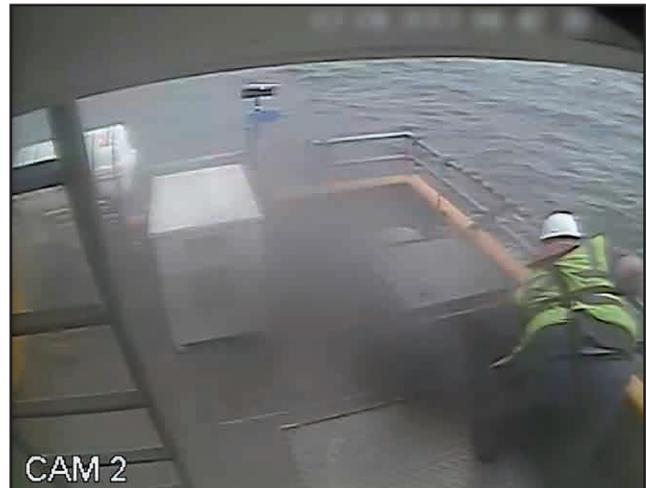
The technicians were soon transferred onto another vessel, but by then plumes of black smoke were coming from the port engine space's natural air vent. As a result, the deckhand had to lean through the smoke to operate the port engine's remote fuel shut-off (Figure 3). The skipper then sealed the port engine space's natural and exhaust vents. A hose was also rigged on the aft deck to provide boundary cooling if required.

Figure 3: Deckhand shutting off fuel supply

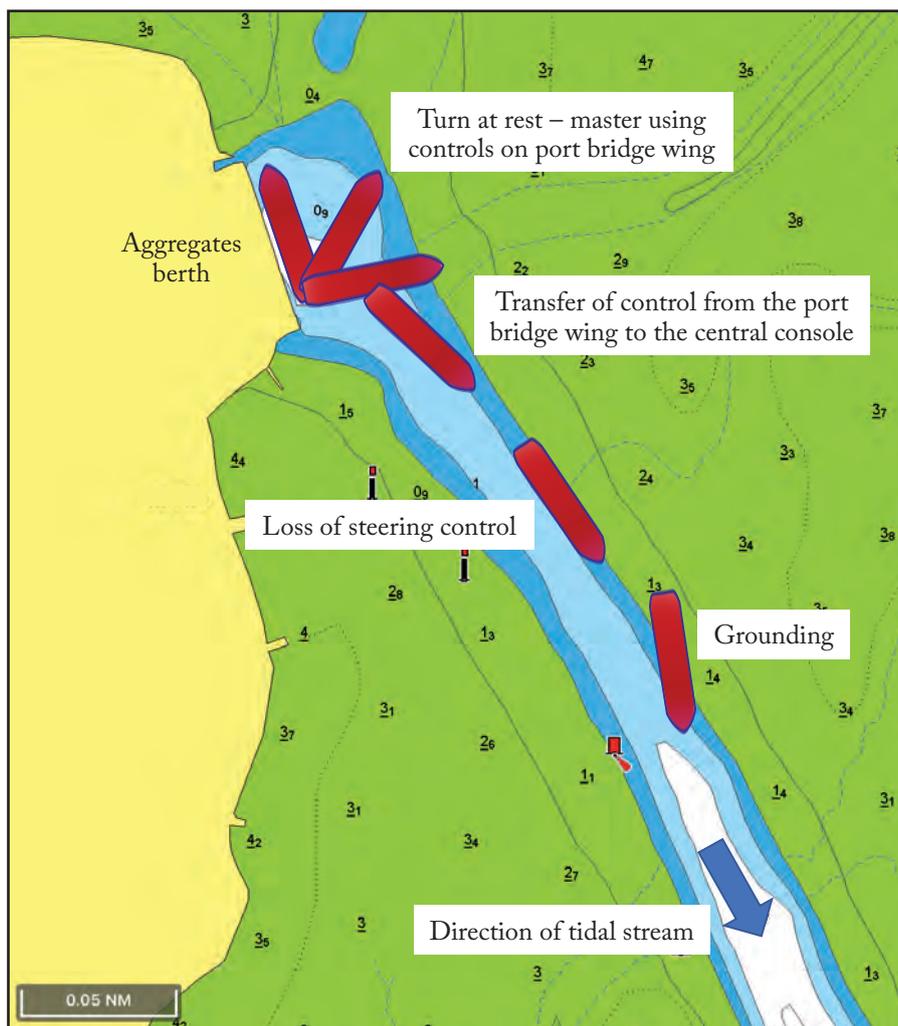
In response to the loss of control, the master reduced speed and attempted to steer the ship using the bow thruster. The master then repeated the procedure for transferring steering control between the consoles, which resulted in regaining control of the rudder from the centreline. However, the recovery of steering control came too late to prevent the dredger grounding gently at about 2kts on the mud bank opposite the berth and a short distance downstream (Figures 1 and 2). The dredger was undamaged and refloated at the next high water.

Figure 1: Chart showing the unberthing, turn at rest and grounding position

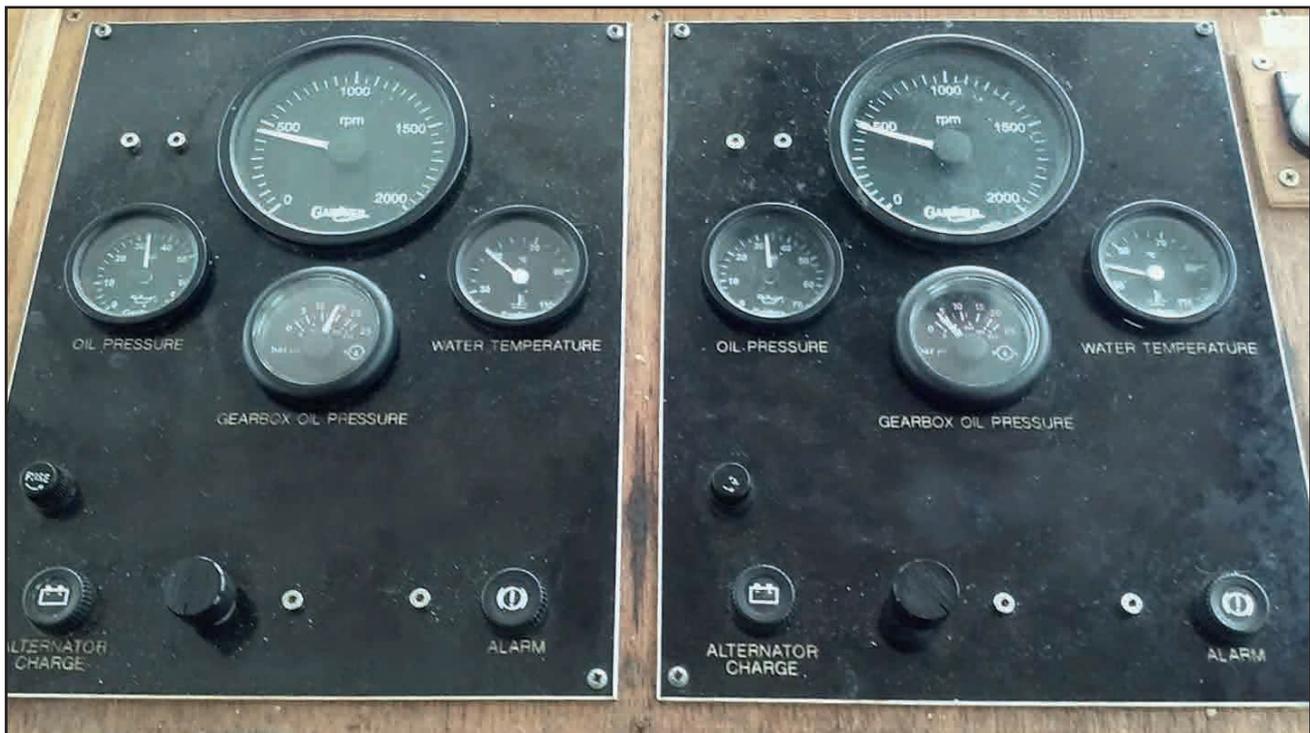
Figure 2: The wheelhouse console

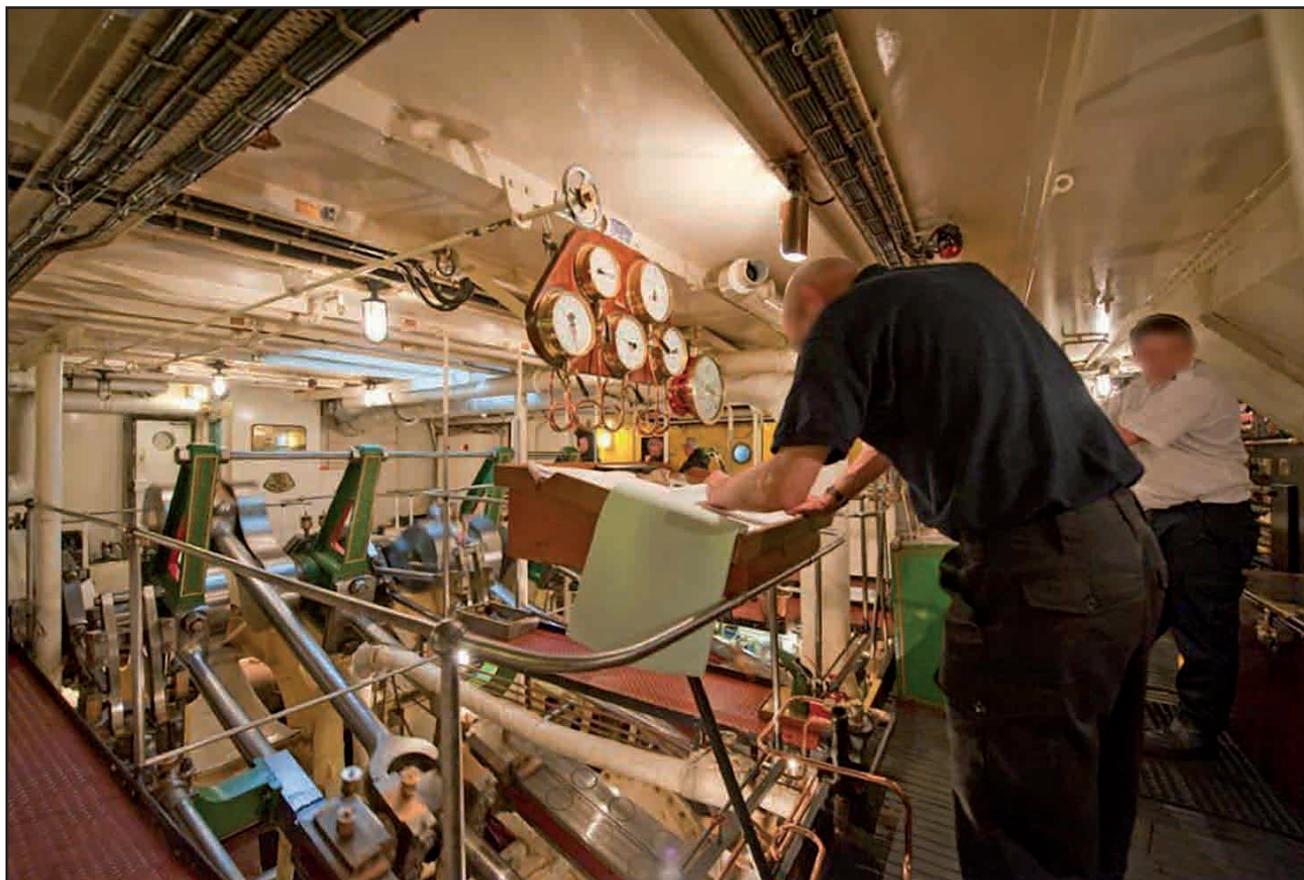
In the engine room, the chief engineer had become distracted while operating the engine controls and was assessing whether a recent

Figure 1: Engine room configuration showing the crew member (left) and chief engineer (right) with the engine telegraph between the two of them

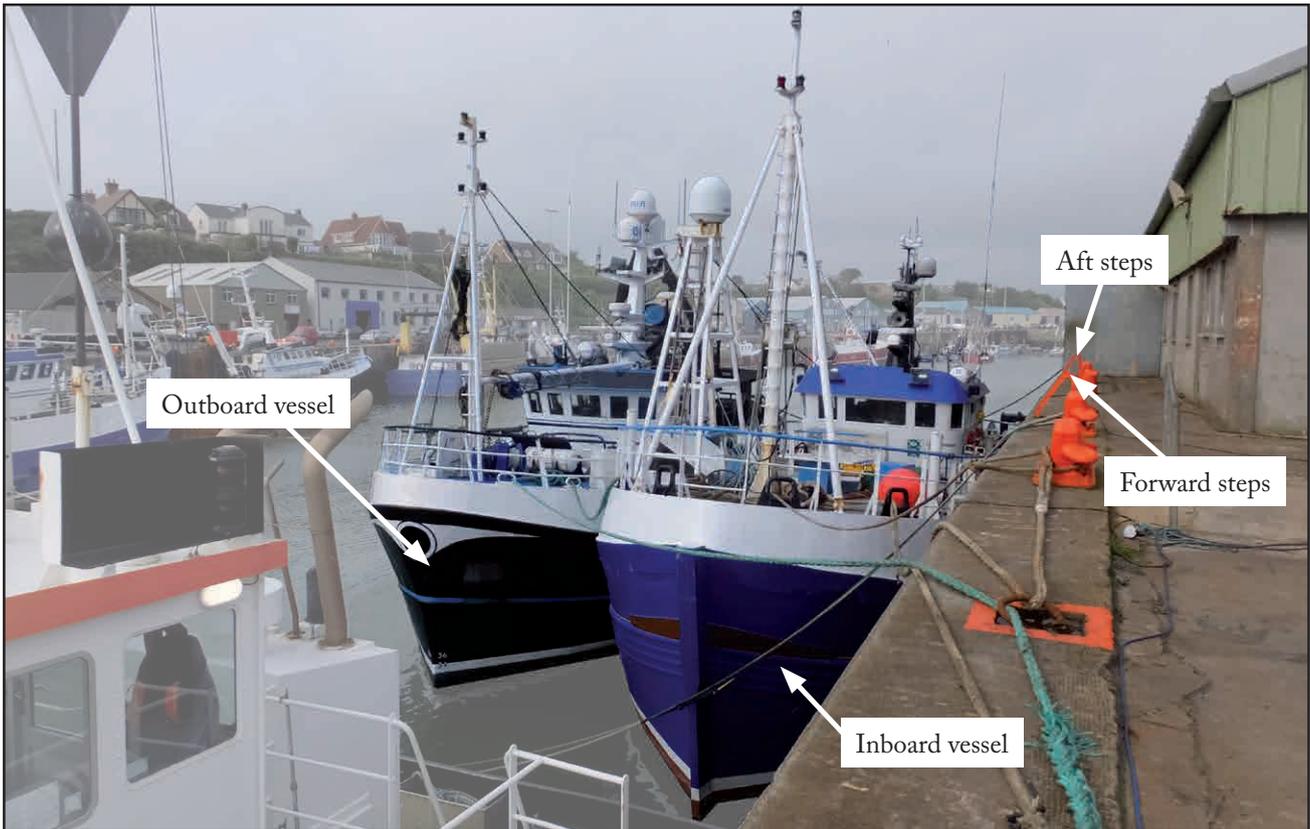
Figure 1: Mooring arrangement

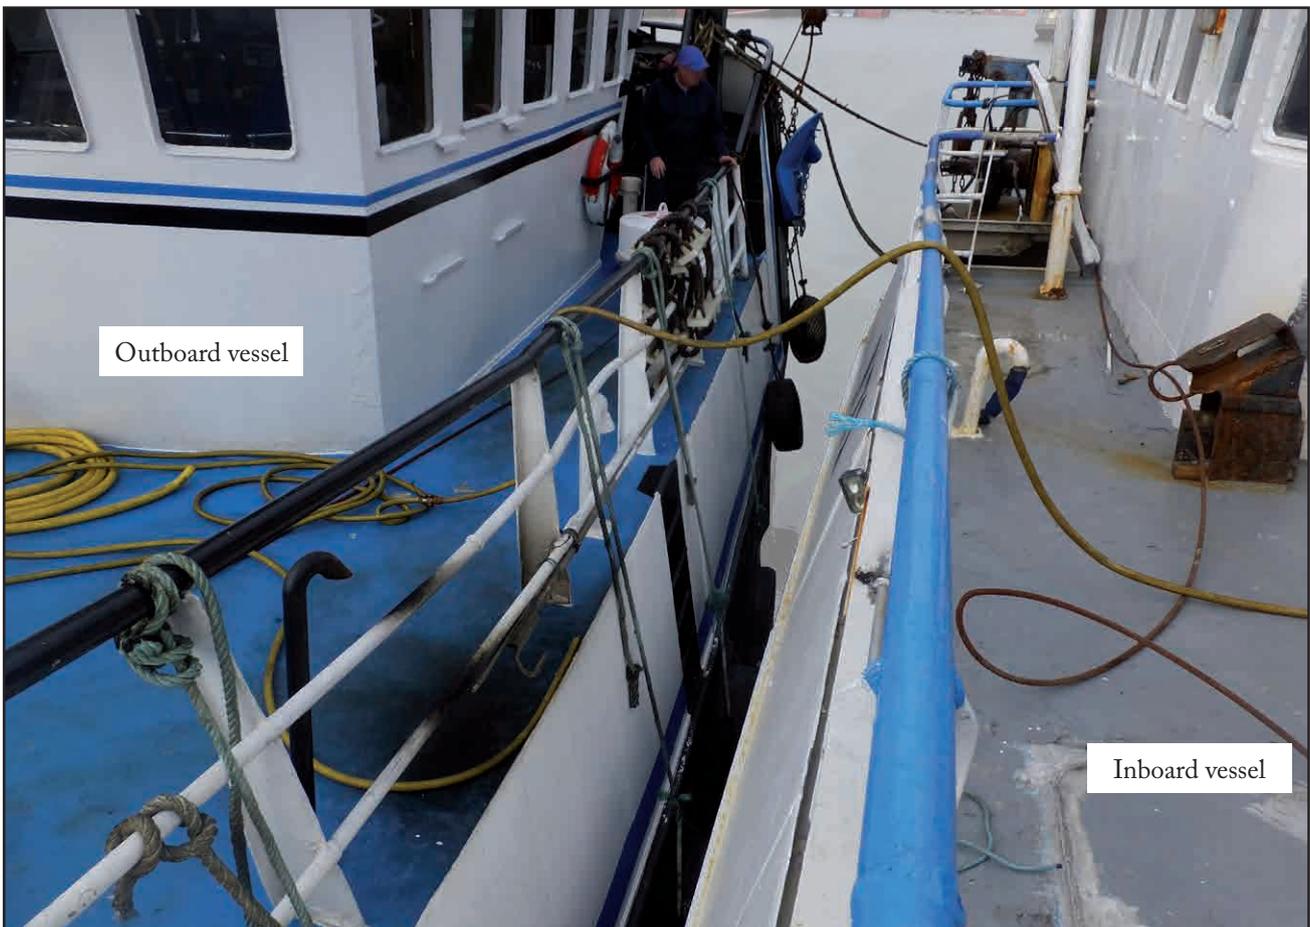
Figure 2: Vessel to vessel access

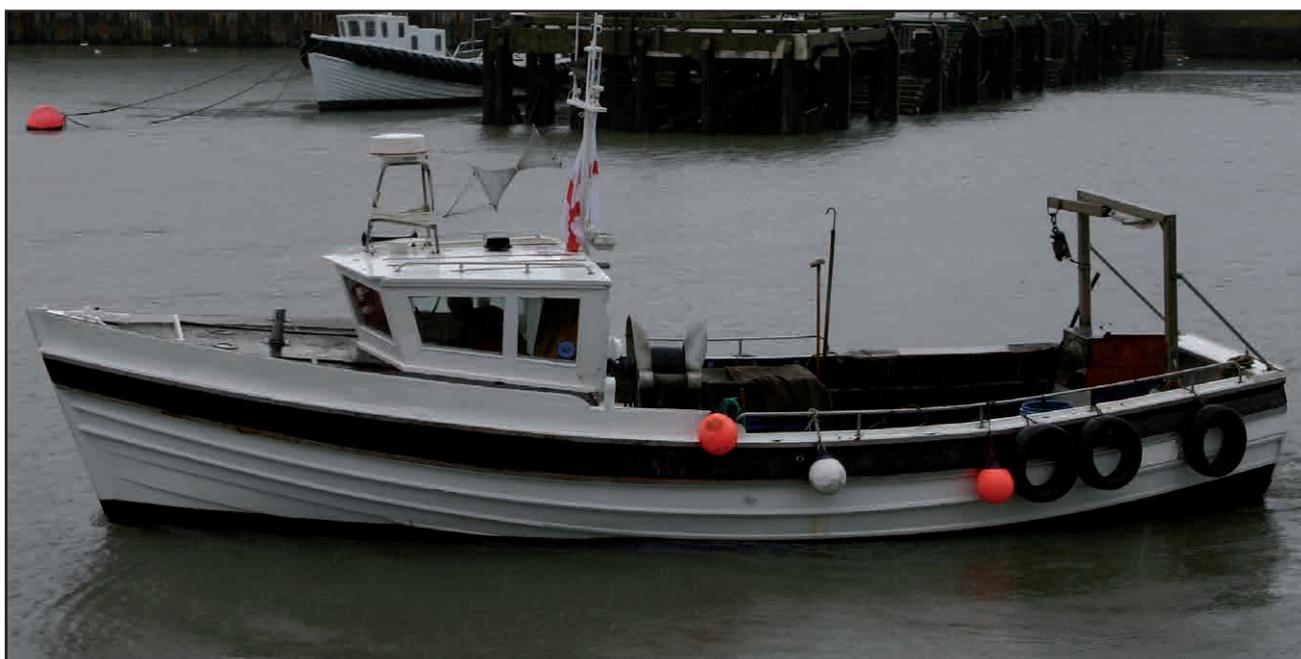
Throughout the morning's fishing, the bilges of the boat had remained dry. The flooding was sudden and was observed to come from the forward part of the boat, and was most likely due to a sprung hull plank. Although the boat was fitted with an electric bilge pump that was started straight away by the skipper, the volume of incoming water soon overwhelmed it and the boat sank.

Figure: The wooden clinker-built fishing vessel

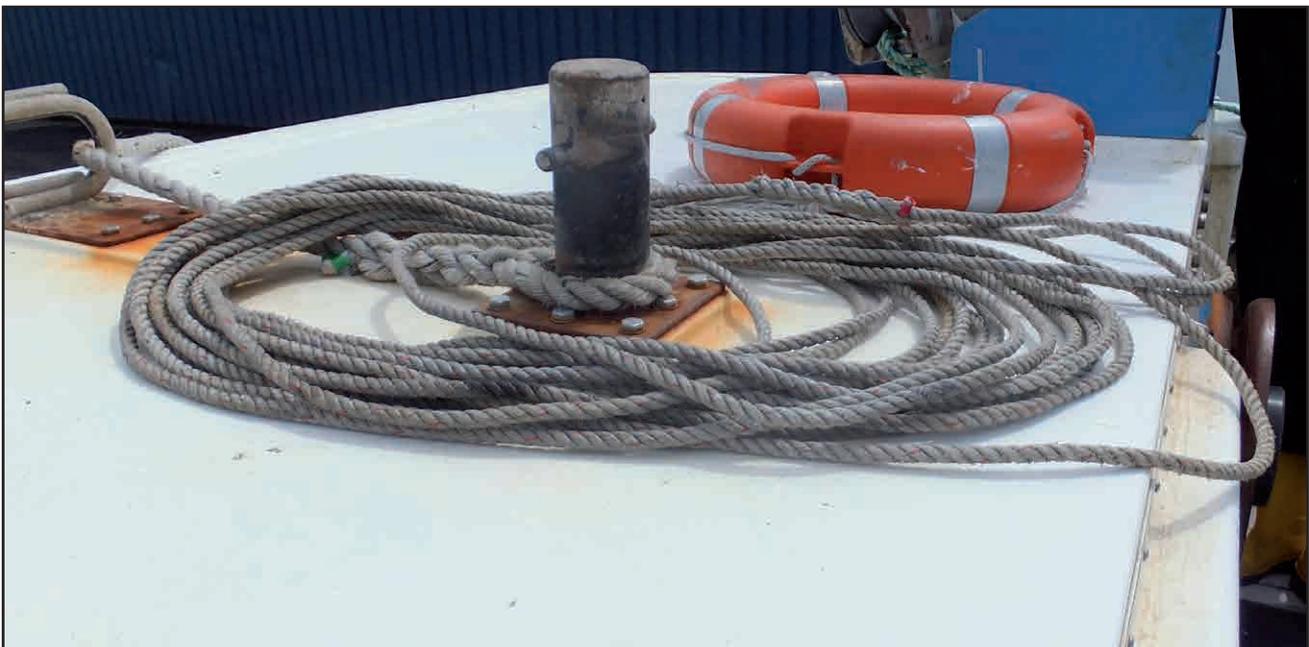
The lost crewman had possibly been using recreational drugs that were found among his personal effects on board, and he had jumped into the water despite the skipper instructing him not to do so. He and the other deckhand almost certainly suffered from cold water shock following immersion.

Figure: The lifebuoy and polysteel rope

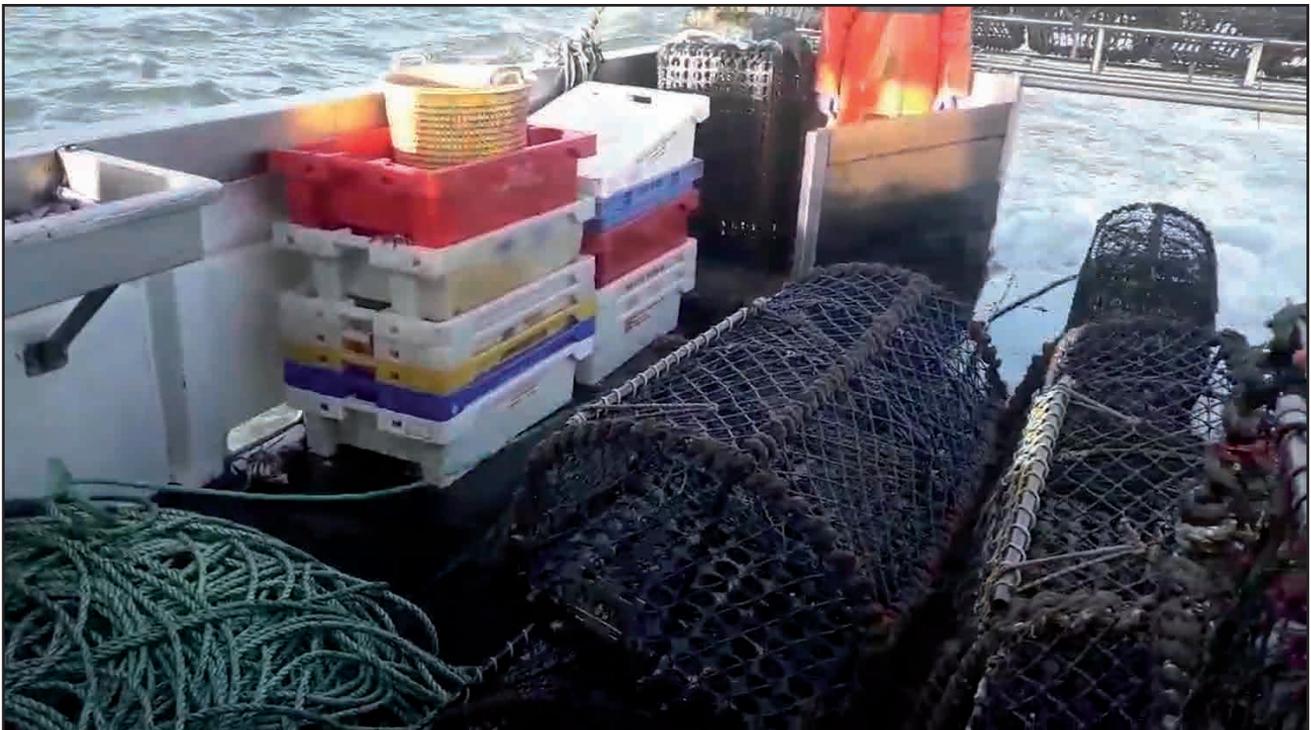
When shooting a fleet of pots, the deckhand usually remained in a ‘safe area’ behind pound boards (see figure) until about five or six pots remained on deck. The deckhand could then walk over the relatively clear deck towards the wheelhouse to complete the shooting process by dropping the fleet’s remaining anchor and marker buoy. This time, the deckhand left the ‘safe area’ without apparent reason, and attempted to cross over the running backrope while about 20 pots and their associated lines remained on deck.

Figure: Typical set-up when shooting pots

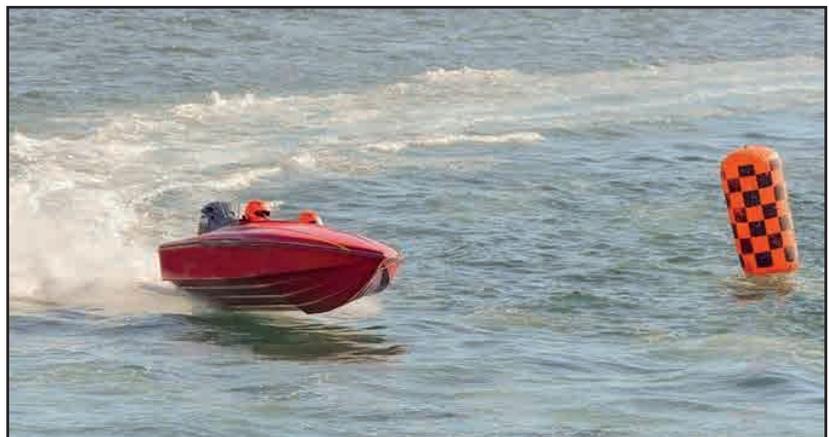
The driver suffered three broken ribs and was discharged from hospital later that day. The navigator had suffered a very deep laceration to his ankle and, unfortunately, his foot was later amputated.

Figure: The racing powerboat (not during the accident)

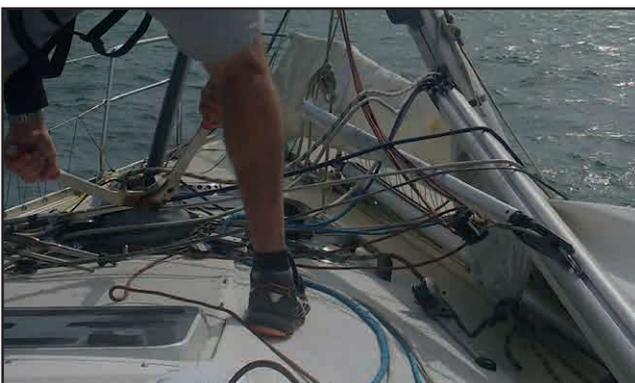
The skipper checked the welfare of the students, assessed the damage and informed the coastguard. He then cut the remaining rigging free, dropping it to the seabed, and returned to port under engine power.

Figure 1: The rigging being cut

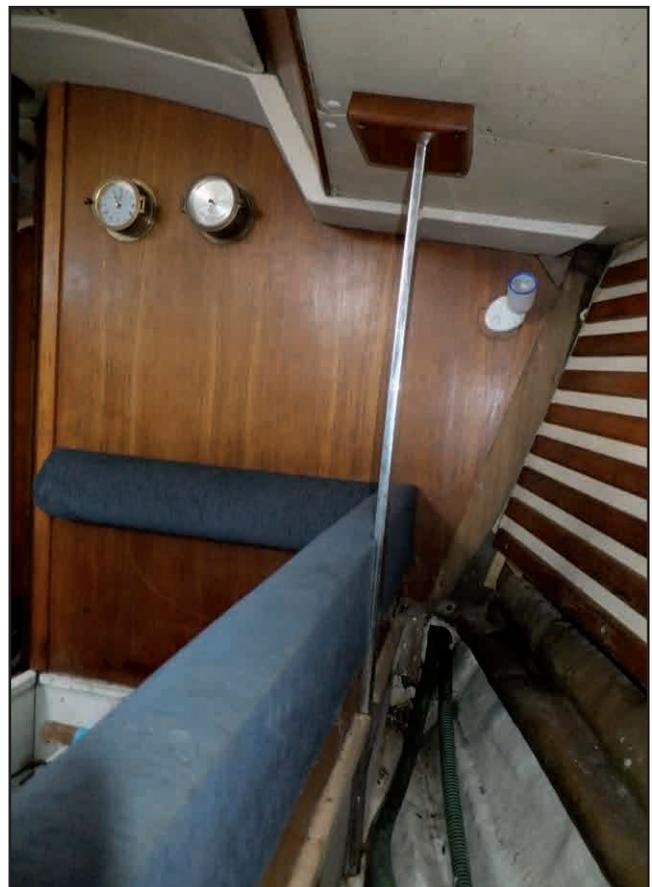
hull structure (Figure 2). The investigation into the cause of the failure found that the weld between the tie bar and lateral retaining member embedded within the GRP of the hull structure, had failed (Figure 3).

Metallurgical testing of the failed tie bar found that

- The weld fracture occurred as a result of cyclic loading
- The weld was not a full penetration weld
- Surface corrosion was found close to the point of failure but was not considered a causal factor.

This boat had been in commercial ownership for a number of years and had covered a lot of miles. The cyclic loading on the tie bar would therefore have been high, and ultimately led to the failure of the welded joint.

Figure 2: The starboard tie bar intact and in-situ

1. This vessel recently had all of its standing rigging renewed; it was not deemed practical to inspect the tie bar securing point as it was inaccessible without removing a significant amount of the internal fixtures. However, owners and surveyors should carefully consider the risk of a failure such as this occurrence given a yacht's age and usage when deciding which critical elements of structure should be examined.

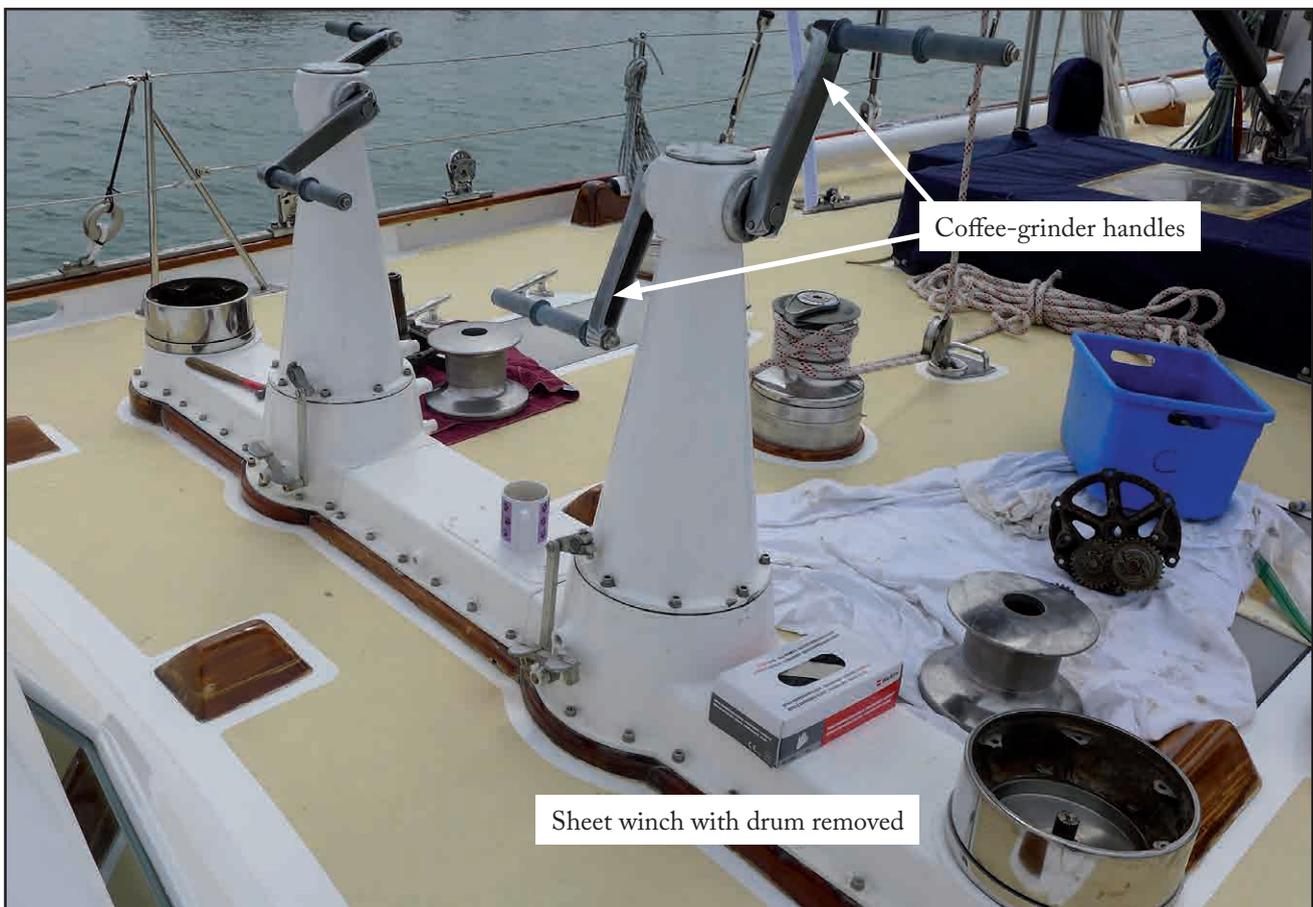
Post-accident examination of the gearing system inside the starboard winch drum identified that a load-bearing pinion on the central spindle had catastrophically failed. This had resulted in the tension in the winch drum being instantly released back up through the pedestal to the handles, causing their violent, hazardous reversal of direction.

Figure 1: Pedestal winch system

3. Should any part of a load-bearing, high tension system such as this winch require a repair or a replacement part, it is vital that the new component meets the manufacturer's design specification. If necessary, original drawings should be checked or specialists in the area consulted in order to minimise the risk of subsequent failure, equipment damage or crew injury, especially for old or bespoke systems.

4. Routine maintenance of yacht winches should include a detailed visual inspection of all the component parts. The coffee-grinders on this yacht were elderly and possibly a unique design. Therefore, it was particularly important to check for wear, especially cracks that could indicate fatigue.

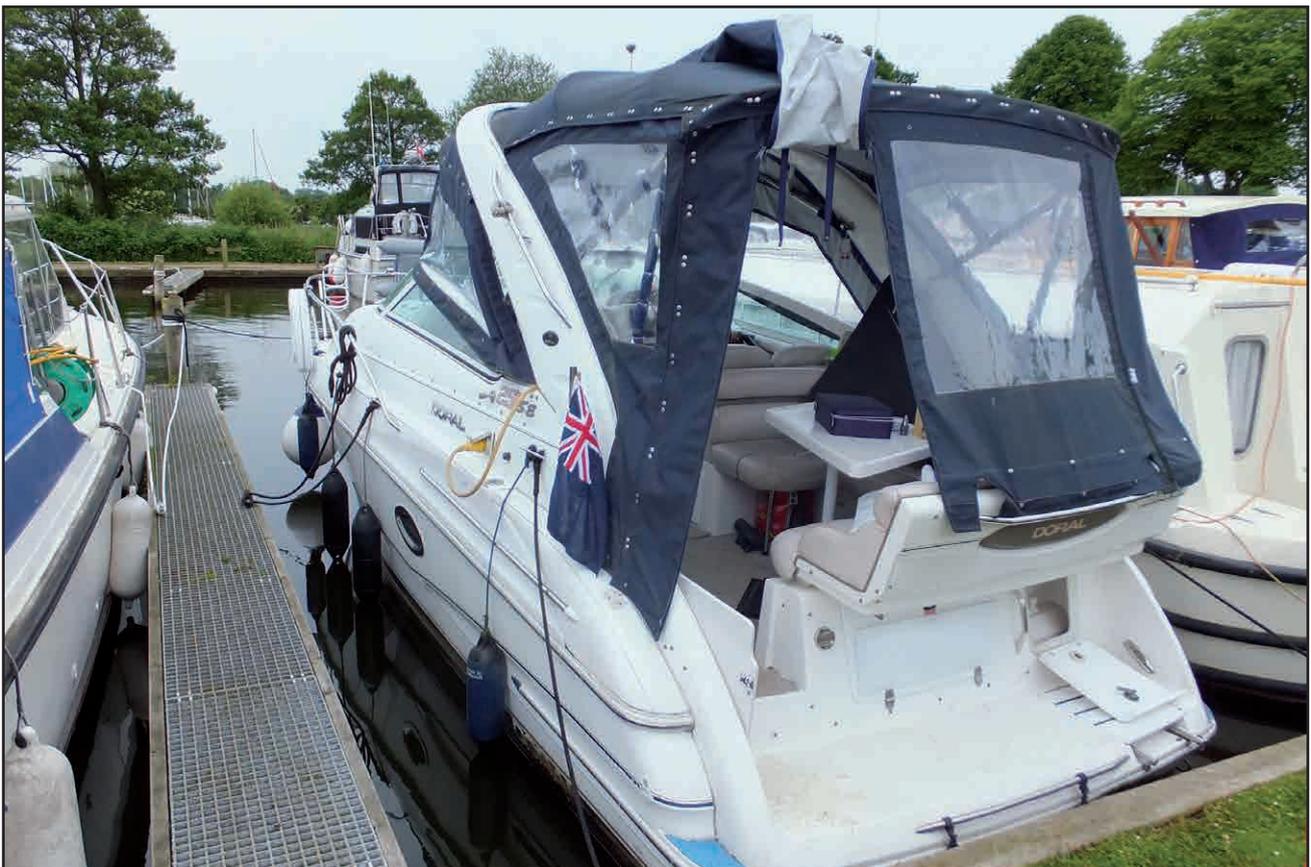
The post-mortem examination showed that the owner and his partner had died of carbon monoxide poisoning.

Figure 1: Configuration of the canvas canopy

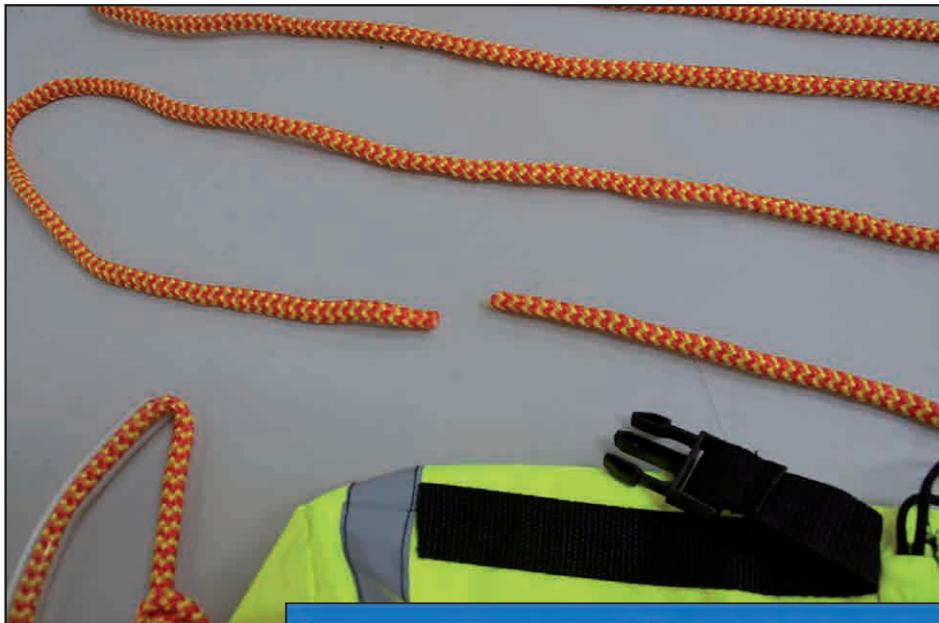
A defective throw bag rescue line was discovered while Warrington Rowing Club was conducting boat capsizing drills for new rowers at Halton Baths in Cheshire, UK. A 15m long polypropylene rescue line in a throw bag, supplied by Riber Products Limited (RIBER), parted (**Figure 1**) while a young person in the water was being pulled to the side of the pool during a simulated rescue. There were no injuries. The rowing club safety advisor subsequently found another throw bag with a defective rescue line that had been purchased from the same supplier. RIBER was informed and the company contacted its customers after identifying a batch of 208 throw bags that could be at risk. A further three defective rescue lines have been identified as a consequence of the customer warning notice posted on Facebook (**Figure 2**).

Figure 1: RIBER 15m throw bag rescue line

On inspection, the defective RIBER throw bag rescue lines identified by Warrington Rowing Club were found to have been made up of sections of polypropylene rope fused together, which broke easily at the joint when put under tension. One line was constructed of two sections of rope fused together, the other was constructed of four sections of rope, resulting in three fused joints in its 15m length (**Figure 3**). Intact and joined sections of one of the defective rescue lines were tested to determine the line's minimum breaking load. The intact section failed at 256 kgf (kilogramme force) and the joined sections failed between 19 and 23 kgf.

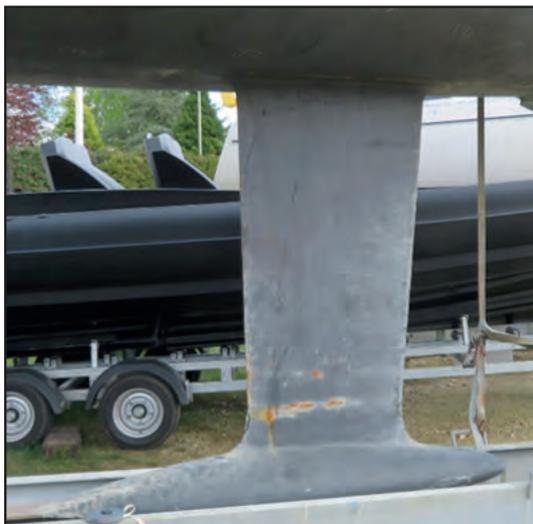
- A 3200kg, 'deep draught bulb keel', consisting of a cast iron fin with a lead bulb fixed to its base (**Figure 2a**); or,
- A 3700kg 'shallow draught, lead keel', consisting of a fabricated rectangular stainless steel top plate and frame, onto which lead was cast to form the keel (**Figure 2b**).

Figure 2a: Deep draught bulb keel not affected by this safety bulletin
